Goulden House Cooperative

Goulden House Structural Survey Report

May 2022

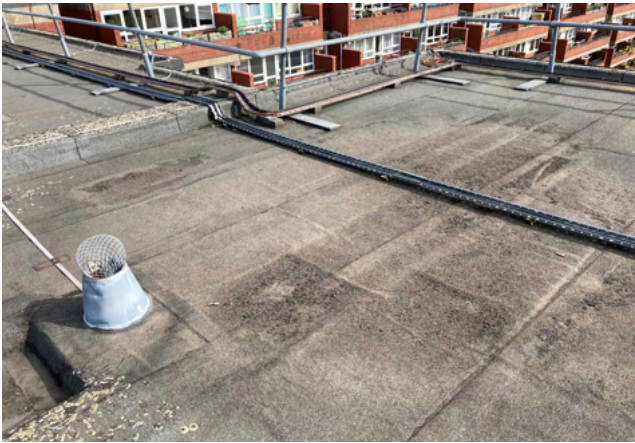
The roof slab is covered with insulation and felt. The drainage inlets are clean and there is evidence of good drainage on the roof. There are however isolated cases of water ponding and a single case where filth is accumulating around the inlet and needs to be cleaned.

Photo 3.1: Roof surface showing evidence of rainwater ponding

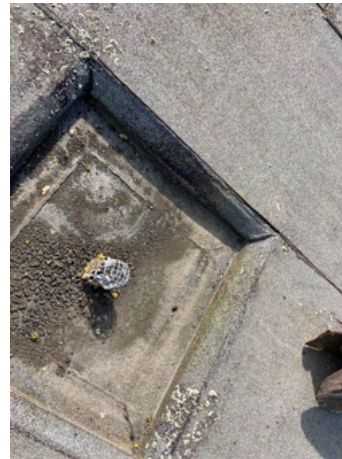
Photo 3.2: Filth around drainage inlet

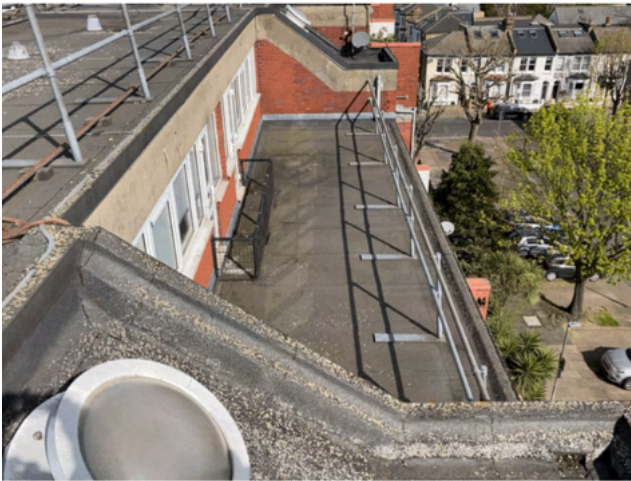
Photo 3.3: 5th floor Communal Balcony Evidence of rainwater ponding

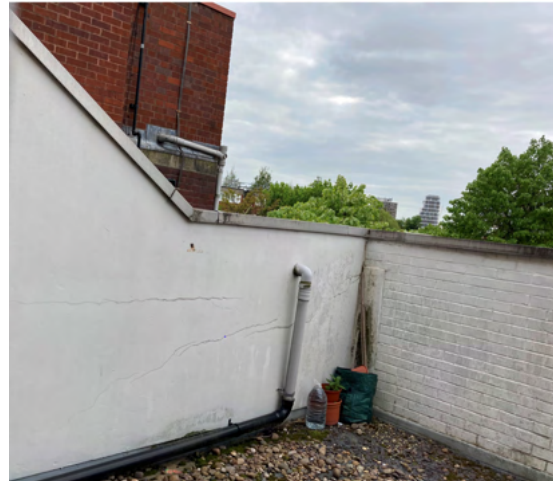
Similar pattern of cracks can be seen where the side walls to the terraces are rendered. The cracks appear to be in the render. Movement of the brick walls could have caused the brittle finishes to crack. Further intrusive investigation will be required to establish the cause of the cracks and undertake repair works. Repair works should be undertaken before the terraces are open to the residents.

Photo 3.4: 4th Floor Communal Terrace opposite flat 202 showing cracking of side wall

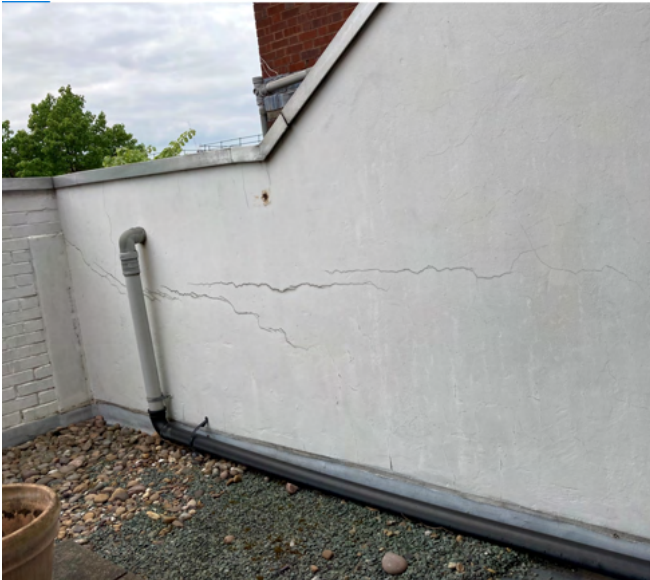
Photo 3.5: 4th Floor Communal Terrace opposite flat 218 showing crack in side wall

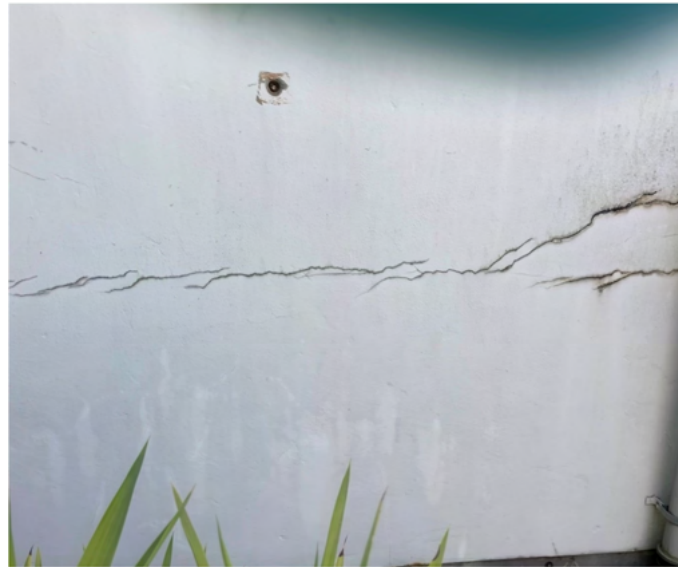
Photo 3.6: 4th Floor Communal Terrace opposite flat 232 showing crack in side wall

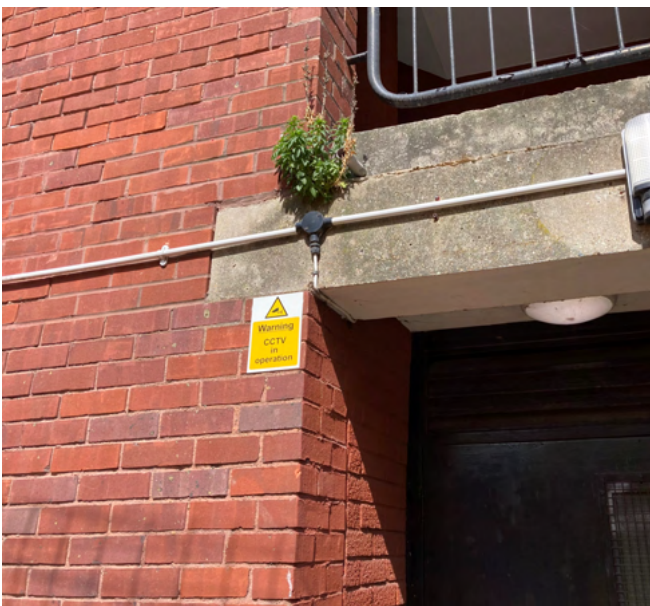
Photo 3.7: 5th floor side elevation adjacent Ball Park. Vegetation growth

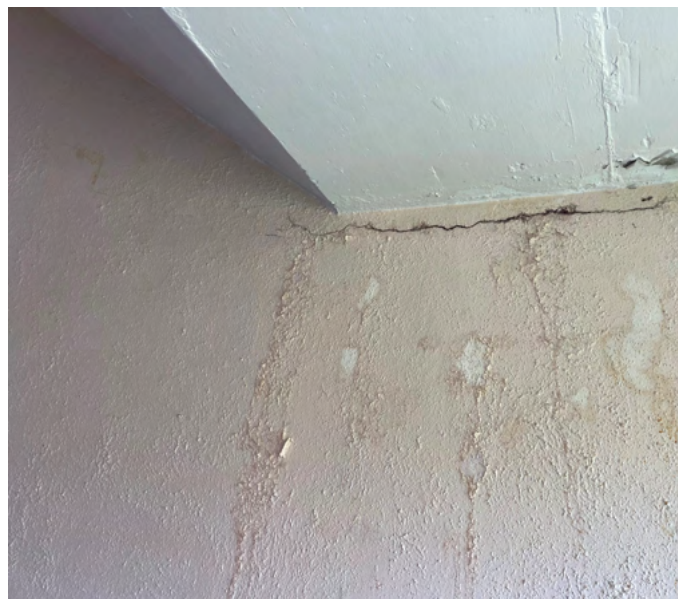
Photo 3.8: Sloped Roof over stairs to sub entry to flats 247-248: Horizontal crack in wall beneath slab. Evidence of moisture ingress.

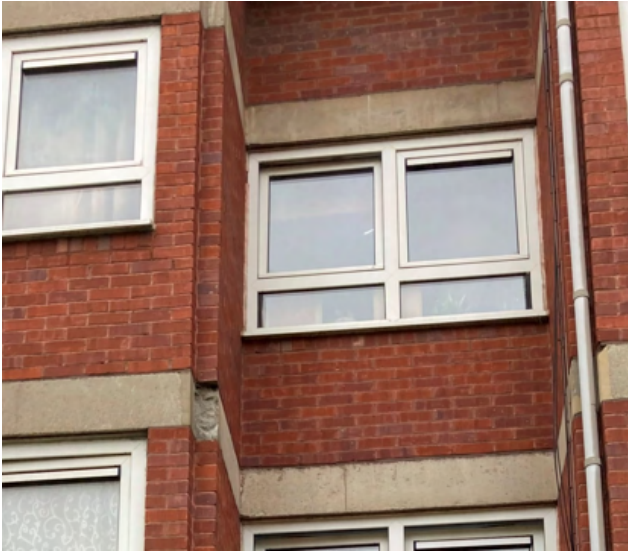
Photo 3.9: 2nd floor slab adjacent flats 128 and 129 Loss of concrete at slab recess leaving brickwork unsupported.

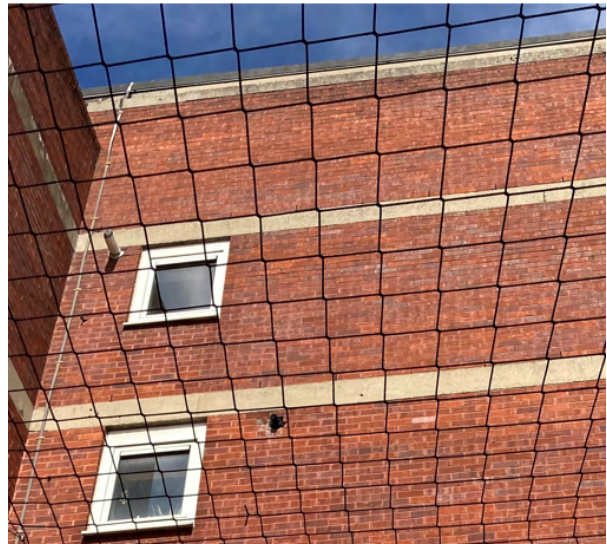
Photo 3.10: Side elevation facing Ball Court showing hole in brickwork underside of 4th floor slab.

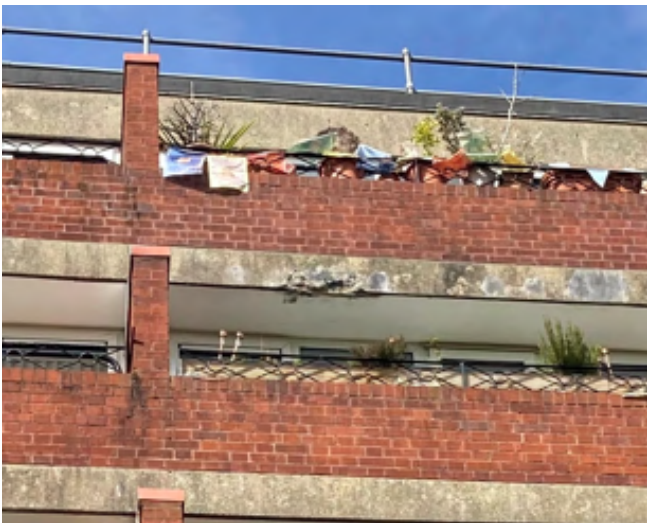
5 th floor balcony and roof slab/beam	Between flats 44 and 38	Spalled concrete exposing reinforcement	Reinforcement corrosion	Photo 3.11
	5 th floor slab/beam	Between sub-entry containing flats 32 and 38	Spalled concrete cover exposing reinforcement	Reinforcement corrosion	-
	5 th floor beam	Adjacent sub-entry to flat 32	Corner of concrete beam cracked.	Reinforcement corrosion	-
	3 rd and 5 th floor slab/beam	Fire stairwell between flat 32 and stairwell	Spalled concrete cover exposing reinforcement	Reinforcement corrosion	-
	2 nd floor slab/beam	Entrance to flats 1 and 2	Cracks in concrete	Reinforcement corrosion	-
	5 th floor slab/beam	Between flats 1/ 2 and 3/4	Spalled concrete adjacent flats 1 and 2 area.	Reinforcement corrosion	-
	3 rd floor slab/beam	Between flats 5 and 6 and fire escape stairwell	Spalled concrete cover exposing reinforcement	Reinforcement corrosion	-
Winders Road	1 st floor balcony cantilever	Adjacent entry to flats 26-28	Cantilever with diagonal crack at the	Reinforcement corrosion	Photo 3.33

Photo 3.11: Spalling of concrete at bottom of 5th floor balcony slab and roof beam facing inner green between sub entry to flats 37-38 and 44-43

Concrete repair works can be undertaken to address the problem. Depending on the degree of spalling the whole surface of local repairs can be undertaken. The process involves testing of the concrete to determine the depth of carbonation and cutting back the concrete to remove all concrete that has been affected. Next the reinforcement is grit blasted to remove all corrosion to the bright metal. The reinforcement is then coated with anti-rust material. Finally, the concrete is repaired using cementitious material such as Fosroc Renderoc products.

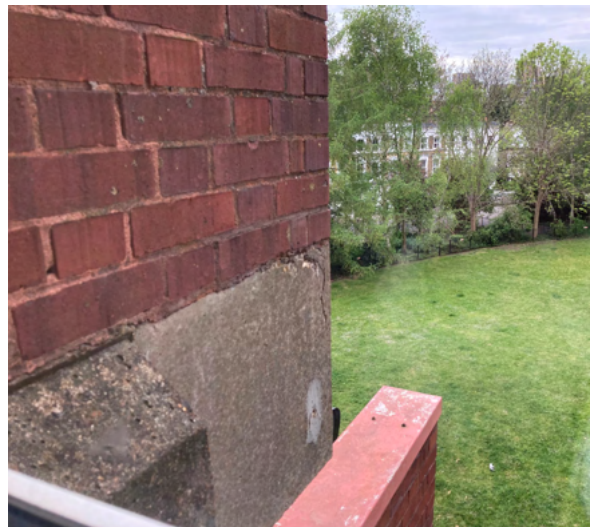
Photo 3.12: Crack in top corner of beam facing green adjacent stairwell to flats 247-248. Visible from landing window.

The cracks in concrete in some of the beams may be due to reinforcement corrosion. Monitoring can also be undertaken to determine whether they are live or historic.

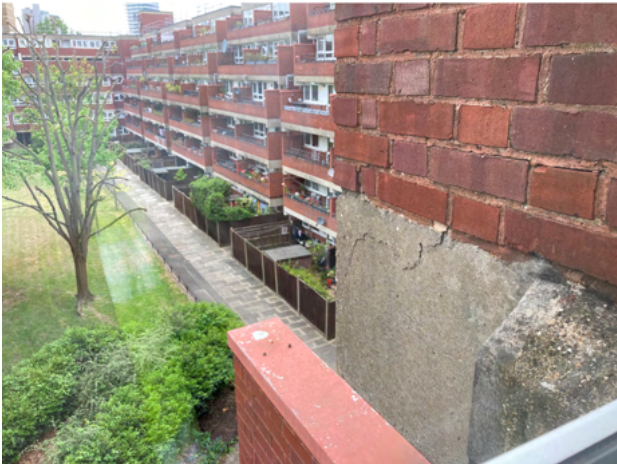
4 th floor column	At RHS of entrance to flats 249-251	Severe crack at base and medium crack at the top.	Reinforcement Corrosion	Photos 3.16 and 3.17
	Masonry top of 5 th floor slab	Between entrance to flats 264-269 and fire escape stairs	Missing bedding to brickwork	Poor workmanship and/or deterioration of mortar	
	4 th floor column	Infront of entrance to flats 252-257	Crack and spalled concrete at base of column	Reinforcement corrosion	Photo 3.15
	4 th floor lintol	Over storage window facing inner green opposite sub entry to flats 227-230	Badly spalled concrete to bottom RHS corner of lintol.	Reinforcement corrosion	Photo 3.38
	4 th floor balcony beam	Facing green adjacent to stairwell to flats 247-248. Visible through stair landing window.	Crack in top corner of beam	Reinforcement corrosion	Photo 3.12
	4 th floor balcony beam	Facing green adjacent stairwell to flats 208-209. Visible	Crack in top corner of beam	Reinforcement corrosion	Photo 3.13

Photo 3.13: Crack in top corner of beam facing green adjacent stairwell to flats 208-209. Visible from landing window.

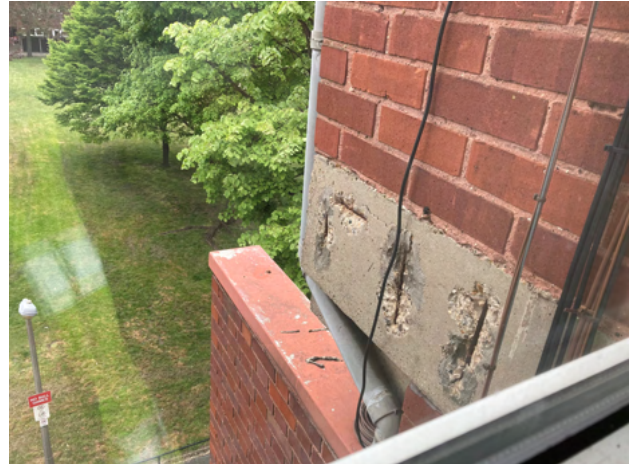
from stair landing window.			
	4 th floor balcony beam	facing green adjacent stairwell to flats 216 and 217. Visible from landing window.	Spalling of concrete on beam surface exposing reinforcement	Reinforcement corrosion	Photo 3.14

Photo 3.14: Spalling of concrete on beam surface exposing reinforcement, facing green adjacent stairwell to flats 216 and 217. Visible from landing window.

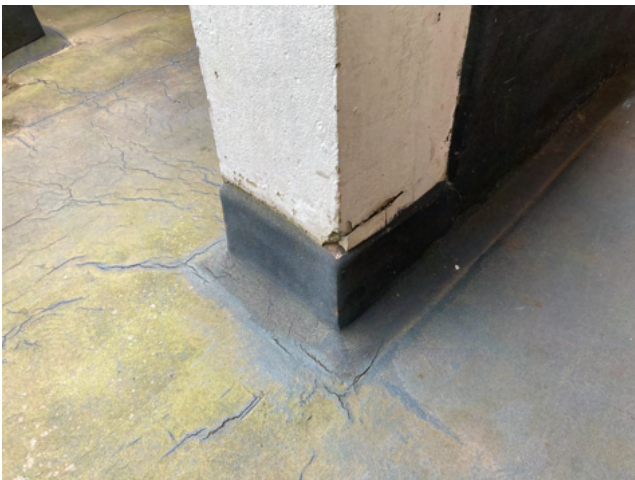
Photo 3.15: Crack in base of column on 4th floor walkway in front of sub entry to flats 252-257

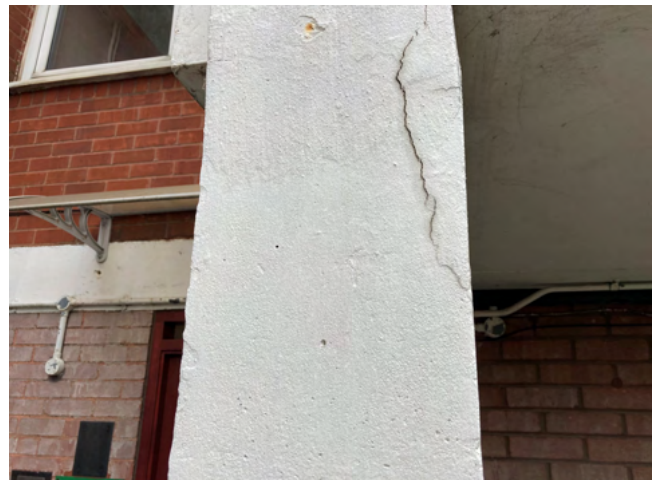
Photo 3.16: Crack at the top of column in front of sub entry to flats 249-251 on 4th floor walkway

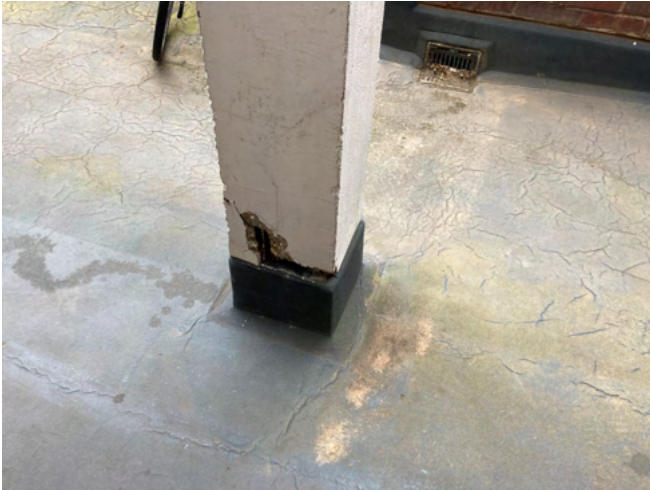
The Column in front of sub entry to flats 249-251 (Refer to Photo 3.17 in Appendix A) and the column adjacent to entry to flats 165-170 (Refer to Photo 3.19 in Appendix A) are severely damaged at the base. Urgent attention should be given to repairing these columns before they become dangerous. The lower sections of these columns may need to be rebuilt.

Photo 3.17: Crack and spalling of concrete at base of column in front of sub entry to flats 249-251 on 4th floor walkway.

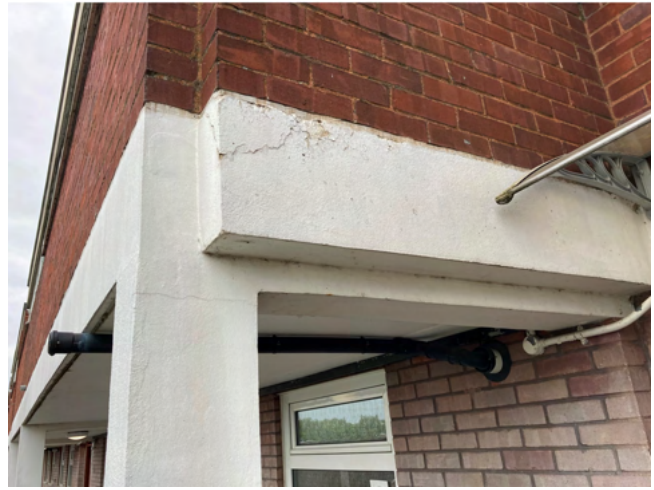
5 th floor beam	RHS entrance to flats 177-182	Spalled concrete at bottom and top corners	Reinforcement corrosion	Photos 3.21 and 3.22
	5 th Floor Beam	Adjacent to entrance to flats 165-170	Diagonal crack in top of beam	Reinforcement corrosion	Photo 3.18
	Column	Adjacent to entrance to flats 165-170	Long crack at base	Reinforcement corrosion	Photo 3.19
	5 th Floor beam and column joint	Adjacent to entrance to flats 171-176	Severe spalling of concrete to beam	Reinforcement corrosion	Photo 3.20
	5 th Floor slab	Between flats 190-194 and 195-197	Concrete spalling from slab edge. Fine crack in slab	Reinforcement corrosion	-
	5 th Floor slab	Adjacent entry canopy to flats 198-200	Spalling of concrete to edge of 5 th floor slab on LHS	Reinforcement corrosion	-
	Corner column	Adjacent entry to flats 198-200	Crack at slab and column joint	Reinforcement corrosion	
	4 th floor column	Adjacent entrance to 264-269	Crack at top of RHS column	Reinforcement corrosion	Photo 3.39

Photo 3.18: crack at top corner of beam LHS of entry to flats 165-170 at on 4th floor walkway.

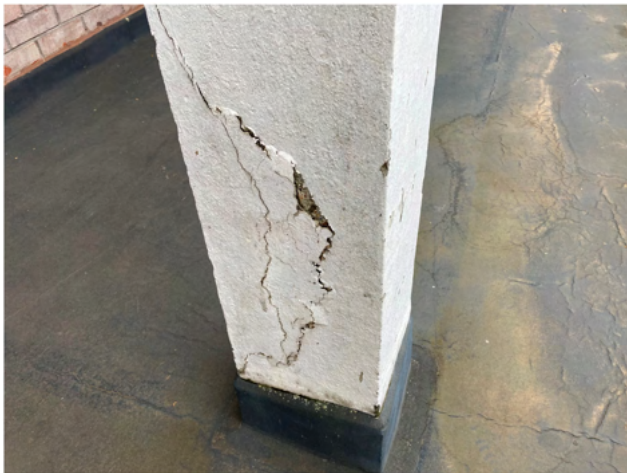
Photo 3.19: Column fractured at bottom on 4th floor walkway, adjacent entry to flats 165-170

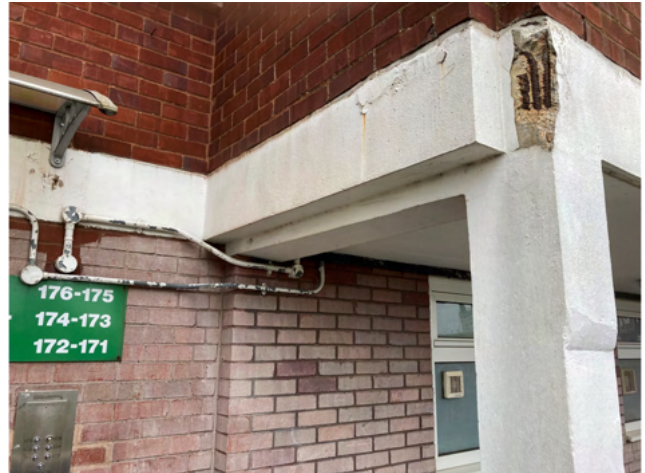
Photo 3.20: Severely spalled concrete exposing reinforcement at beam and column joint on 4th floor walkway adjacent entry to flats 171-176

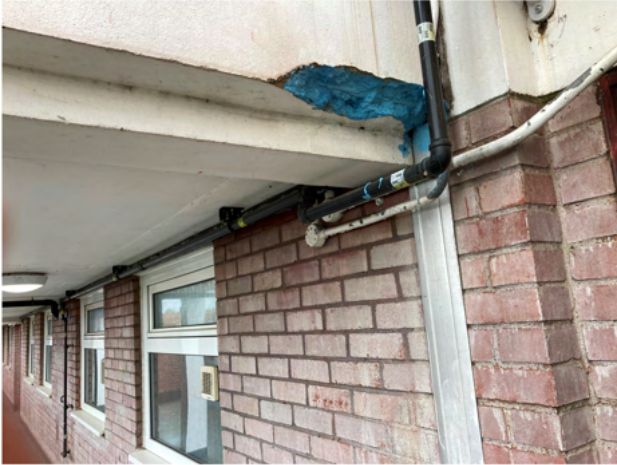
Photo 3.21: Severely spalled concrete with surface painted. Adjacent to entry to flats 177-182 at 4th floor walkway. Same beam in photo 22.

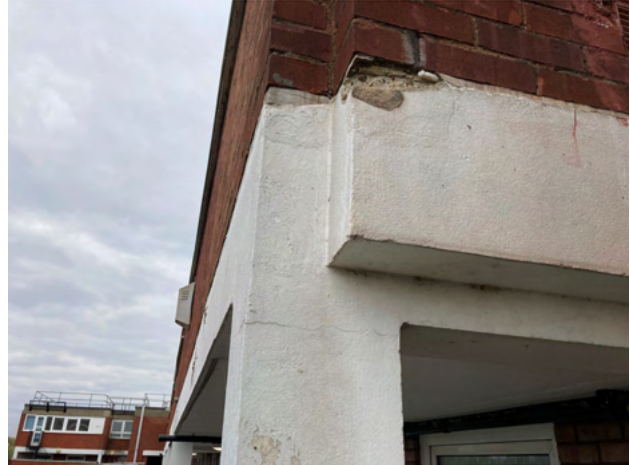
Photo 3.22: Spalling of concrete at top corner of beam. Same beam in photo 21

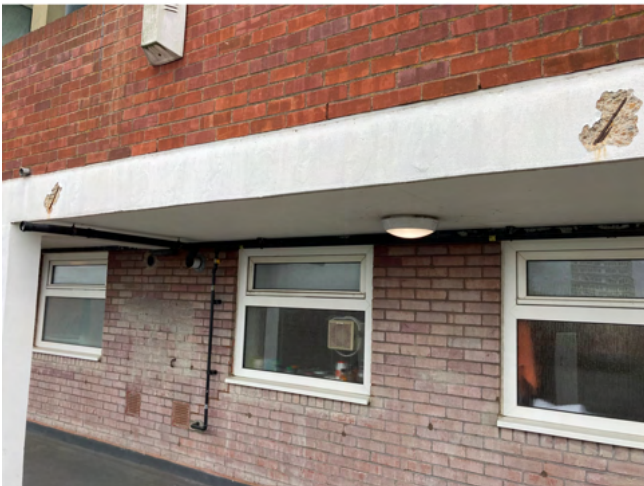
Flat 187	Lintel to living room windows and door	Severely spalled concrete	Reinforcement corrosion	Photo 3.32
	Flat 41	Balcony upstand supporting brick parapet.	Spalled concrete	Reinforcement corrosion	-
	Flat 164	Lintel to living room	Drilled holes to insert ties not reinstated		-
	Flat 66	Lintel to living room	Ties left in place. Spalling of concrete at LHS	Reinforcement corrosion	-
	Flat 167	Upstand and lintel	Spalling of concrete	Reinforcement corrosion	-
4th Floor Walkway	Asphalt surfacing to walkway	General	uneven surface and cracks ranging from medium to severe.	Weathering	Photo 3.25
	Asphalt surfacing and termination on walls	Adjacent entry to flats 198-200	Asphalt severely cracked and termination on wall peeling off.	Weathering	Photo 3.24
	5 th floor slab	Between entrance to flats 177-182 and 183-188	Concrete spalling	Reinforcement corrosion	Photo 3.23

Photo 3.23: Spalling on 5th floor slab edge visible from 4th floor walkway between entry to 177-182 and 183-188

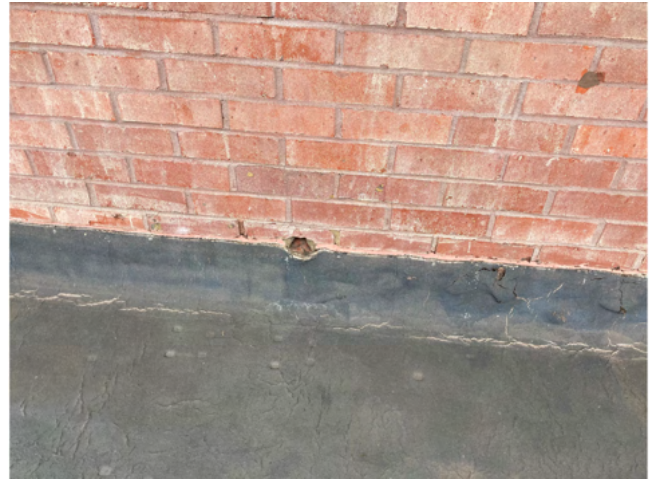
As mentioned in section 3.1, the surface is uneven in many areas. The asphalt has cracks ranging from minor to very severe (Refer to photos 3.24 and 3.25 in Appendix A). The termination on the walls has cracked with holes formed in it and peeling off. The severity of the cracks may have compromised the watertightness which should be investigated.

Photo 3.24: Cracked asphalt termination on wall at 4th floor walkway.

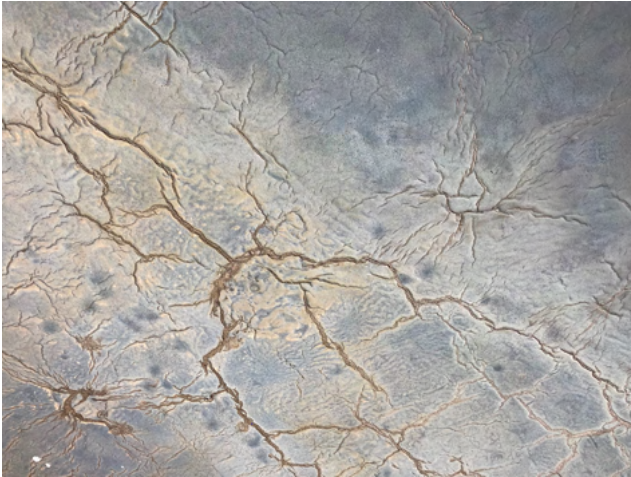
Photo 3.25: Severely cracked asphalt on 4th floor walkway

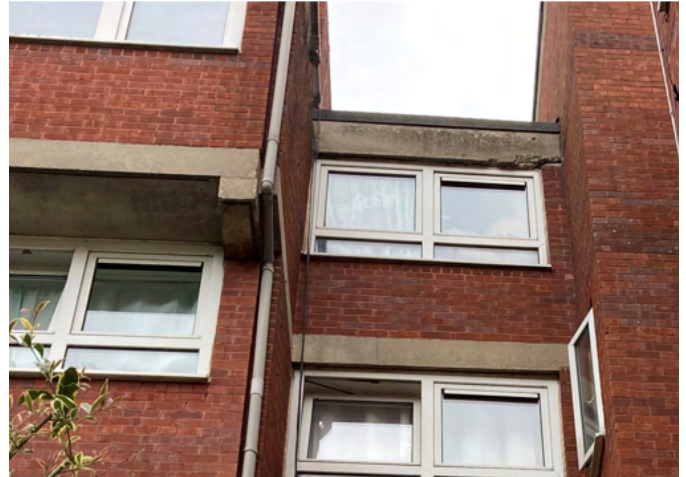
Elevations facing inner green	3 rd floor beam /slab edge	Adjacent fire stairwell Block B	Chip at corner	Reinforcement corrosion	-
	First floor perimeter beam/slab edge	facing bike shelter A	Spalled concrete cover exposing reinforcement	Reinforcement corrosion	-
	2 nd floor beam/slab Adjacent down pipes.	Sub-entry containing flat 121	Loss of concrete at the top on opposite sides	Reinforcement corrosion	-
	4 th floor	Sub-entry containing flat 116	Spalled concrete cover exposing reinforcement	Reinforcement corrosion	-
	4 th floor slab/beam	Sub-entry containing flat 109	Concrete spalling at levels 1, 2, 3 and 4 on both sides at entry point.	Reinforcement corrosion.	-
	2 nd and 3 rd floors beam/slab	Adjacent flat 127, above store shed	Spalled concrete cover exposing reinforcement	Reinforcement corrosion	-
	4 th floor beam/slab	Above flat 127	Severely spalled concrete at bottom left corner of top lintol.	Reinforcement corrosion	Photo 3.26

Photo 3.26: Spalled concrete in bottom corner of top lintol in recessed bay facing inner green above flat 127

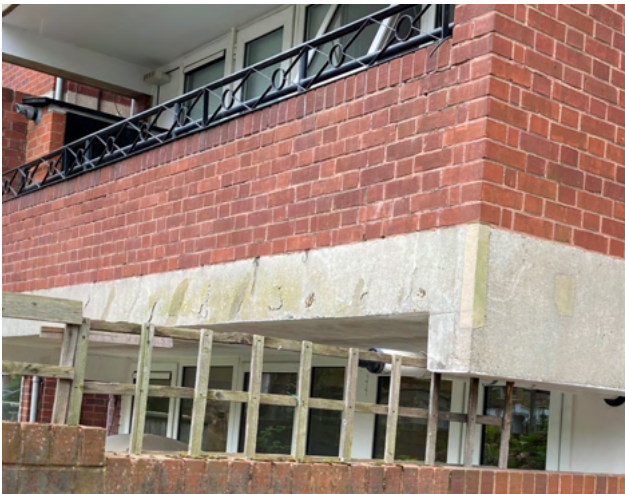
1 st floor slab	Between entrance C and entrance to flat 97	Spalled concrete	Reinforcement corrosion	-
	1 st floor slab	LHS of entrance C	Multiple cracks and bulging in concrete cover	Reinforcement corrosion	Photo 3.27
	4 th and 5 th floors and roof slab	Above entrance to flats 99 and 100	Spalled concrete	Reinforcement corrosion	-
	4 th Floor slab	Between entrances to flats 100-99 and 102-101	Spalled concrete	Reinforcement corrosion	-
	4 th and 5 th floor slab	Recessed bay between Flat 77 and Entrance B	Spalled concrete exposing reinforcement	Reinforcement corrosion	Photo 3.28
Selected Balconies	Flat 182	Lintel to living room windows and door	Spalled concrete and drilled holes	Reinforcement corrosion. Drilled holes for fixing ties not reinstated	-
	Flat 182	Underside of living room ceiling adjacent balcony lintel	Cracks in paintwork. Damp patch	moisture ingress from roof.	Photo 3.31
	Flat 182	Balcony upstand supporting brick parapet	Spalled concrete	Reinforcement corrosion	-

Photo 3.27: Multiple cracks on face of concrete slab at 1st floor, LHS of Entrance C on Bullen Street

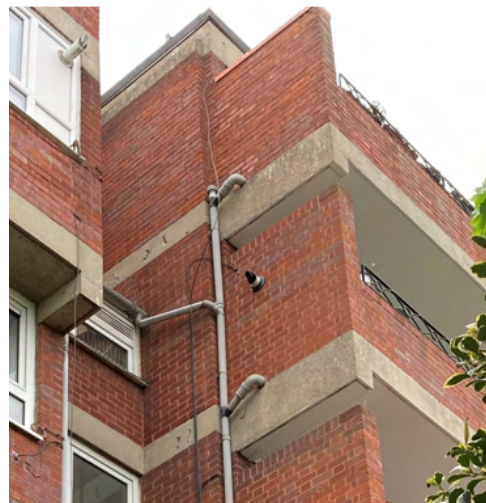
Photo 3.28: Cracks in recessed bay on 4th and 5th floor slab/beam faces adjacent downpipe between Flat 77 and Entrance B on Bullen Street

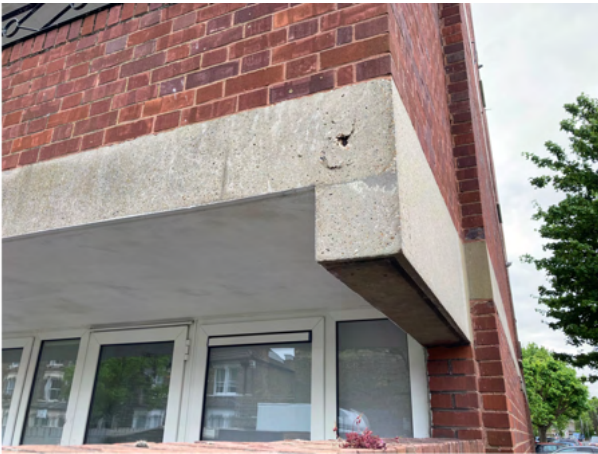
Photo 3.29: Cracked and spalled concrete on face of 1st floor slab at corner of Bullen Street and Shuttleworth Road junction.

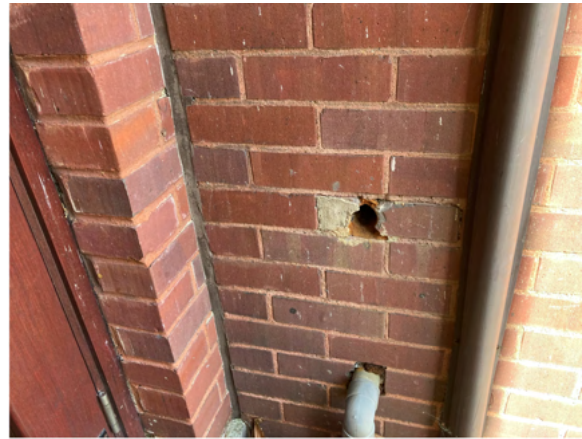
131 & 130			
	3 rd Floor balcony parapet	Between entry to flats 131&130/133 &132	Two flaking bricks	Weathering	-
	2 nd and 3 rd floors	Adjacent ground floor flat 78	Bricks damaged with drilled holes	works undertaken to insert cables.	-
	2 nd floor slab/beam	Adjacent sub-entry containing flat 56	Spalled concrete	Reinforcement corrosion	-
	3 rd floor beam	Adjacent to sub-entry containing flat 56	Spalled concrete at corner of cantilever	Reinforcement corrosion	-
	3 rd floor beam/slab	Between entrances to flats 50 and 56	Spalled concrete	Reinforcement corrosion	
	5 th floor slab/beam	Between entrances to flats 50 and 56	Spalled concrete	Reinforcement corrosion	
	2 nd and 3 rd floor slab	Adjacent sub-entry containing flat 44 near down pipe	Cracks in concrete. Repair works carried out in the past but cracks have reappeared	Reinforcement corrosion	
	Ground floor	Brick wall at entrance to flat 44	Hole in brick work at bottom right.	Created by removal of pipe which was not reinstated	Photo 3.30

Photo 3.30: Entrance side wall to flat 44 facing inner green showing hole in brickwork resulting from pipe removal.

Generally, the brick work is in good condition. There are however isolated cases listed in Table 3.1 where defects such as dislodged bricks, flaking bricks, holes created due to drilling and loss of mortar occur. These can be easily repaired.

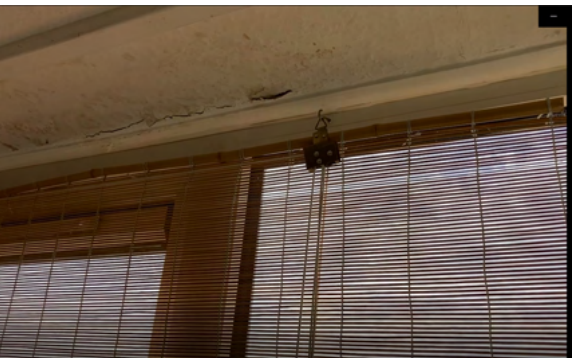
Photo 3.31: Peeling of paint underside of roof slab in living room of flat 182

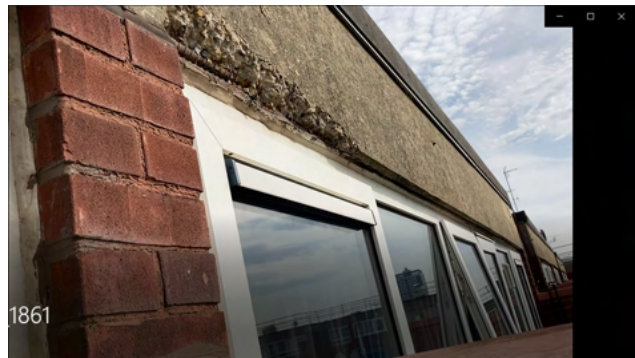
Photo 3.32: spalled concrete underside of balcony lintel in flat 187.

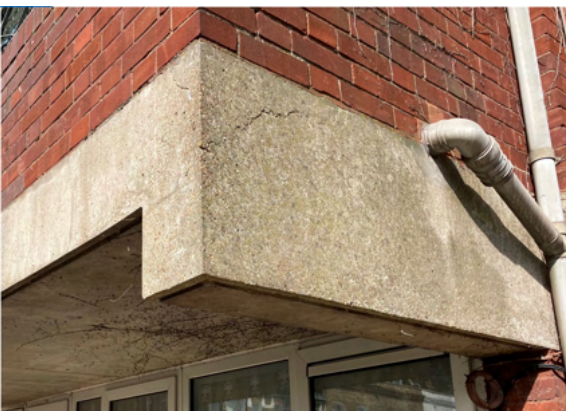
Elevation			top which appears to have been repaired in the past		
	Ground floor lintol	Below entrance A signpost	Spalling of concrete to the side and at the corner.	Reinforcement corrosion	-
	4 th Floor RHS of entrance A	Balcony slab edge/beam between entrance A and flat 24.	Spalling of concrete cover exposing reinforcement	Reinforcement corrosion	-
	4 th floor slab/beam	Above entrance to flats 12-11	Spalled concrete above entrance 12-11	Reinforcement corrosion	-
	4 th floor beam/slab	Above entrance to flats 12-11	Spalled concrete cover exposing reinforcement		-
	2 nd floor beam/slab	Between entrance to flats 8-7 and end of block	Spalled concrete cover exposing reinforcement	Reinforcement corrosion	-
	Transformer room door lintol	Corner of Winders Road and Goulden House approach	missing Brick cladding to lintol missing	Loss of bond between concrete and mortar.	
Shuttleworth Road Elevation	Ground floor beam above "Shuttleworth Road" signage	Adjacent Shuttleworth Road junction with Winders Road.	Fine vertical crack in beam at top of window	Thermal/shrinkage crack	Photo 3.34

Photo 3.33: crack in repair work to concrete beam in the past

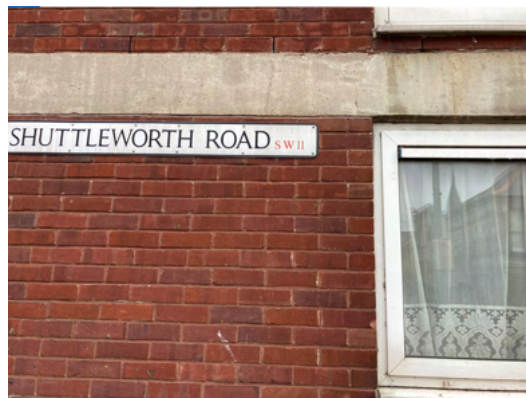
Photo 3.34: Fine crack in beam

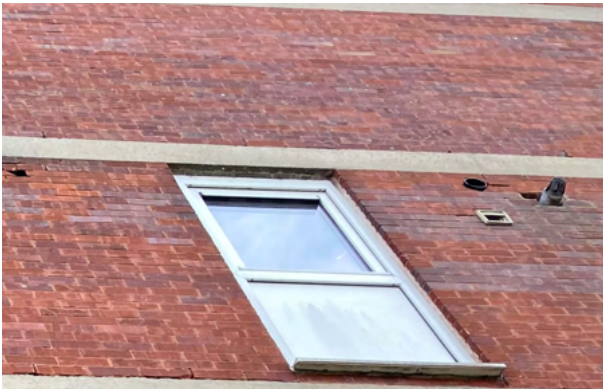
1 ST floor slab/beam	Adjacent entrance to flats 55-60	Crack at corner	Reinforcement corrosion	-
	1 st floor brickwork	Rear of flats 63-65	Loss of pointing	Weathering	-
	3 RD floor brickwork	Flank wall to flats 63-65	Broken and dislodged bricks.	Could be due to removal of ties fixed into the wall.	Photo 3.35
	2 nd floor brickwork	Flank wall to flats 63-65 facing Shuttleworth Road	Location where boiler exhaust pipe is inserted. Bricks dislodged	Damage caused by boiler installers and not reinstated.	Photo 3.36
Bullen Street Elevation	1 st floor slab/beam	Adjacent to entrance to flats 63-65 at corner of Shuttleworth Road and Bullen Street	Spalling of concrete	Reinforcement corrosion.	Photo 3.29
	4 th Floor slab/beam	Between Entrance B and flat 77	Spalling of concrete	Reinforcement Corrosion	-
	5 th Floor Slab Beam	Between Entrance B and flat 77	Spalling of concrete	Reinforcement Corrosion	-
	5 TH Floor	Between entrances B and entrance to Flats 80-79	Vegetation growth on wall	Moisture ingress	-

Photo 3.35: Holes in brick work on Shuttleworth Road elevation to flats 63-65

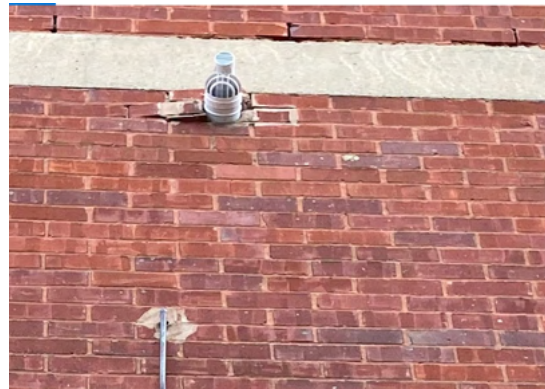
Photo 3.36: Dislodged bricks around boiler exhaust on Shuttleworth Road elevation to flats 63-65

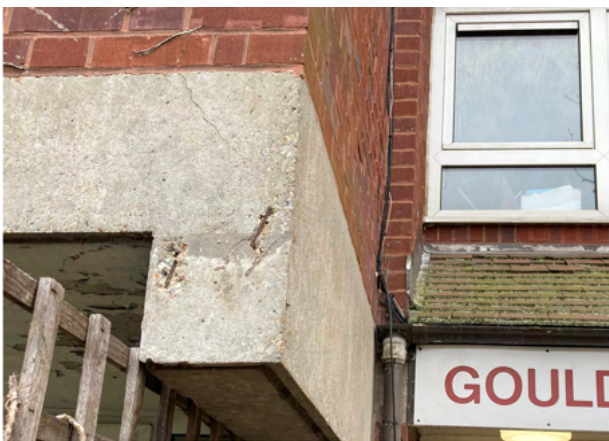
1 st Floor beam/slab	LHS of Entrance B.	Spalling of concrete exposing reinforcement in beam and diagonal crack in slab at corner of slab	Reinforcement corrosion. Diagonal crack requires monitoring and further investigation which is not part of the scope of this survey	Photo 3.37
	1 st Floor slab	LHS of Entrance to flats 80-79 adjacent downpipe	Spalled concrete leaving a hole at slab bottom corner. Evidence of past repair works.	Reinforcement corrosion	-
	5 th Floor Slab	Between Entrance C and entrance to flat 85	Spalled concrete	Reinforcement corrosion	-
	Roof slab edge	Above entrance C	Spalled concrete	Reinforcement corrosion	-

Photo 3.37: Spalling of concrete and diagonal top crack in beam LHS of Entrance B on Bullen Street

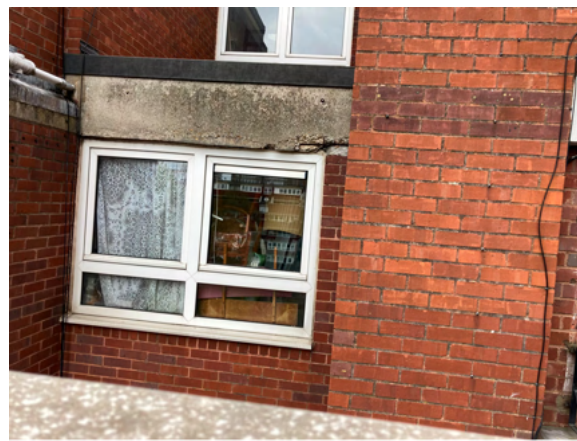
Photo 3.38: Concrete spalling at bottom RHS corner of lintol over storage window

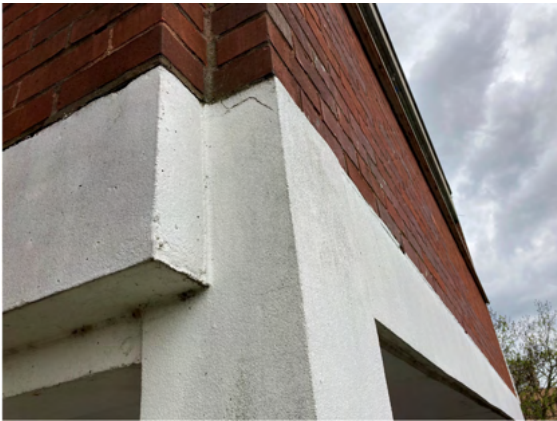
Photo 3.39: Crack at top corner of column on 4th floor walkway adjacent to entrance to flats 264-269
