# Memo

**To:** Goulden House  
**From:** **Stephanie Pascal, Project Controller**  
**CC:**  
**Date:** 18<sup>th</sup> March 2024  
**Re:** Goulden House Co-op – Intrusive Survey

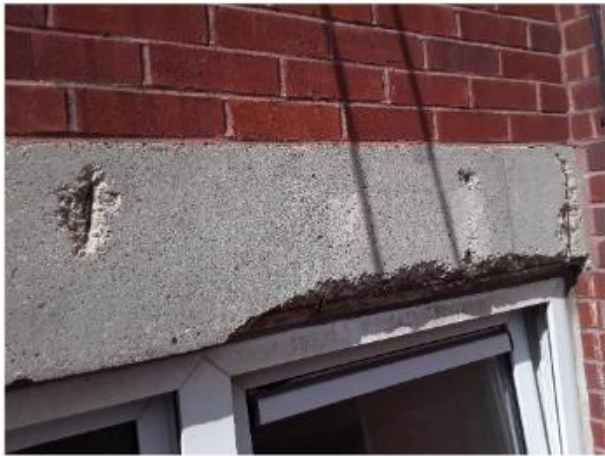
CAN’s Survey Report has confirmed that exposed concrete is in a poor condition to varying degrees throughout, with many areas of cracked and spalling concrete with reinforcement exposed and rusting at the surface. The likely cause is possible or ineffective joint/head restraint. (see attached drawings within document labelled J3L5946-GOUL-RP01)

Photo 99 – Defect EED02, Area of concrete spalls, 4 no. spalls, <100mm wide, area of previous repair, material removed during survey

It is recommended that full concrete repairs are undertaken at least within the next three years to include the application of anti-carbonation coatings to all exposed concrete members.

Short-term risk mitigation measures, comprising of cleaning, and priming of exposed rebars and infilling of spalled concrete with a proprietary repair material, can all be facilitated by roped access. The recommended permanent repairs should be undertaken within two years of any holding repairs.

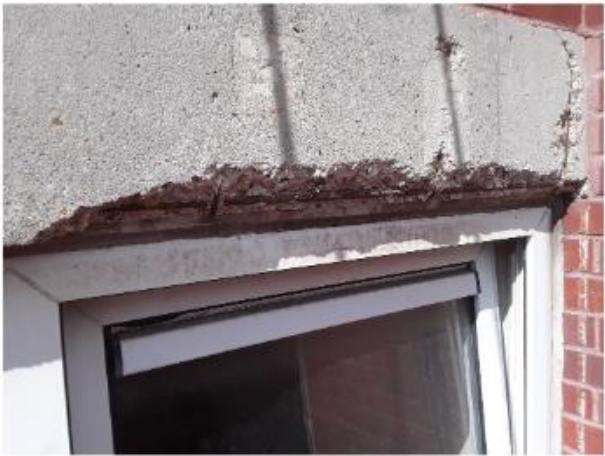
Photo 100 – Defect EED02, Area of concrete spalls, 4 no. spalls, <100mm wide, area of previous repair, material removed during survey

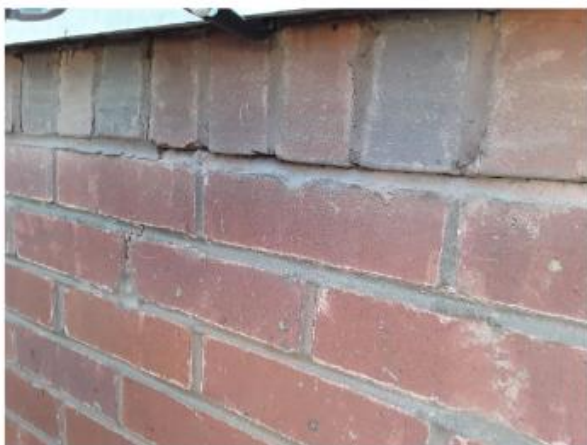
Failure of previous concrete repairs was also evident and that loose and bulging brickwork in brickwork panels mainly below and adjacent to windows were also noted which could have occurred during window replacement and carries potential damage

Photo 133 – Defect EEE19, Bulging brickwork, mortar surface degraded, and area of vertical cracks in mortar, 3 no. cracks, <2mm wide

Further investigation to reveal underlying construction/ condition and dependant on findings:  i) consider renewal of horizontal joint, re-bedding any loose brickwork and re-pointing ii) as i) + possible installation of remedial wall ties

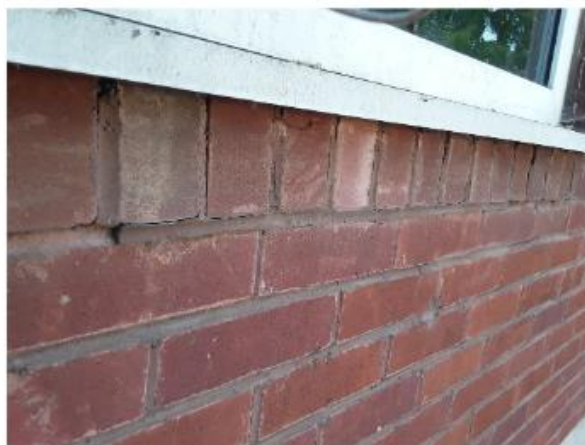
Photo 134 – Defect EEE19, Bulging brickwork, mortar surface degraded, and area of vertical cracks in mortar, 3 no. cracks, <2mm wide

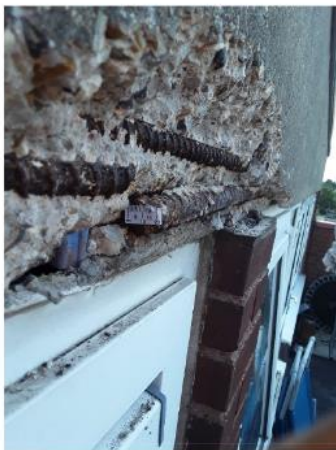
Potential risk of falling materials revealed during the survey has been removed and been left un-repaired which will accelerate deterioration of condition. (see attached drawings within document labelled J3L5946-GOUL-RP01)

Photo 671 – Defect EWU01, Spalled concrete, material removed during survey

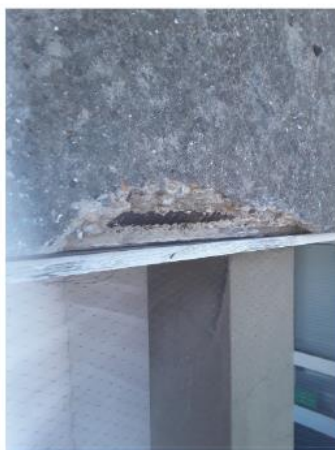
Photo 503 – Defect EWE01, Spalled concrete, material removed during survey

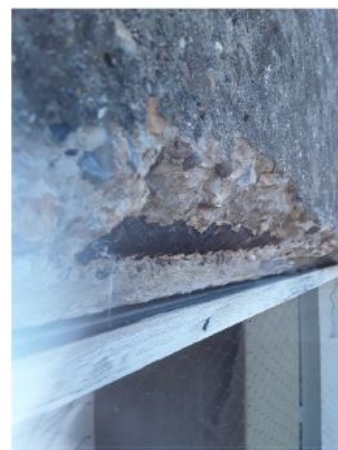
Photo 504 – Defect EWE01, Spalled concrete, material removed during survey
