## VENTILATION HYGIENE REPORT

Site Name: Goulden House

Overclean Job Ref: 33331

Completion Date: 05/05/2023

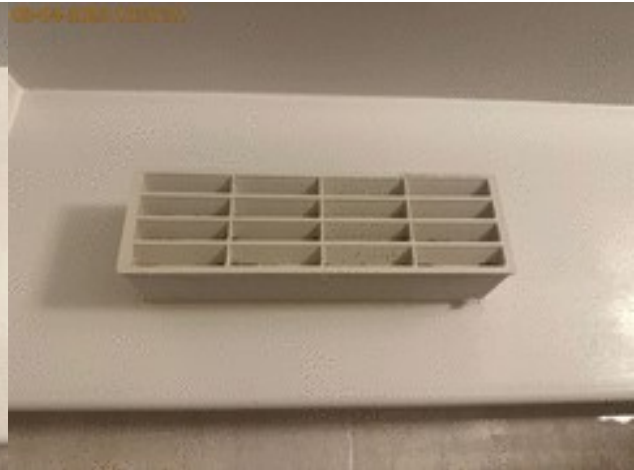
Goulden House - Entrance A Ground Floor Flat 2 - toilet extract ducting. Solid ducting in good condition (visual and borescope camera inspection). We can not reach vertical riser duct from this grille to see if any fire dampers fitted. No access to vertical ducting riser from this Flat.

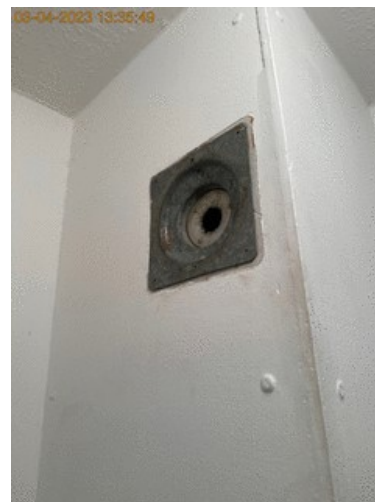
Goulden House - Flat 7 - bathroom extract. Solid ducting in good condition (visual and borescope camera inspection). We can not reach vertical riser duct from this grille to see if any fire dampers fitted. No access to vertical ducting riser from this Flat.

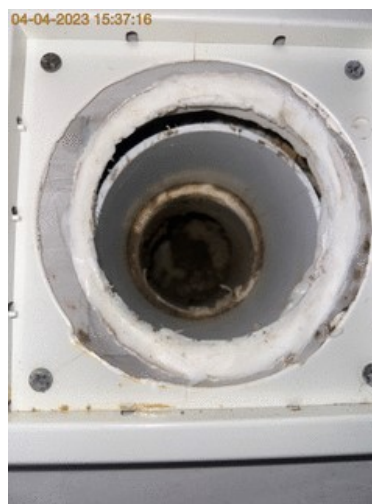
Goulden House - Entrance A Flat 9 - bathroom extract. Flexible ducting in good condition (visual and borescope camera inspection). We can not reach vertical riser duct from this grille to see if any fire dampers fitted. No access to vertical ducting riser from this Flat.

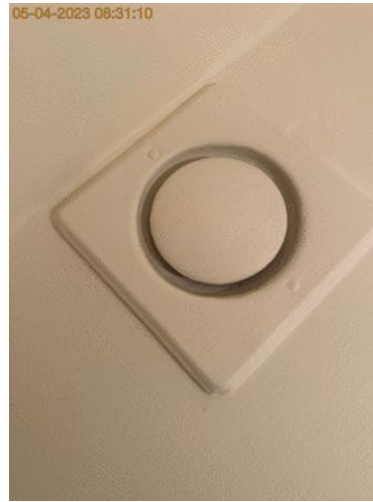
Goulden House - Entrance A Level 1 Flat 21 - toilet extract. Solid ducting in good condition (visual and borescope camera inspection). We can not reach vertical riser duct from this grille to see if any fire dampers fitted. No access to vertical ducting riser from this Flat.

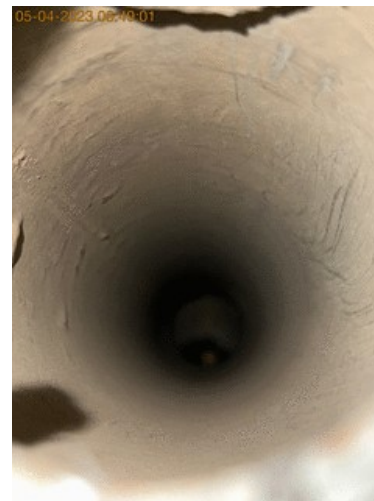
Goulden House - Entrance A Level 2 Flat 18 toilet extract. Solid ducting in good condition (visual and borescope camera inspection). We can not reach vertical riser duct from this grille to see if any fire dampers fitted. No access to vertical ducting riser from this Flat.

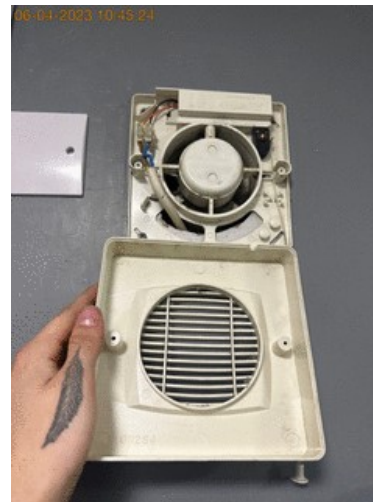
Goulden House - Flat 16 bathroom extract. Solid ducting in good condition (visual and borescope camera inspection). We can not reach vertical riser duct from this grille to see if any fire dampers fitted. No access to vertical ducting riser from this Flat.

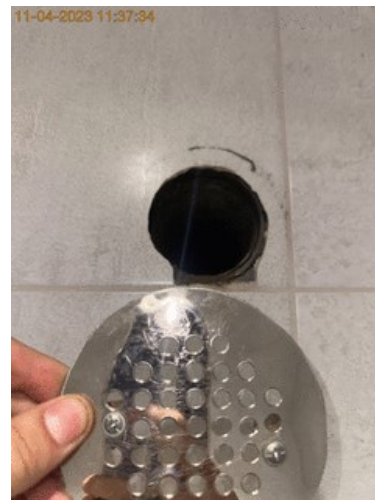
Goulden House - Entrance A Level 4 Flat 157 - bathroom extract. Solid ducting in good condition (visual and borescope camera inspection). We can not reach vertical riser duct from this grille to see if any fire dampers fitted. No access to vertical ducting riser from this Flat.

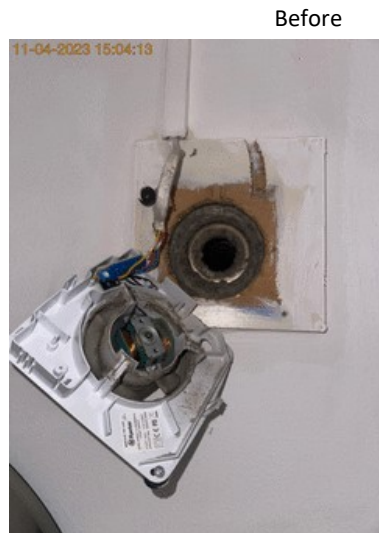
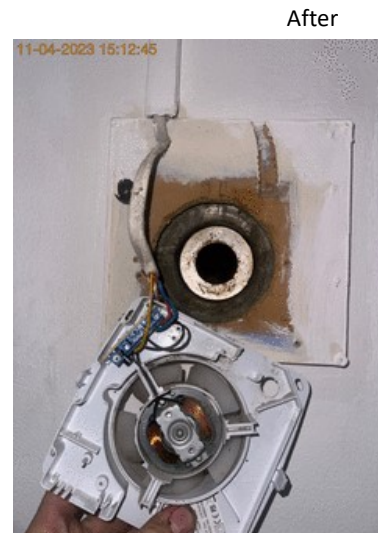
Goulden House - Entrance A Level 4 Flat 159 – bathroom extract. Flexible ducting in good condition (visual and borescope camera inspection). We can not reach vertical riser duct from this grille to see if any fire dampers fitted. No access to vertical ducting riser from this Flat.

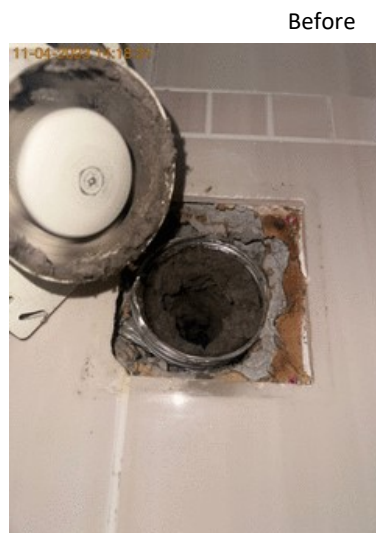
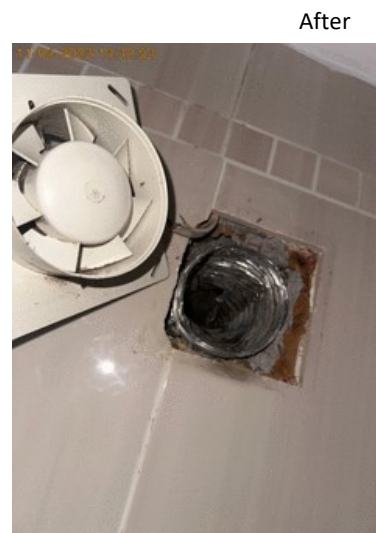
Goulden House - Entrance A Level 4 Flat 163. Solid ducting in good condition (visual and borescope camera inspection). We can not reach vertical riser duct from this grille to see if any fire dampers fitted. No access to vertical ducting riser from this Flat. This Flat has also window fan fitted.

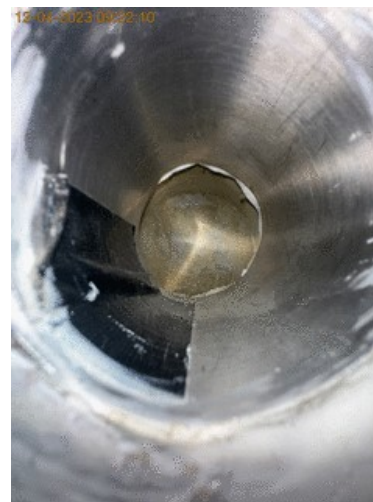
Goulden House - Entrance A Level 4 Flat 142 - Solid ducting in good condition (visual and borescope camera inspection).  
We can not reach vertical riser duct from this grille to see if any fire dampers fitted. No access to vertical ducting riser from this Flat.

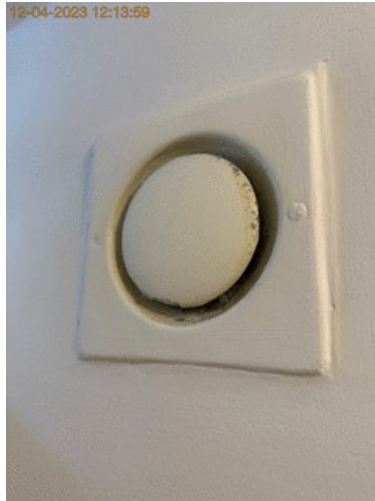
Goulden House - Entrance A Level 4 Flat 171 – bathroom extract. Solid ducting in good condition (visual and borescope camera inspection). We can not reach vertical riser duct from this grille to see if any fire dampers fitted. No access to vertical ducting riser from this Flat

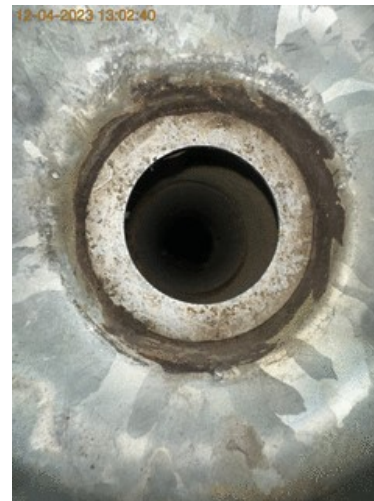
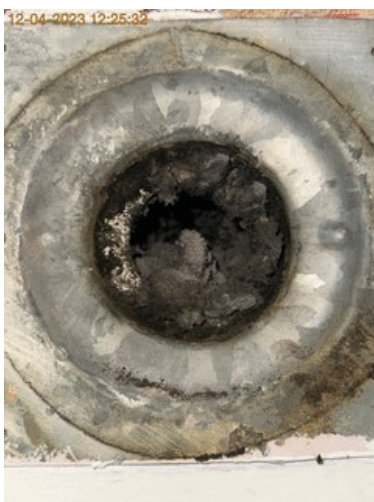
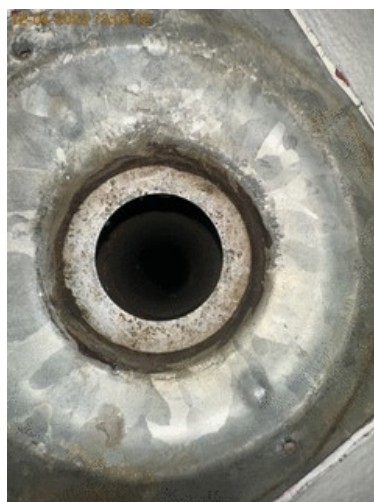
Goulden House - Entrance A Level 4 Flat 172 - bathroom. Solid ducting in good condition (visual and borescope camera inspection). We can not reach vertical riser duct from this grille to see if any fire dampers fitted. No access to vertical ducting riser from this Flat.

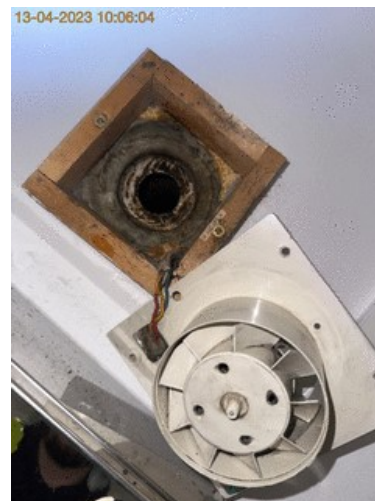
Goulden House - Entrance A Flat 28 - bathroom extract. Solid ducting in good condition (visual and borescope camera inspection). We can not reach vertical riser duct from this grille to see if any fire dampers fitted. No access to vertical ducting riser from this Flat.

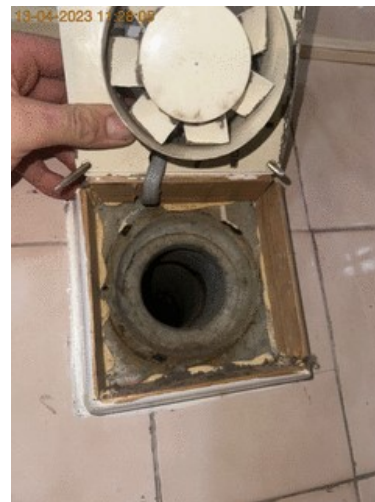
Goulden House - Entrance A Flat 27 - bathroom extract. Solid ducting in good condition (visual and borescope camera inspection). We can not reach vertical riser duct from this grille to see if any fire dampers fitted. No access to vertical ducting riser from this Flat.

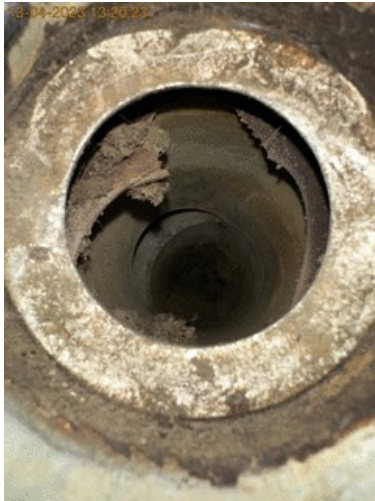
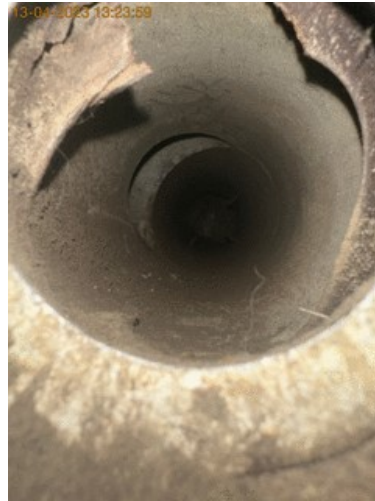
Goulden House - Entrance A Flat 39 - bathroom extract. Solid ducting in good condition (visual and borescope camera inspection). We can not reach vertical riser duct from this grille to see if any fire dampers fitted. No access to vertical ducting riser from this Flat.

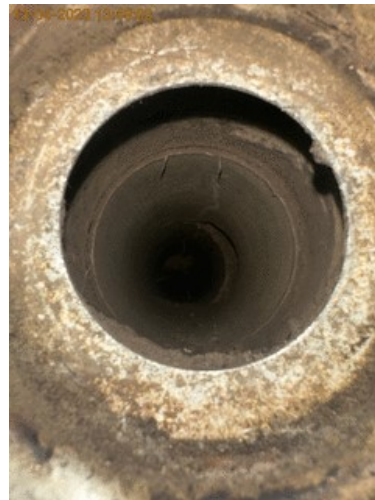
Goulden House - Entrance A Level 4 Flat 155 - bathroom extract. Solid ducting in good condition (visual and borescope camera inspection). We can not reach vertical riser duct from this grille to see if any fire dampers fitted. No access to vertical ducting riser from this Flat.

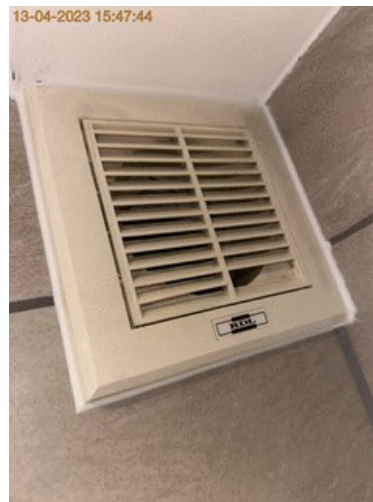
Goulden House - Entrance A Level 4 Flat 151 bathroom extract. Solid ducting in bad condition (visual and borescope camera inspection). We can not reach vertical riser duct from this grille to see if any fire dampers fitted. No access to vertical ducting riser from this Flat.

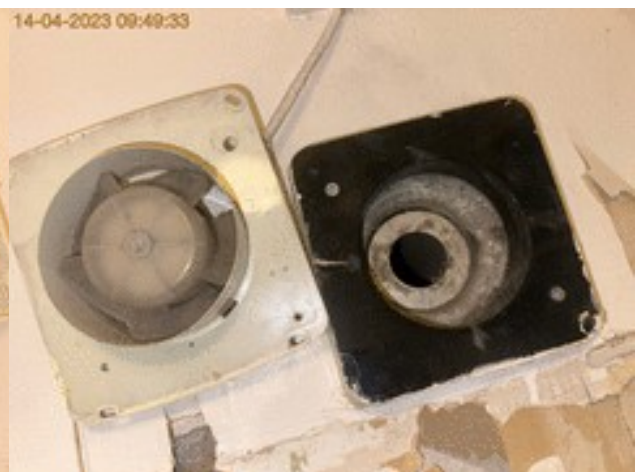
Goulden House - Entrance A Flat 151 - bathroom extract. Solid ducting in good condition (visual and borescope camera inspection). We can not reach vertical riser duct from this grille to see if any fire dampers fitted. No access to vertical ducting riser from this Flat.

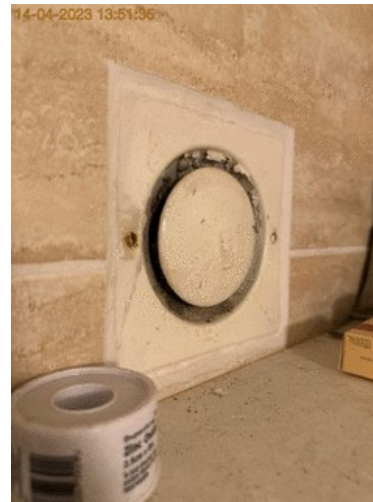
Goulden House - Entrance A Flat 41 - bathroom extract. Solid ducting in good condition (visual and borescope camera inspection). We can not reach vertical riser duct from this grille to see if any fire dampers fitted. No access to vertical ducting riser from this Flat.

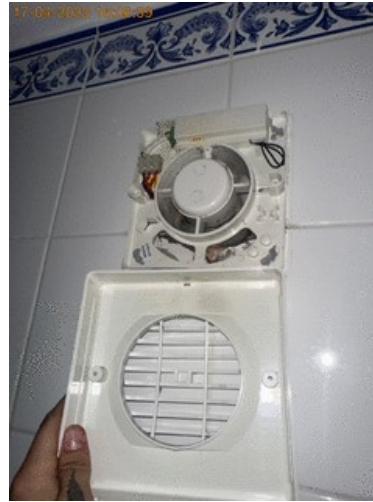
Goulden House - Entrance B Level 0 Flat 77 - bathroom extract. Solid ducting in good condition (visual and borescope camera inspection). We can not reach vertical riser duct from this grille to see if any fire dampers fitted. No access to vertical ducting riser from this Flat.

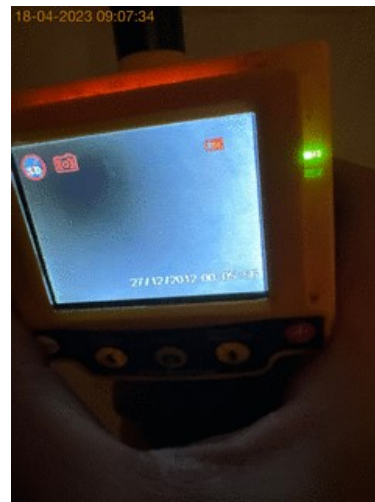
Goulden House - Flat 77 - toilet extract. Solid ducting in good condition ((visual and borescope camera inspection). We can not reach vertical riser duct from this grille to see if any fire dampers fitted. No access to vertical ducting riser from this Flat.

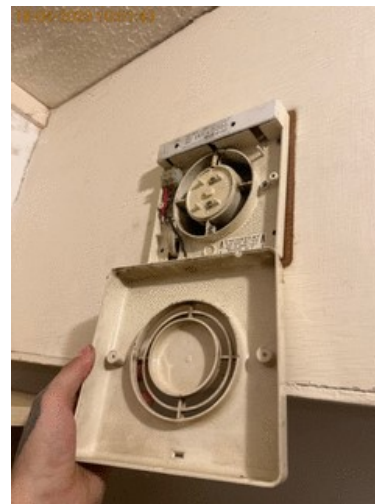
Goulden House - Flat 128- bathroom extract. Solid ducting in good condition (visual and borescope camera inspection). We can not reach vertical riser duct from this grille to see if any fire dampers fitted. No access to vertical ducting riser from this Flat.

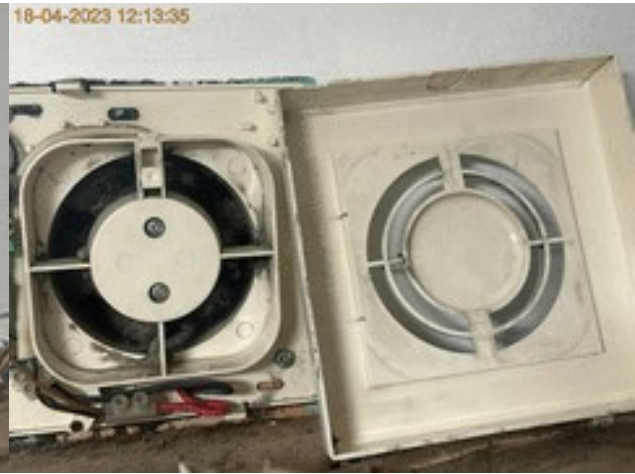
Gouldon House - Entrance B Level 0 Flat 133 - bathroom extract. Solid ducting in good condition (visual and borescope camera inspection). We can not reach vertical riser duct from this grille to see if any fire dampers fitted. No access to vertical ducting riser from this Flat.

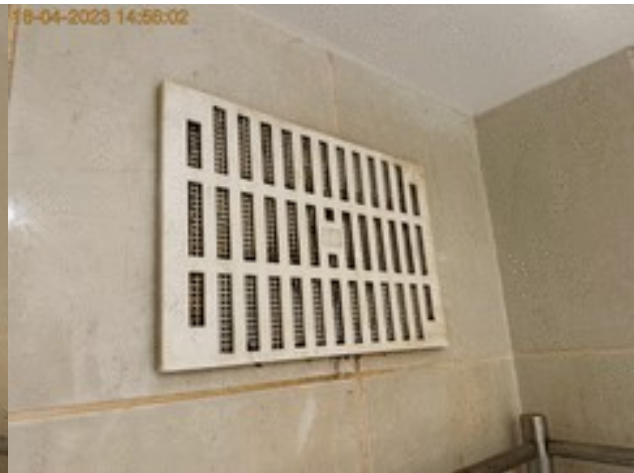
Goulden House - Flat 56 - bathroom extract. Solid ducting in good condition (visual and borescope camera inspection). We can not reach vertical riser duct from this grille to see if any fire dampers fitted. No access to vertical ducting riser from this Flat.

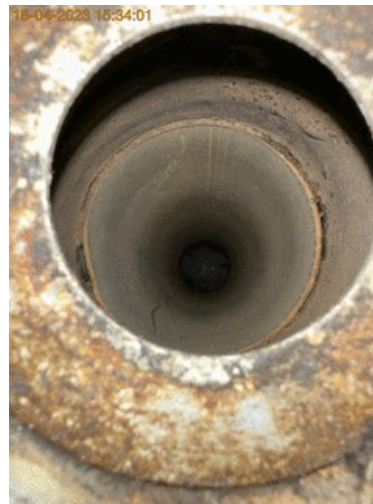
Goulden House - Flat 45 bathroom. Ducting in bad condition (visual and borescope camera inspection). We can not reach vertical riser duct from this grille to see if any fire dampers fitted. No access to vertical ducting riser from this Flat.

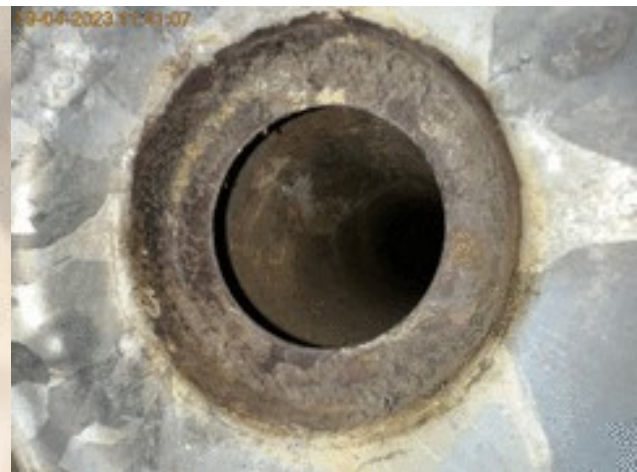
Goulden House - Flat 35 - bathroom extract. Solid ducting in good condition (visual and borescope camera inspection). We can not reach vertical riser duct from this grille to see if any fire dampers fitted. No access to vertical ducting riser from this Flat.

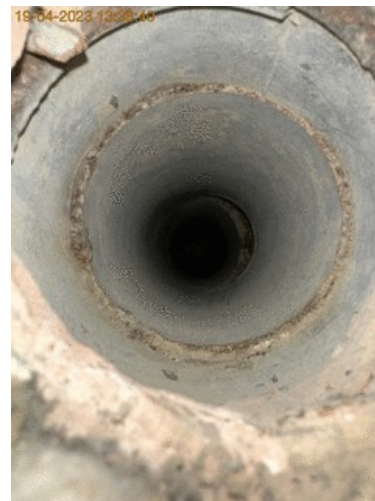
Goulden House - Entrance B Level 0 Flat 129 - bathroom extract. Solid ducting in bad condition (visual and borescope camera inspection). We can not reach vertical riser duct from this grille to see if any fire dampers fitted. No access to vertical ducting riser from this Flat.

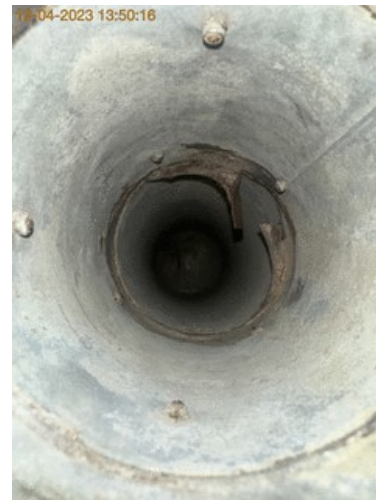
Goulden House - Entrance B Level 4 Flat 163 - bathroom extract. Flexible ducting in bad condition (visual and borescope camera inspection). We can not reach vertical riser duct from this grille to see if any fire dampers fitted. No access to vertical ducting riser from this Flat.

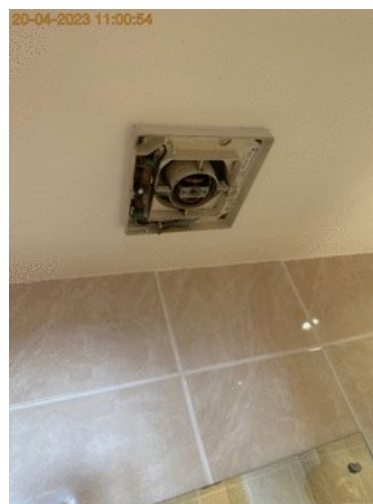
Goulden House - Entrance B Level 3 Flat 68 - bathroom extract. Flexible ducting in good condition (visual and borescope camera inspection). We can not reach vertical riser duct from this grille to see if any fire dampers fitted. No access to vertical ducting riser from this Flat.

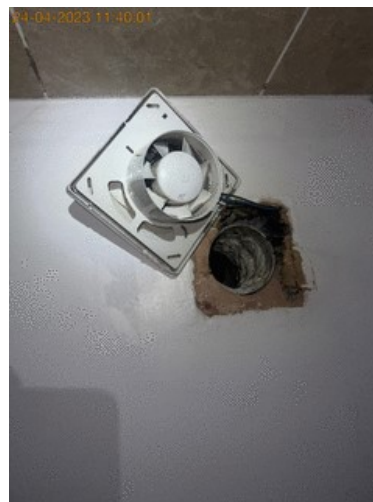
Gouldon House - Entrance B Flat 181 - bathroom extract. Solid ducting in good condition (visual and borescope camera inspection). We can not reach vertical riser duct from this grille to see if any fire dampers fitted. No access to vertical ducting riser from this Flat.

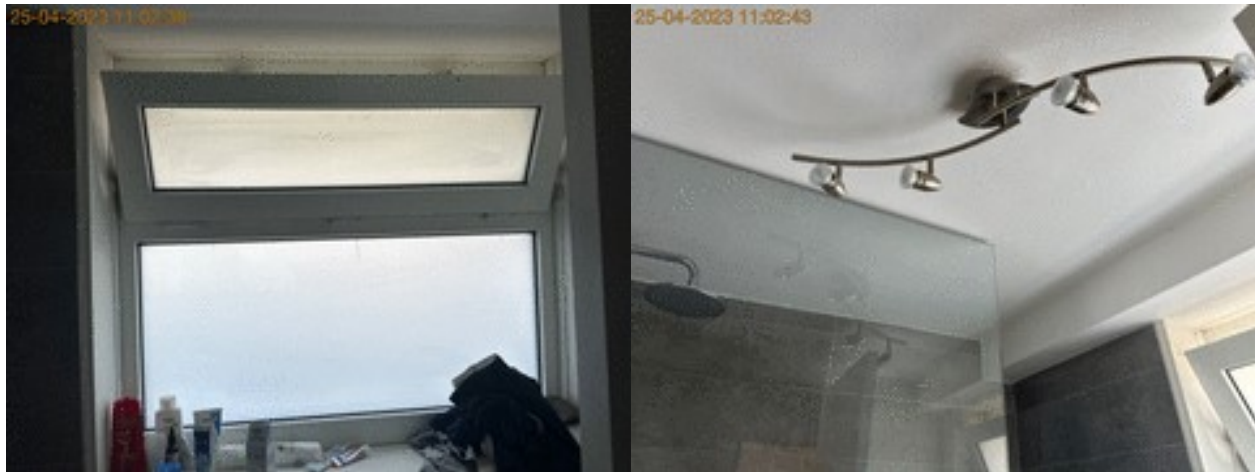
Goulden House - Entrance B Level 4 Flat 188 bathroom extract. Solid ducting in bad condition (visual and borescope camera inspection). We can not reach vertical riser duct from this grille to see if any fire dampers fitted. No access to vertical ducting riser from this Flat.

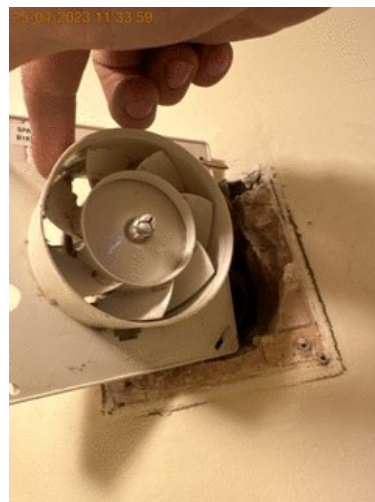
Goulden House - Entrance B Level 4 Flat 190 - bathroom extract. Solid ducting in good condition (visual and borescope camera inspection). We can not reach vertical riser duct from this grille to see if any fire dampers fitted. No access to vertical ducting riser from this Flat.

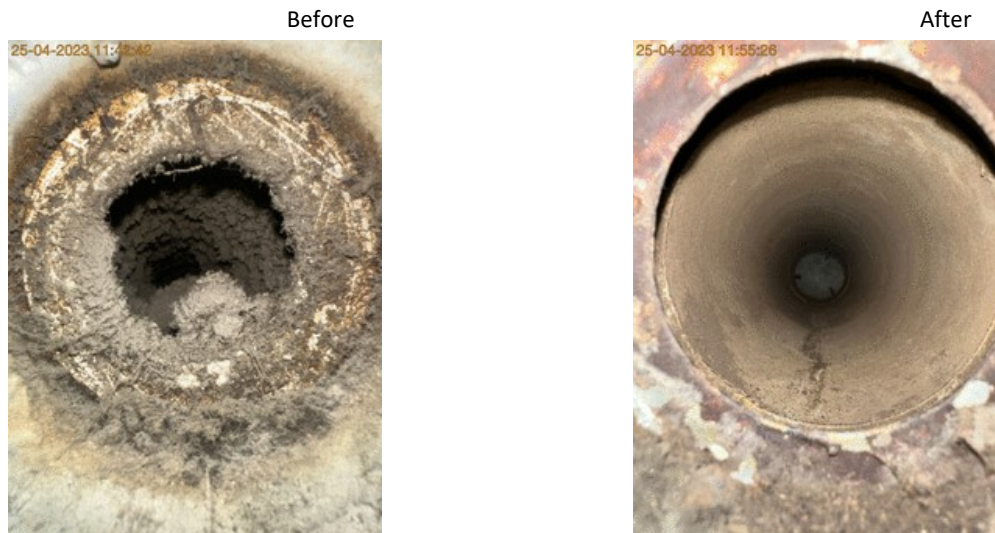
Goulden House - Flat 190 - bathroom extract. Flexible ducting in bad condition (visual and borescope camera inspection). We can not reach vertical riser duct from this grille to see if any fire dampers fitted. No access to vertical ducting riser from this Flat.

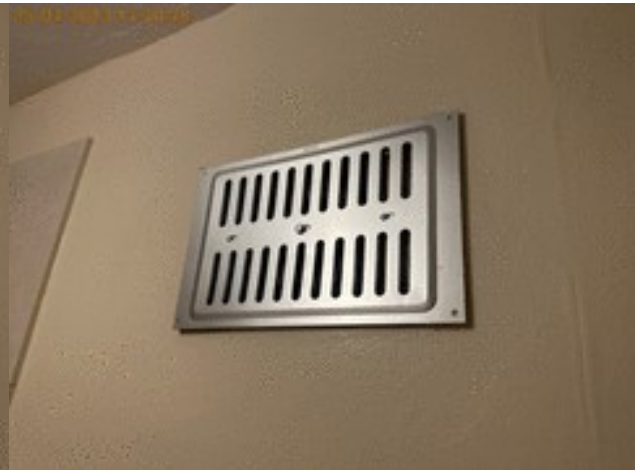
Goulden House - Entrance B Level 4 Flat 207 bathroom extract. Solid ducting in good condition (visual and borescope camera inspection). We can not reach vertical riser duct from this grille to see if any fire dampers fitted. No access to vertical ducting riser from this Flat.

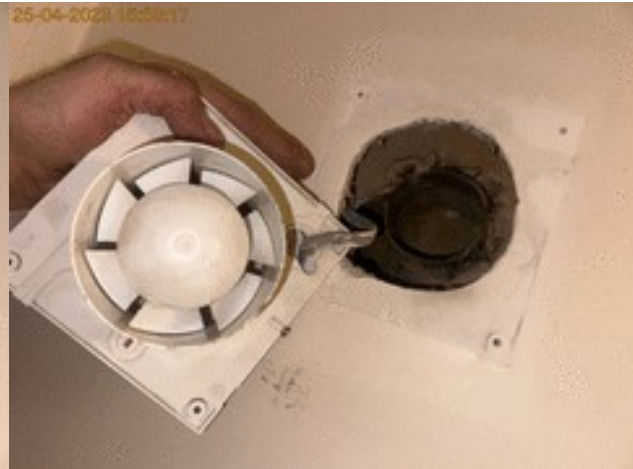
Goulden House - Entrance B Level 4 Flat 208 - bathroom extract. Solid ducting in bad condition (visual and borescope camera inspection). We can not reach vertical riser duct from this grille to see if any fire dampers fitted. No access to vertical ducting riser from this Flat.

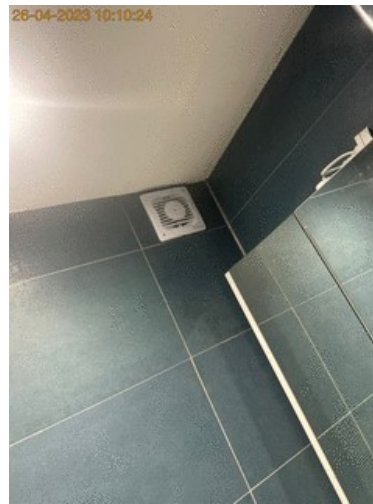
Goulden House - Entrance B Level 4 Flat 215 - bathroom extract. Solid ducting in bad condition (visual and borescope camera inspection). We can not reach vertical riser duct from this grille to see if any fire dampers fitted. No access to vertical ducting riser from this Flat.

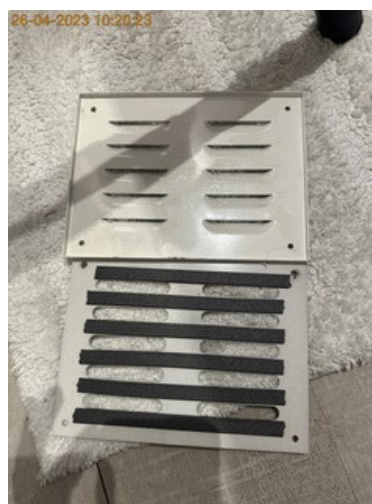
Goulden House - Entrance B Level 4 Flat 217 - bathroom extract. Solid ducting in bad condition (visual and borescope camera inspection). We can not reach vertical riser duct from this grille to see if any fire dampers fitted. No access to vertical ducting riser from this Flat.

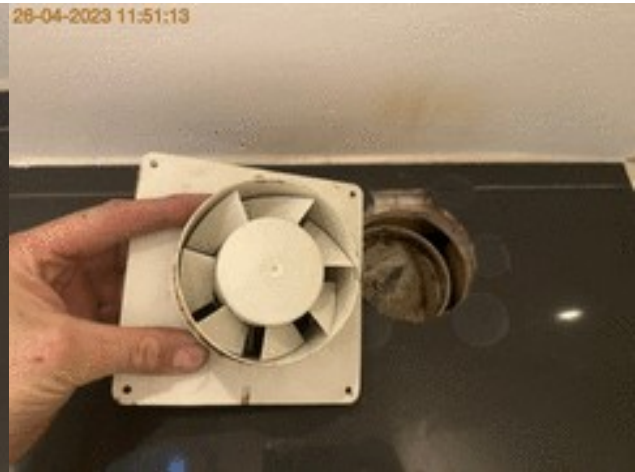
Goulden House - Entrance B Level 4 Flat 198 - bathroom extract. Solid ducting in good condition (visual and borescope camera inspection). We can not reach vertical riser duct from this grille to see if any fire dampers fitted. No access to vertical ducting riser from this Flat.

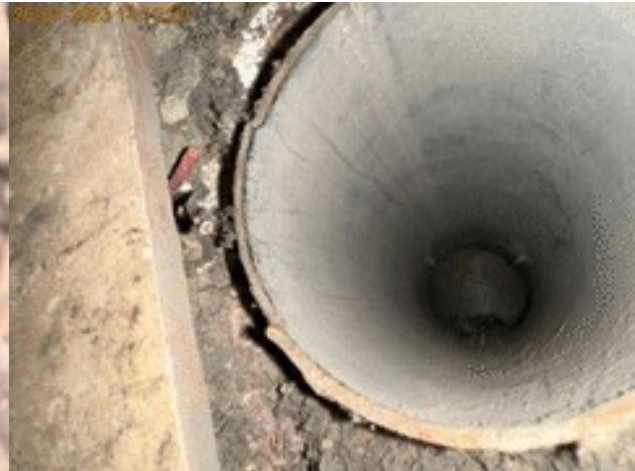
Goulden House - Entrance B Level 4 Flat 209 - bathroom extract. Solid ducting in bad condition (visual and borescope camera inspection). We can not reach vertical riser duct from this grille to see if any fire dampers fitted. No access to vertical ducting riser from this Flat.

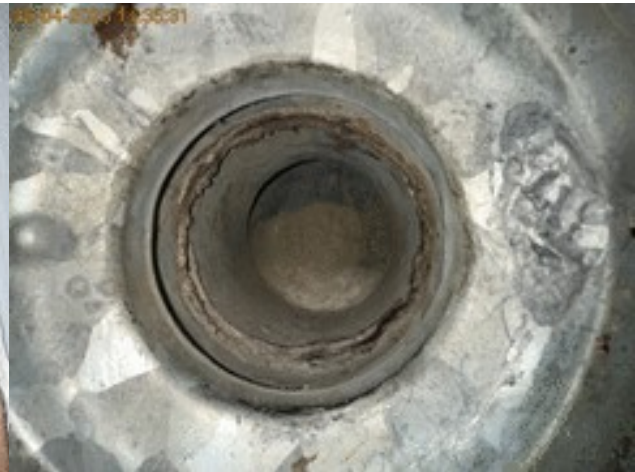
Goulden House - Entrance B Level 4 Flat 212 - bathroom extract. Solid ducting in bad condition (visual and borescope camera inspection). We can not reach vertical riser duct from this grille to see if any fire dampers fitted. No access to vertical ducting riser from this Flat.

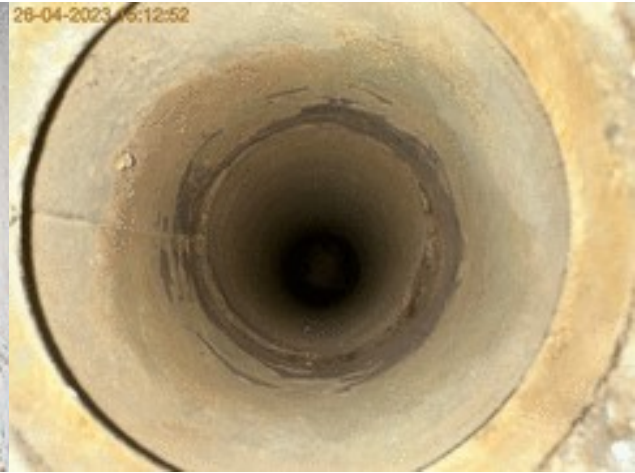
Goulden House - Entrance C Level 1 Flat 96 – bathroom extract. Solid ducting in good condition (visual and borescope camera inspection). We can not reach vertical riser duct from this grille to see if any fire dampers fitted. No access to vertical ducting riser from this Flat

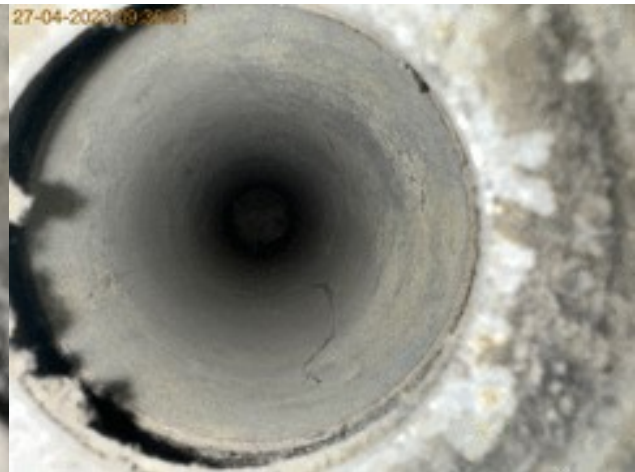
Goulden House - Entrance C Level 3 Flat 88 - bathroom extract. Solid ducting in bad condition (visual and borescope camera inspection). We can not reach vertical riser duct from this grille to see if any fire dampers fitted. No access to vertical ducting riser from this Flat.

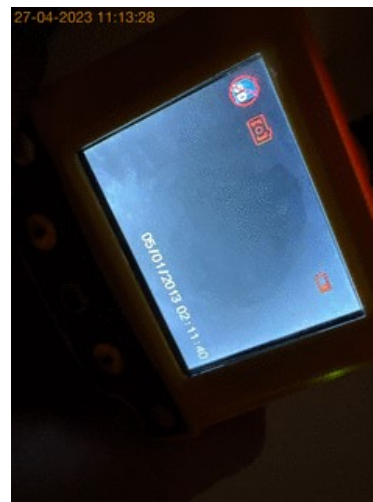
Goulden House - Entrance C Level 3 Flat 90 - bathroom extract. Solid ducting in bad condition (visual and borescope camera inspection). We can not reach vertical riser duct from this grille to see if any fire dampers fitted. No access to vertical ducting riser from this Flat.

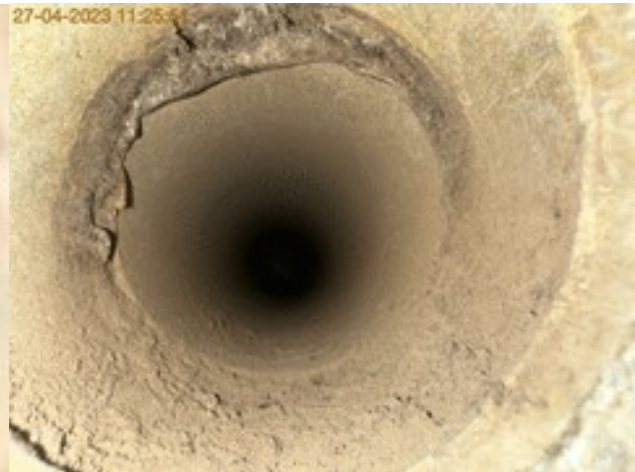
Goulden House - Entrance C Level 4 Flat 239 - bathroom extract. Flexible to solid ducting after flexible section in bad condition (visual and borescope camera inspection). We can not reach vertical riser duct from this grille to see if any fire dampers fitted. No access to vertical ducting riser from this Flat.

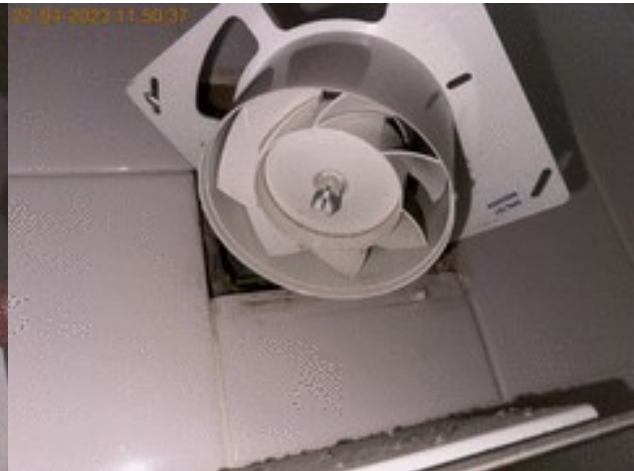
Goulden House - Entrance C Level 2 Flat 91 - bathroom extract. Flexible to solid ducting in good condition (visual and borescope camera inspection). We can not reach vertical riser duct from this grille to see if any fire dampers fitted. No access to vertical ducting riser from this Flat.

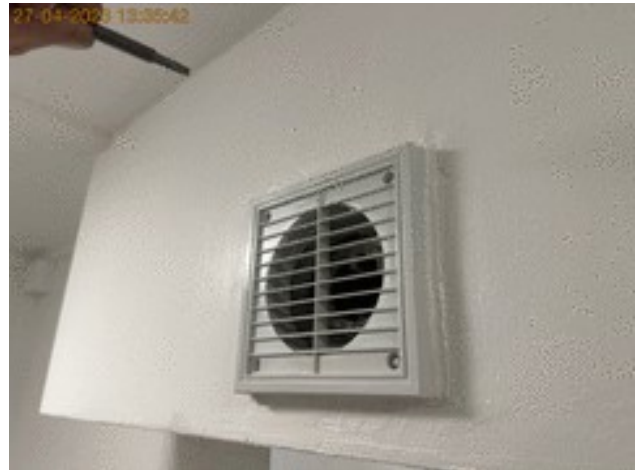
Goulden House - Flat 105 - bathroom extract. Solid ducting in good condition (visual and borescope camera inspection). We can not reach vertical riser duct from this grille to see if any fire dampers fitted. No access to vertical ducting riser from this Flat.

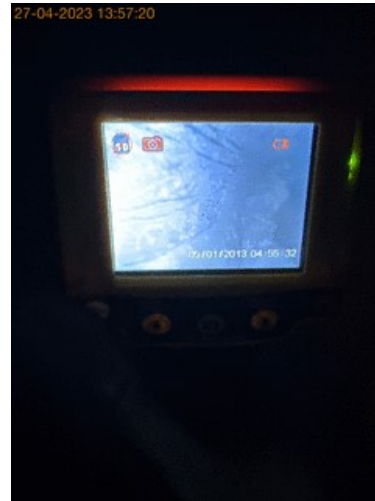
Goulden House - Flat 108 - bathroom extract. Solid ducting in good condition (visual and borescope camera inspection). We can not reach vertical riser duct from this grille to see if any fire dampers fitted. No access to vertical ducting riser from this Flat.

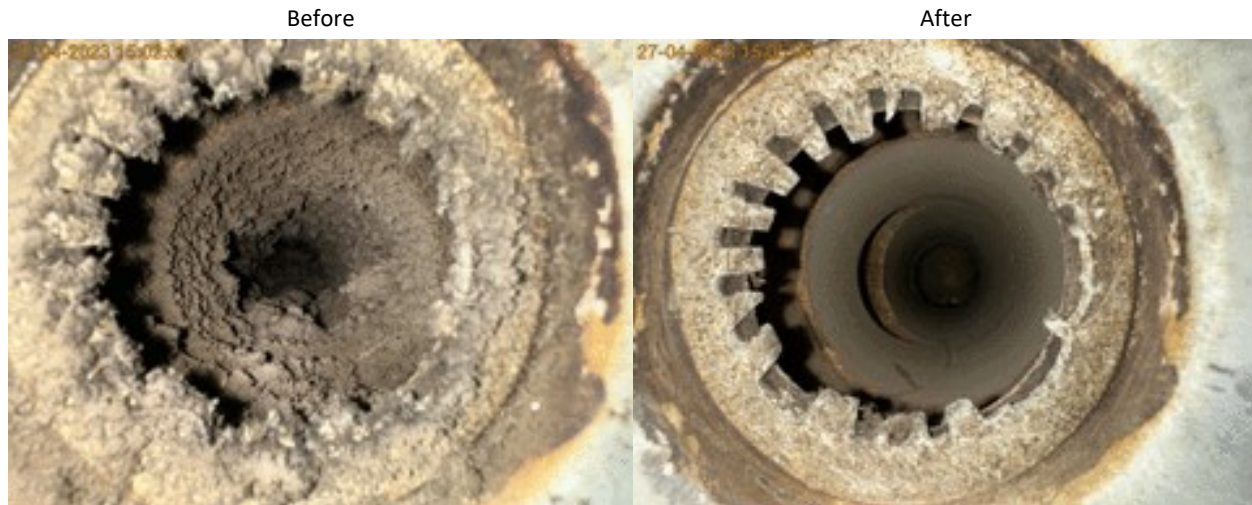
Goulden House - Flat 109 - bathroom extract. Solid ducting in good condition (visual and borescope camera inspection). We can not reach vertical riser duct from this grille to see if any fire dampers fitted. No access to vertical ducting riser from this Flat. – Extract

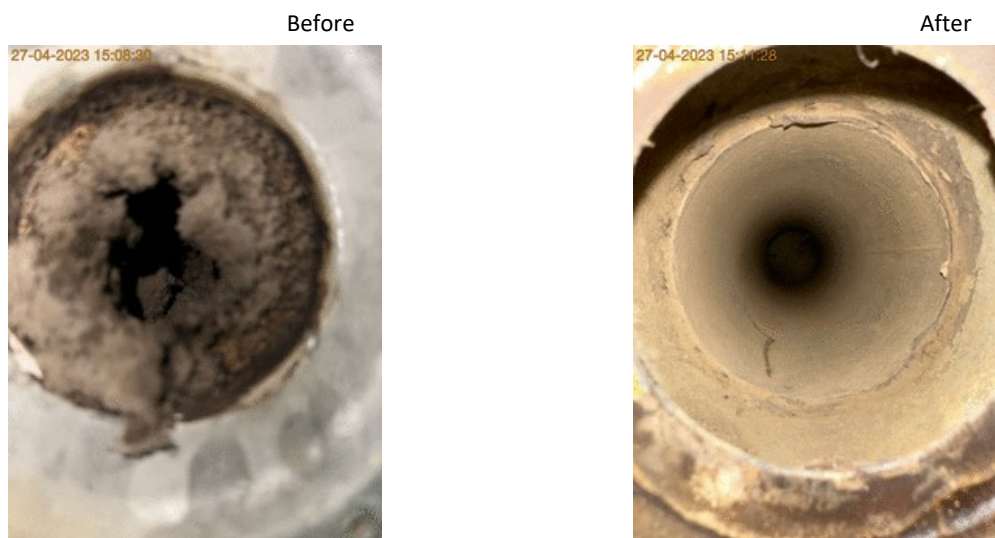
Goulden House - Flat 112 - bathroom extract. Solid ducting in good condition (visual and borescope camera inspection). We can not reach vertical riser duct from this grille to see if any fire dampers fitted. No access to vertical ducting riser from this Flat.
