## VENTILATION HYGIENE REPORT

Site Name: Goulden House

Overclean Job Ref: 33331

Completion Date: 05/05/2023

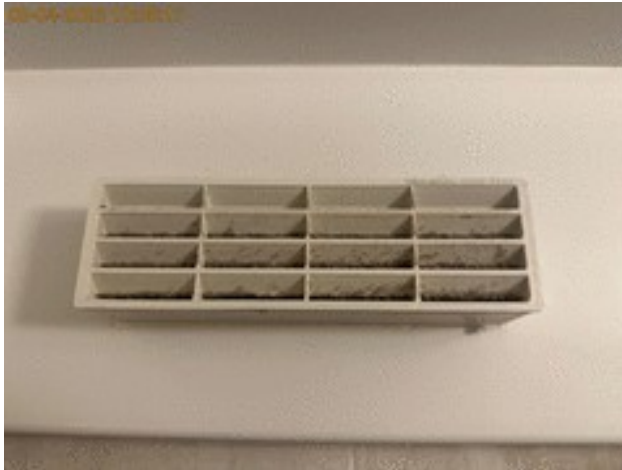
Goulden House - Entrance A Ground Floor Flat 1 bathroom extract - no access to the ducting due to sealed grille. The grille has been cleaned. No access to the vertical duct riser from this Flat.

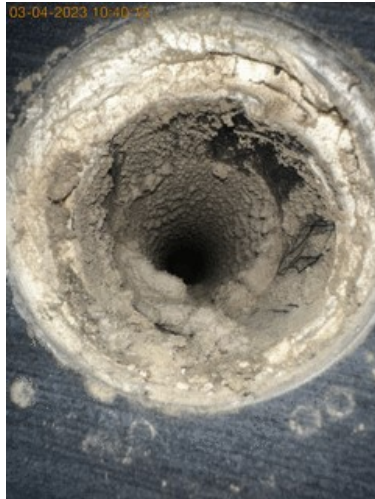
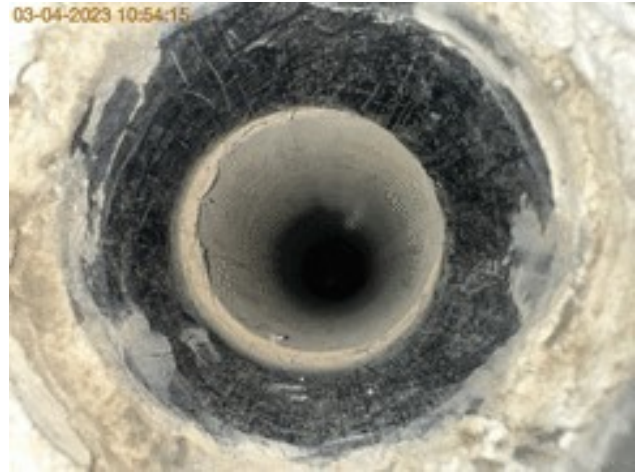
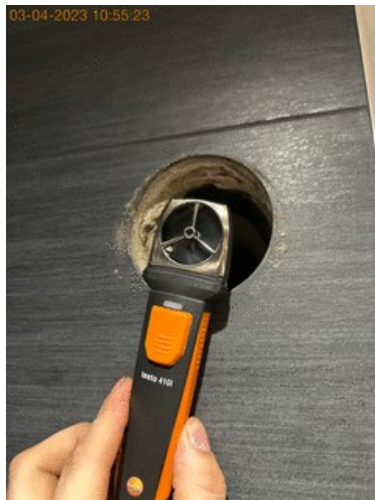
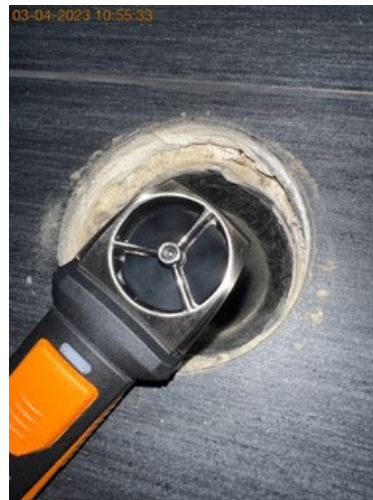
Goulden House - Entrance A Ground Floor Flat 2 - toilet extract ducting. Solid ducting in good condition (visual and borescope camera inspection). We can not reach vertical riser duct from this grille to see if any fire dampers fitted. No access to vertical ducting riser from this Flat.

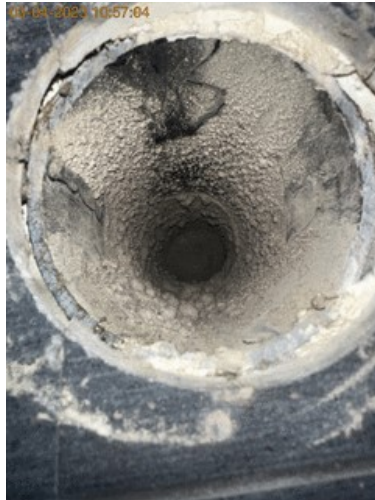
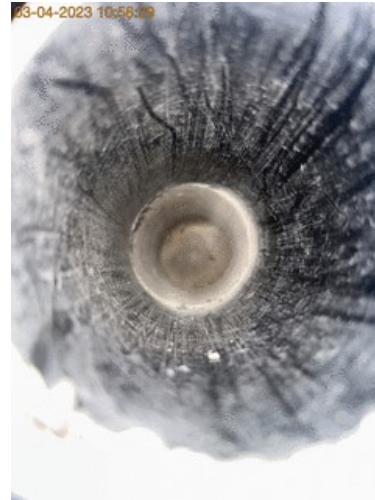
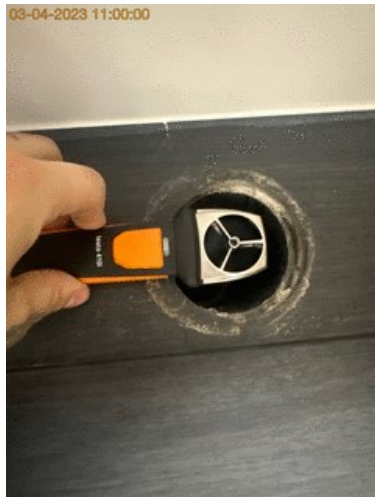
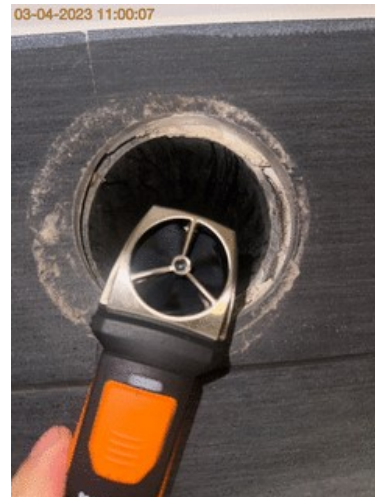
Goulden House - Flat 2 - bathroom extract ducting. Solid ducting in good condition (visual and borescope camera inspection). We can not reach vertical riser duct from this grille to see if any fire dampers fitted. No access to vertical ducting riser from this Flat.

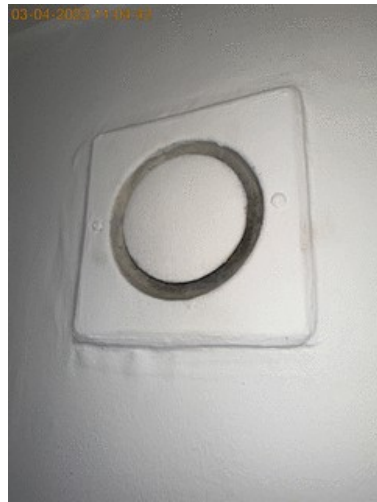
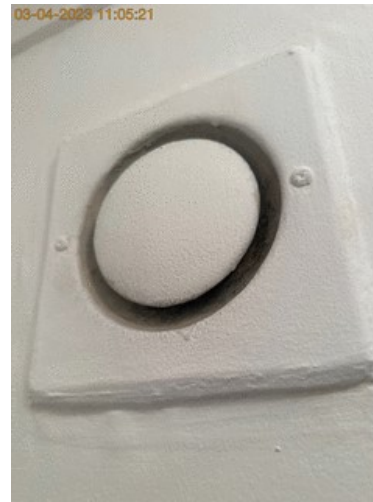
Goulden House - Entrance A Ground Floor Flat 4 - toilet vent. No access to the ducting as the unit is sealed. No access to the vertical ducting riser from this Flat. The unit has been cleaned. - Extract

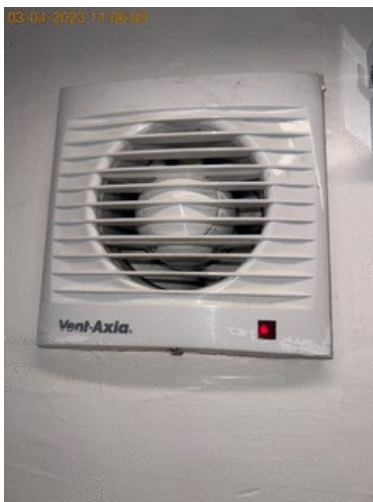
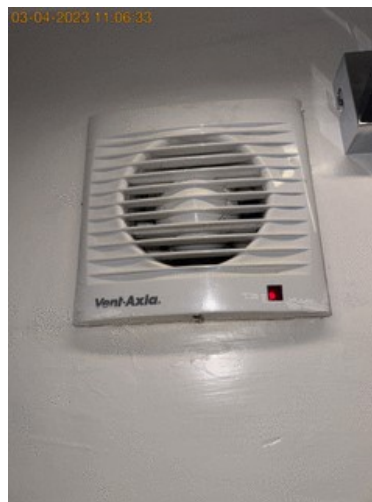
Goulden House - Flat 4 bathroom - No access to the ducting as the unit is sealed. No access to the vertical ducting riser from this Flat. The unit has been cleaned. - Extract

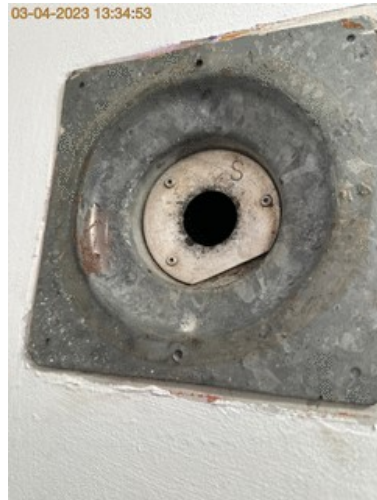
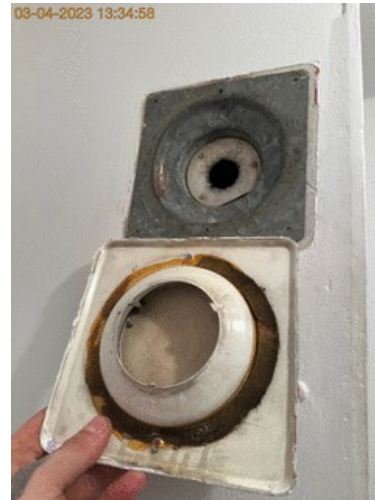
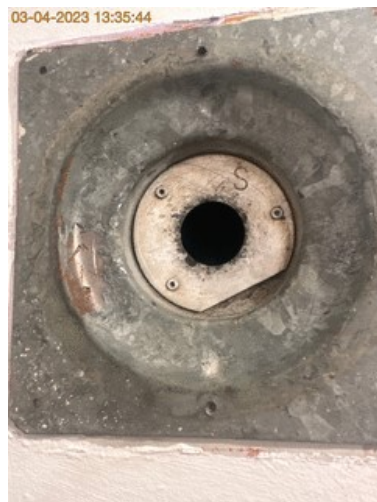
Goulden House - Entrance A Ground Floor Flat 7 – toilet extract. Solid ducting in good condition (visual and borescope camera inspection). We can not reach vertical riser duct from this grille to see if any fire dampers fitted. No access to vertical ducting riser from this Flat.

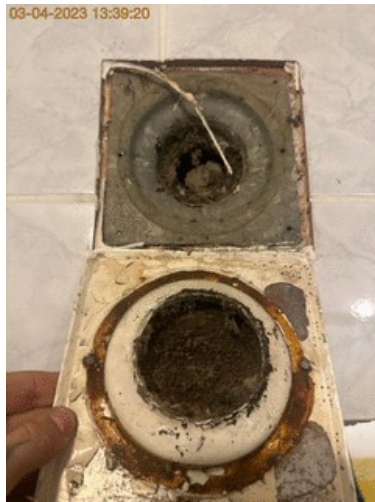
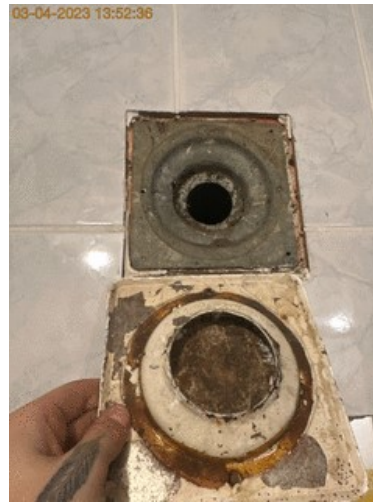
Goulden House - Flat 7 - bathroom extract. Solid ducting in good condition (visual and borescope camera inspection). We can not reach vertical riser duct from this grille to see if any fire dampers fitted. No access to vertical ducting riser from this Flat.

Air flow reading:  
3.59 – before clean  
3.67 – after clean

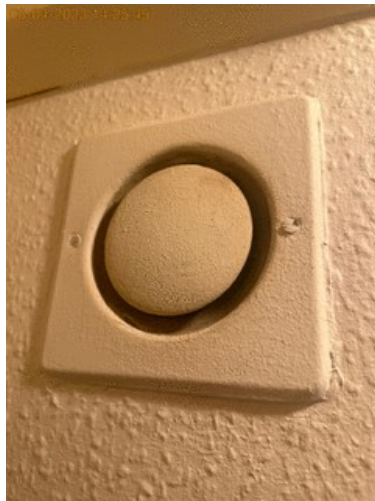
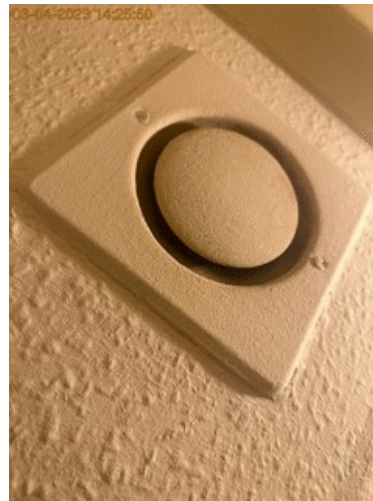
Goulden House - Entrance A Ground Floor Flat 11 – toilet extract. No access to the ducting as the unit is sealed. No access to the vertical ducting riser from this Flat. The unit has been cleaned

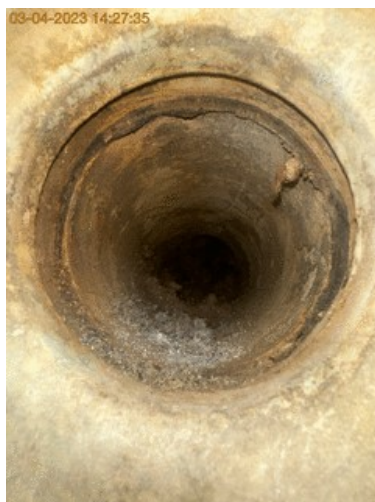
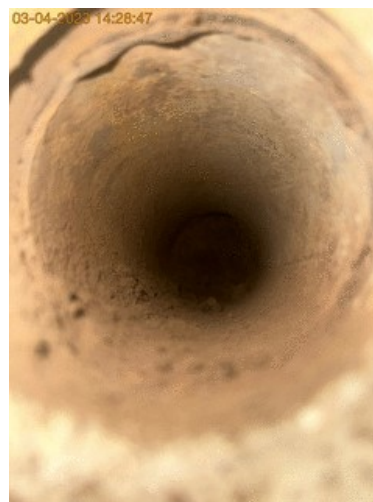
Goulden House - Flat 11 - upstairs bathroom extract. Solid ducting in good condition (visual and borescope camera inspection). We can not reach vertical riser duct from this grille to see if any fire dampers fitted. No access to vertical ducting riser from this Flat.

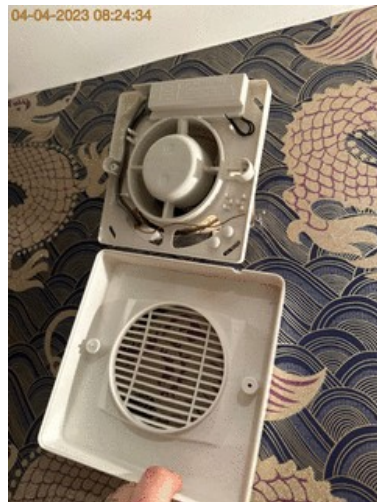
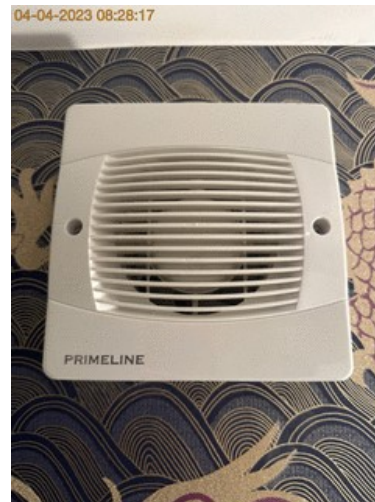
Goulden House - Entrance A Ground Floor Flat 47 - toilet extract. No access to the ducting as the unit is sealed. No access to the vertical ducting riser from this Flat. The unit has been cleaned.

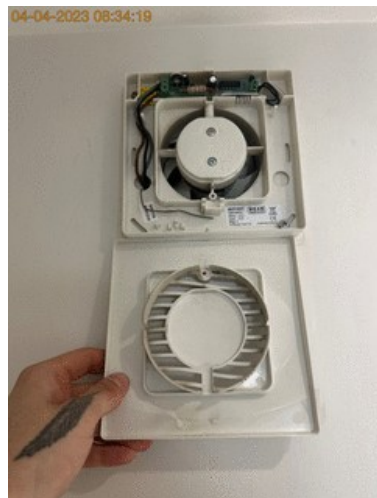
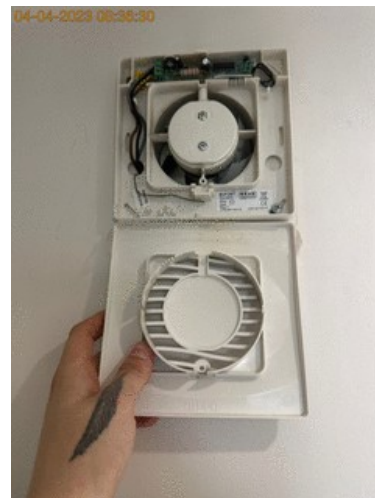
Goulden House - Flat 47 - bathroom. No access to the ducting as the unit is sealed. No access to the vertical ducting riser from this Flat. The unit has been cleaned.

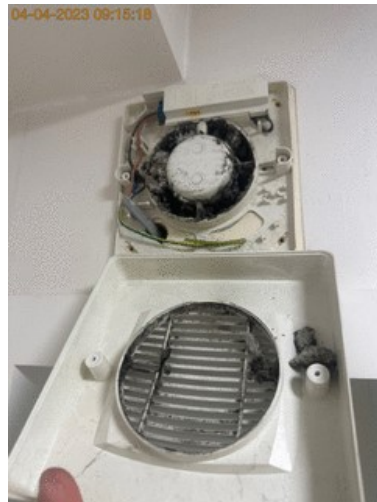
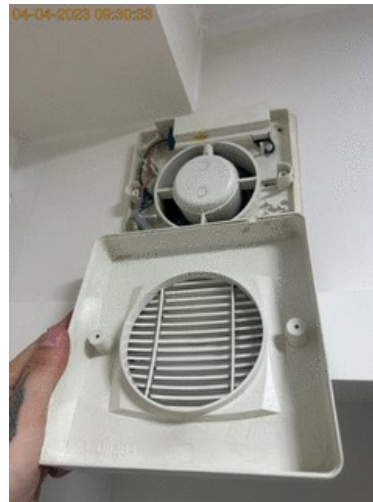
Goulden House - Entrance A Ground Floor Flat 24 - shower room extract. No access to the ducting as the unit is sealed. No access to the vertical ducting riser from this Flat. The unit has been cleaned. - Extract

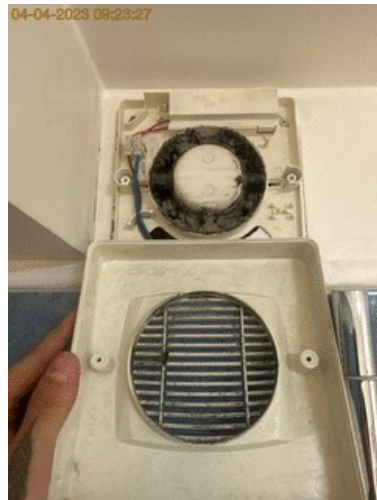
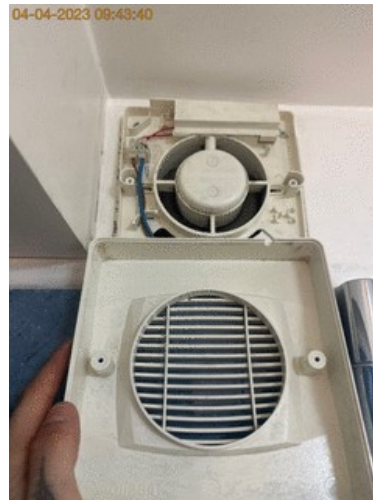
Goulden House - Flat 24 – bathroom extract. No access to the ducting as the unit is sealed. No access to the vertical ducting riser from this Flat. The unit has been cleaned. - Extract

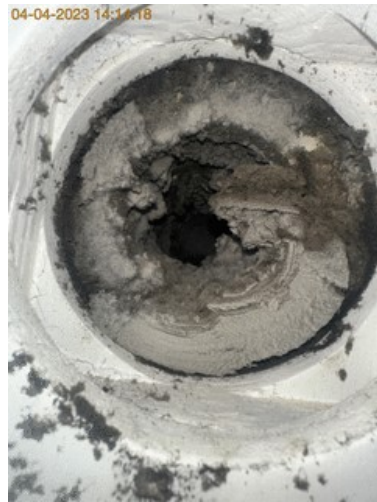
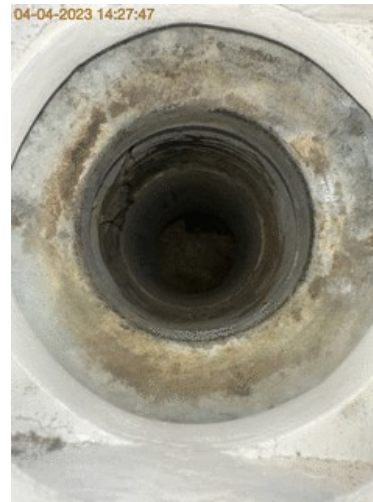
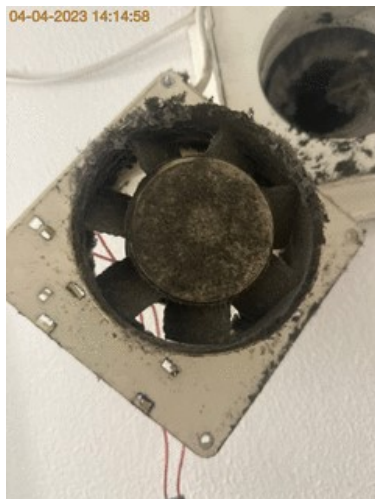
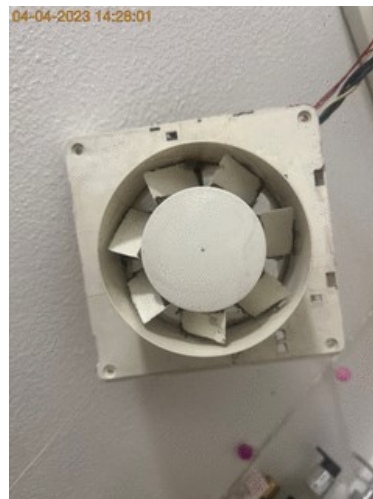
Goulden House - Entrance A Level 5 Flat 14 bathroom extract. Solid ducting in good condition (visual and borescope camera inspection). We can not reach vertical riser duct from this grille to see if any fire dampers fitted. No access to vertical ducting riser from this Flat.

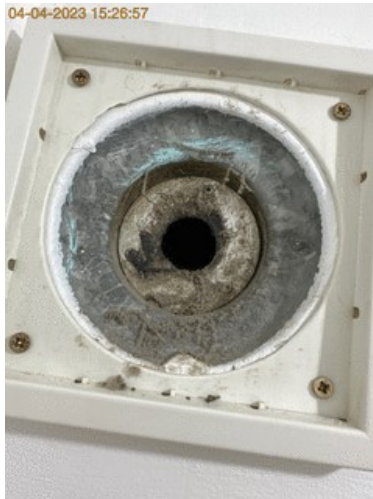
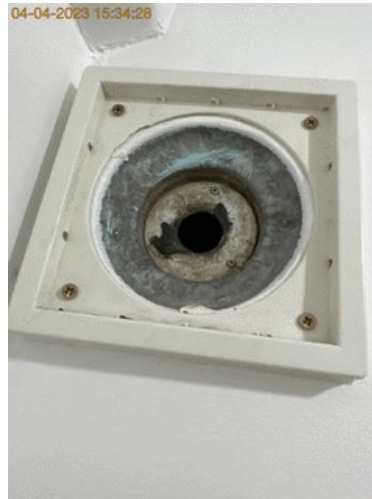
Goulden House - Entrance A Ground Floor Flat 5 – toilet extract. No access to the as the unit is sealed. No access to the vertical ducting riser from this Flat. The unit has been cleaned.

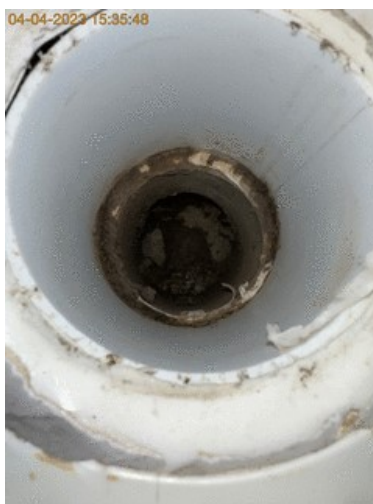
Goulden House - Flat 5 – bathroom extract. Solid ducting in good condition (visual and borescope camera inspection). We can not reach vertical riser duct from this grille to see if any fire dampers fitted. No access to vertical ducting riser from this Flat.

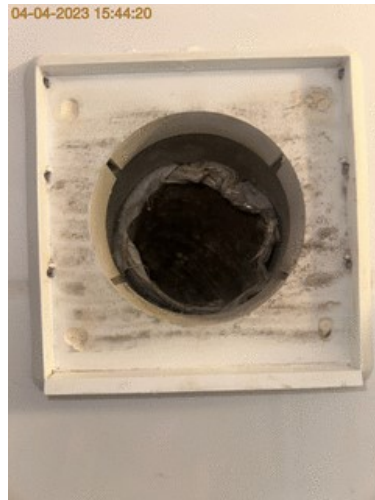
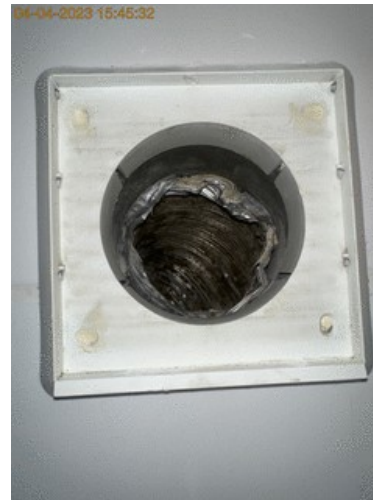
Goulden House - Entrance A Flat 9 - bathroom extract. Flexible ducting in good condition (visual and borescope camera inspection). We can not reach vertical riser duct from this grille to see if any fire dampers fitted. No access to vertical ducting riser from this Flat.

Air flow reading:  
3.51 – before clean  
3.62 – after clean

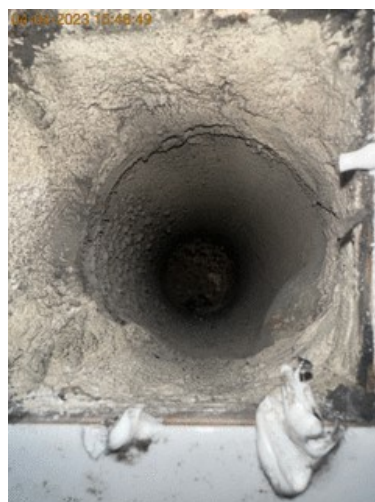
Goulden House - Flat 9 - bathroom extract. Solid ducting in good condition (visual and borescope camera inspection). We can not reach vertical riser duct from this grille to see if any fire dampers fitted. No access to vertical ducting riser from this Flat.

Air flow reading:  
before clean flow - 3.66  
after clean flow - 3.74

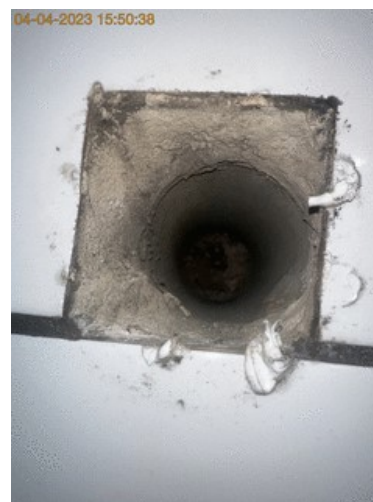
Goulden House - Entrance A Ground Floor Flat 3 – toilet extract.. No access to the ducting as the unit is sealed. No access to the vertical ducting riser from this Flat. The unit has been cleaned. The fan is not running.

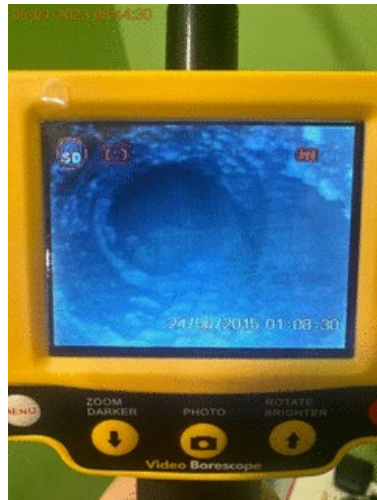
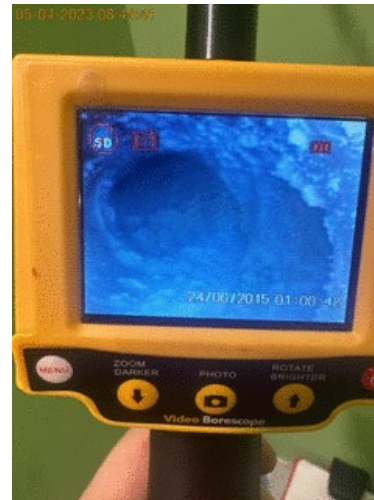
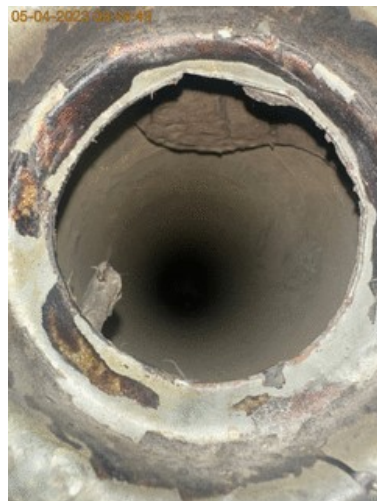
Goulden House - Entrance A Level 1 Flat 21 - toilet extract. Solid ducting in good condition (visual and borescope camera inspection). We can not reach vertical riser duct from this grille to see if any fire dampers fitted. No access to vertical ducting riser from this Flat.

Air flow reading:  
4.21- before clean  
4.67 – after clean

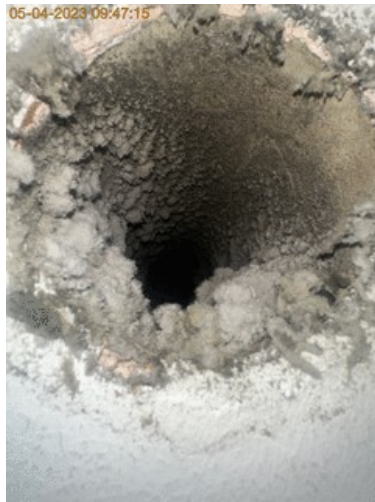
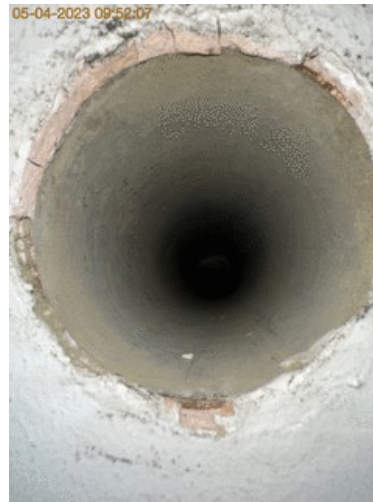
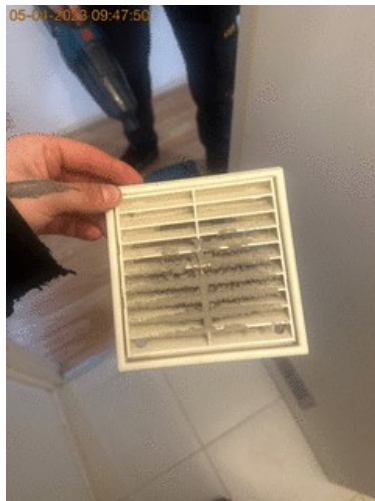
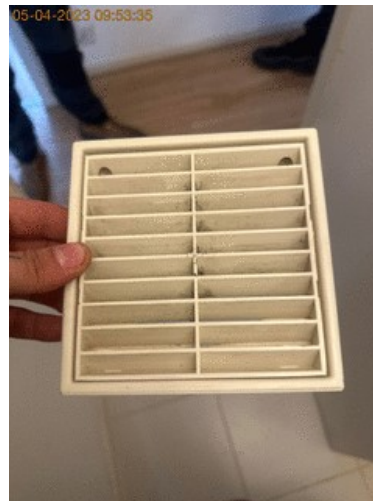
Goulden House - Entrance A Level 2 Flat 18 toilet extract. Solid ducting in good condition (visual and borescope camera inspection). We can not reach vertical riser duct from this grille to see if any fire dampers fitted. No access to vertical ducting riser from this Flat.

4.88 – after clean

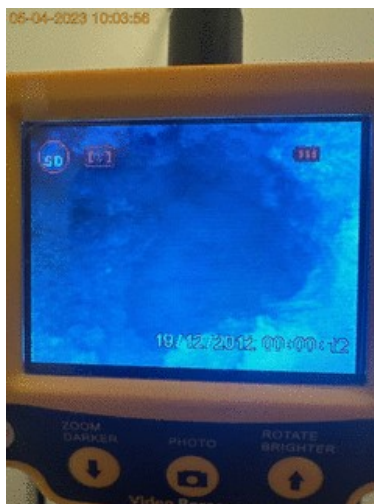
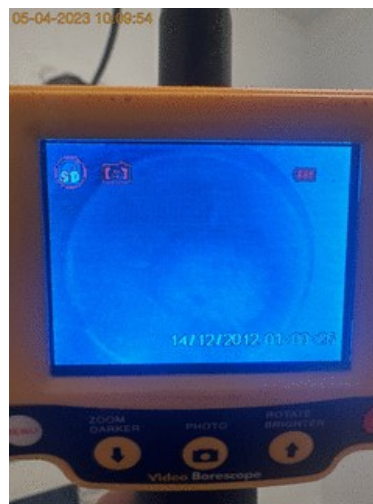
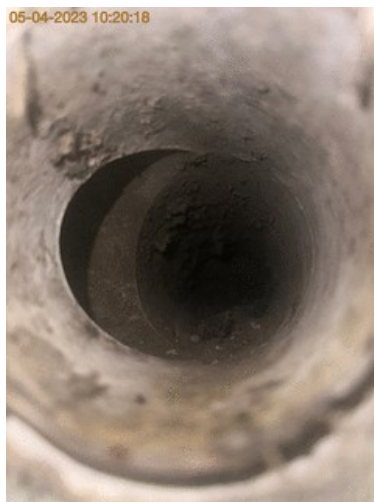
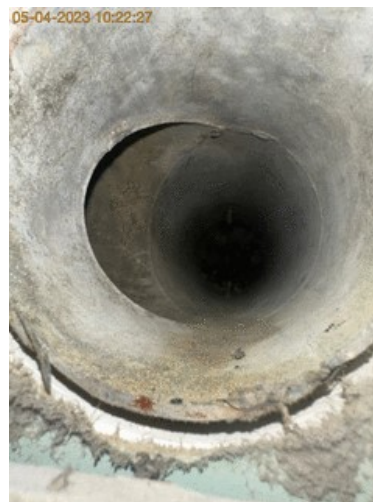
Goulden House - Entrance A Ground Floor Flat 30 - bathroom extract. Solid ducting in good condition (visual and borescope camera inspection). We can not reach vertical riser duct from this grille to see if any fire dampers fitted. No access to vertical ducting riser from this Flat.

Air flow reading:  
3.89 – before clean  
4.01 – after clean

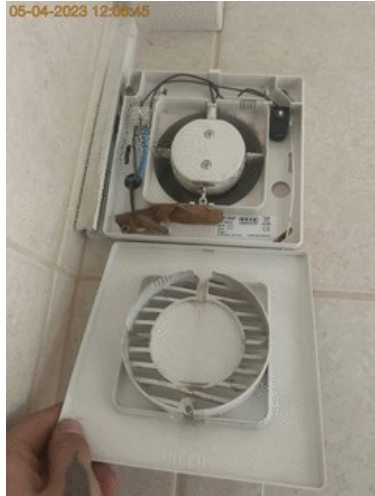
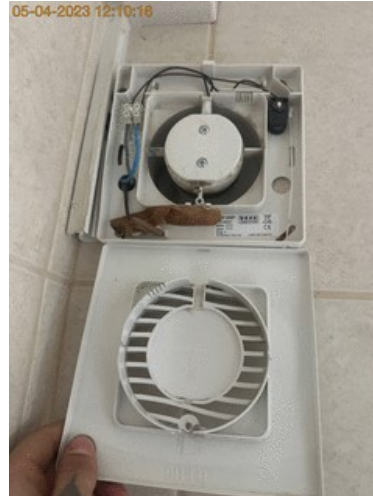
Goulden House - Entrance A Level 4 Flat 136 - bathroom extract fan. No access to the ducting as the unit is sealed. No access to the vertical ducting riser from this Flat. The unit has been cleaned.

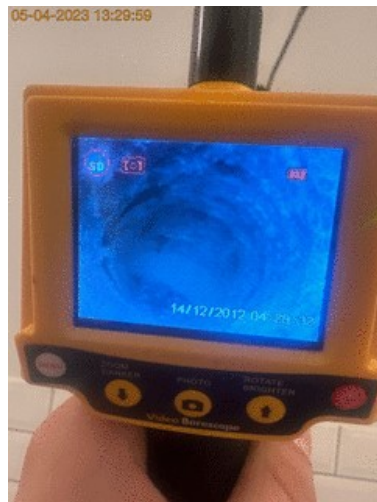
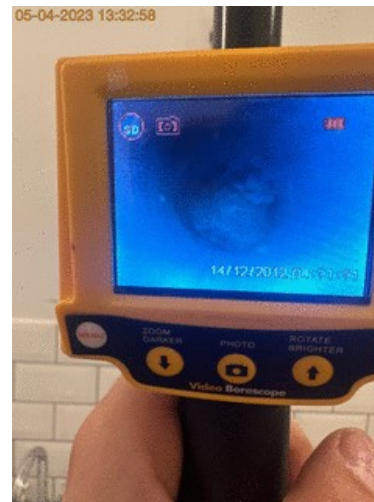
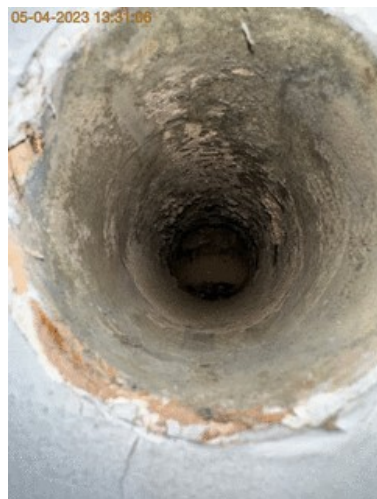
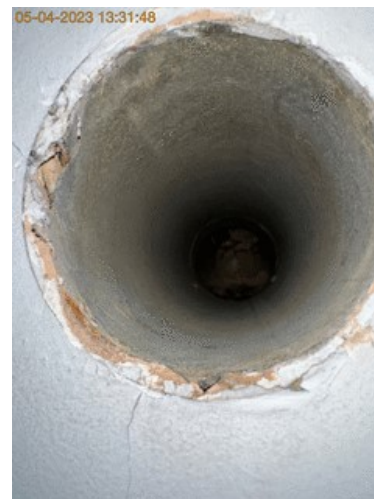
Goulden House - Entrance A Flat 10 bathroom extract. Solid ducting in good condition (visual and borescope camera inspection). We can not reach vertical riser duct from this grille to see if any fire dampers fitted. No access to vertical ducting riser from this Flat.

Air flow reading:  
6.70 – before clean  
9.56 – after clean

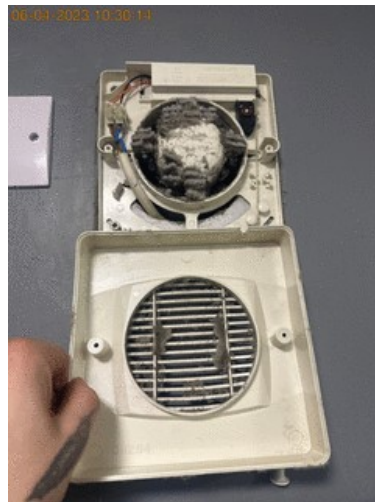
Goulden House - Entrance A Level 3 Flat 16 bathroom extract fan. No access to the ducting as the unit is sealed. No access to the vertical ducting riser from this Flat. The unit has been cleaned.

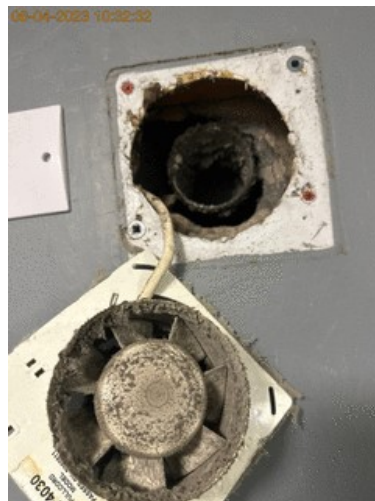
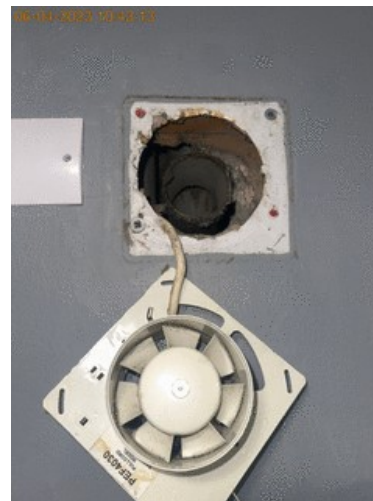
Goulden House - Flat 16 bathroom extract. Solid ducting in good condition (visual and borescope camera inspection). We can not reach vertical riser duct from this grille to see if any fire dampers fitted. No access to vertical ducting riser from this Flat.

4.38 – after clean

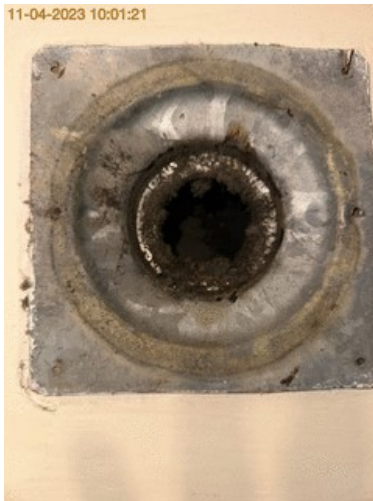
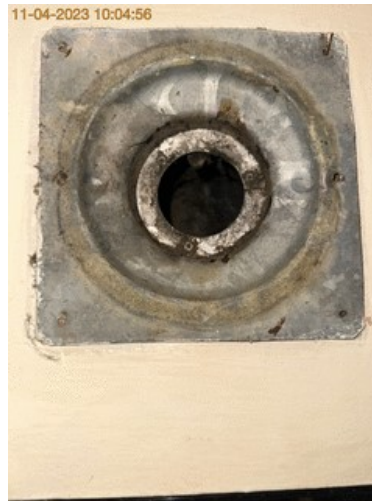
Goulden House - Entrance A Level 4 Flat 134 - bathroom extract. Solid ducting in good condition (visual and borescope camera inspection) We can not reach vertical riser duct from this grille to see if any fire dampers fitted. No access to vertical ducting riser from this Flat.

3.66 – after clean

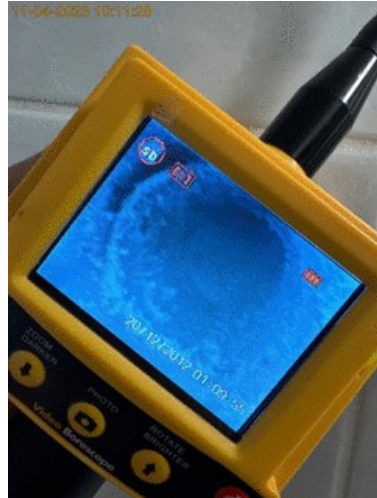
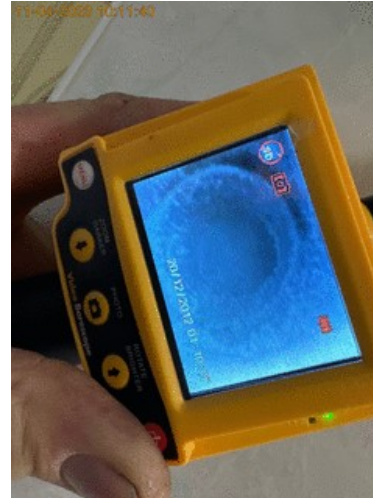
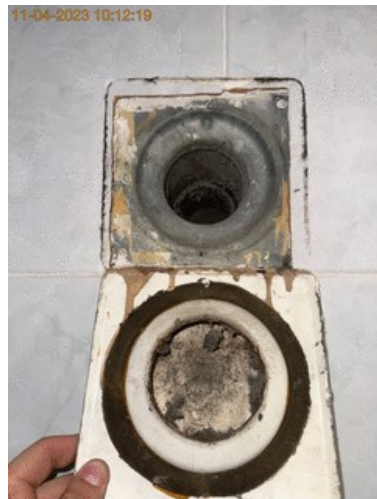
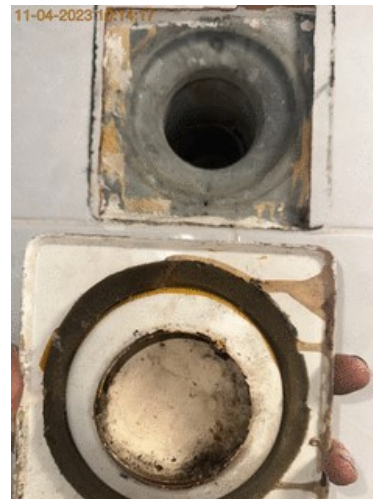
Goulden House - Entrance A Level 4 Flat 137 bathroom extract. Solid ducting in good condition. We can not reach vertical riser duct from this grille to see if any fire dampers fitted. No access to vertical ducting riser from this Flat.

Air flow reading:  
3.45 – before clean  
3.47 – after clean

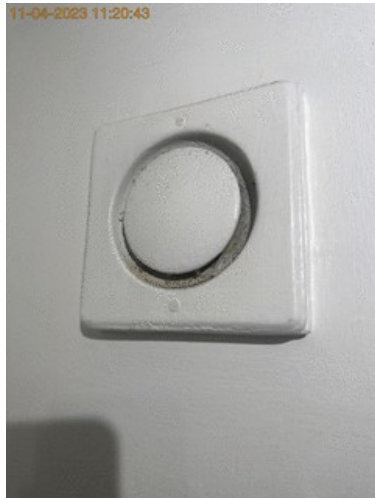
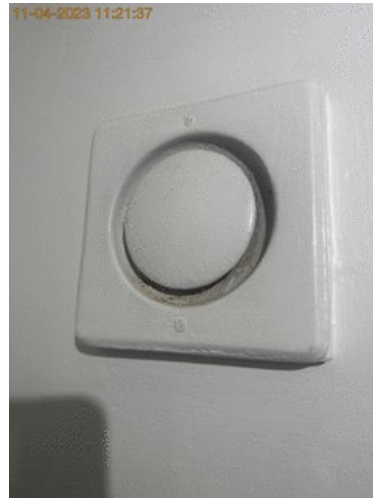
Goulden House - Entrance A Level 4 Flat 152 - bathroom extract. No access to the ducting as the unit is sealed. No access to the vertical ducting riser from this Flat. The unit has been cleaned.

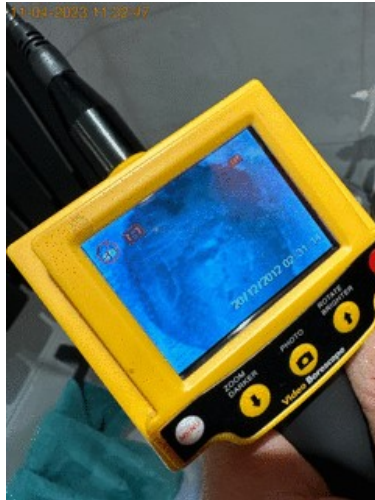
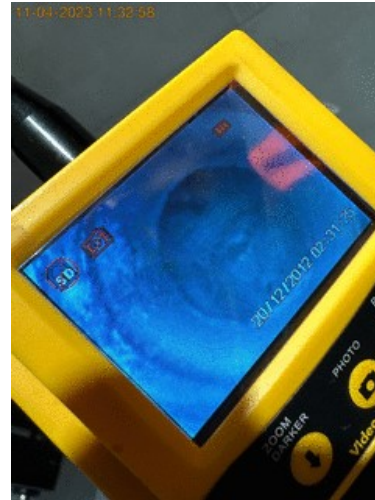
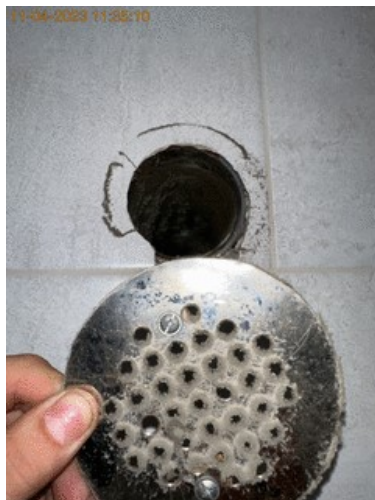
Goulden House - Entrance A Level 4 Flat 156 toilet extract. Solid ducting in good condition (visual and borescope camera inspection). We can not reach vertical riser duct from this grille to see if any fire dampers fitted. No access to vertical ducting riser from this Flat.

Air flow reading:  
3.22 – before clean  
3.38 – after clean

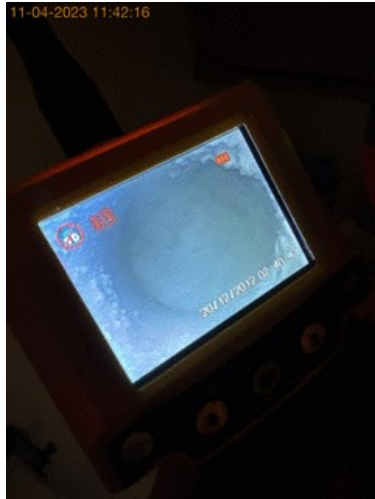
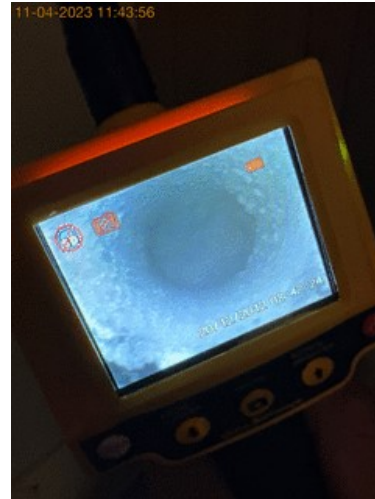
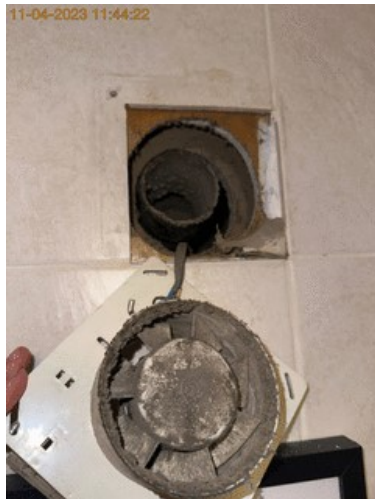
Goulden House - Entrance A Level 4 Flat 157 - bathroom extract. Solid ducting in good condition (visual and borescope camera inspection). We can not reach vertical riser duct from this grille to see if any fire dampers fitted. No access to vertical ducting riser from this Flat.

Air flow reading:  
1.06 – before clean  
1.29 – after clean

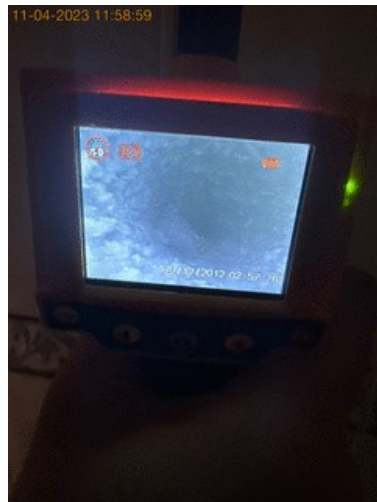
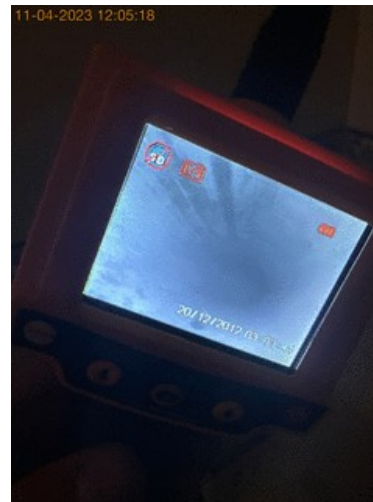
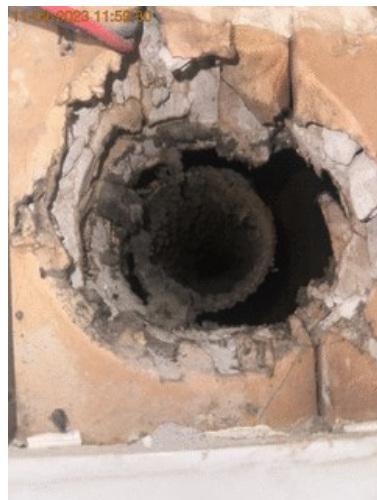
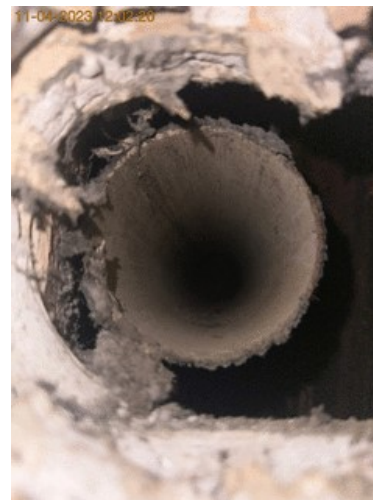
Goulden House - Entrance A Level 4 Flat 158 bathroom extract. Solid ducting in bad condition (visual and borescope camera inspection). We can not reach vertical riser duct from this grille to see if any fire dampers fitted. No access to vertical ducting riser from this Flat.

Air flow reading:  
2.12 – before clean  
2.37 – after clean

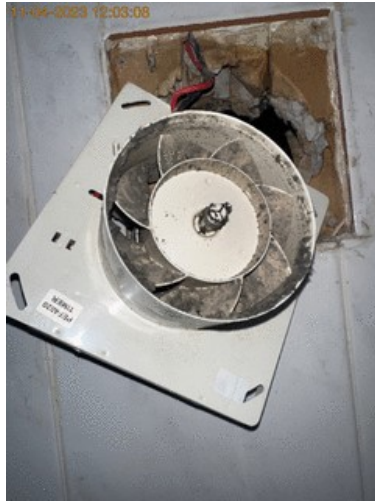
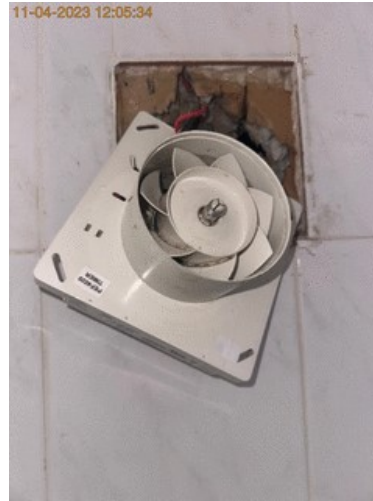
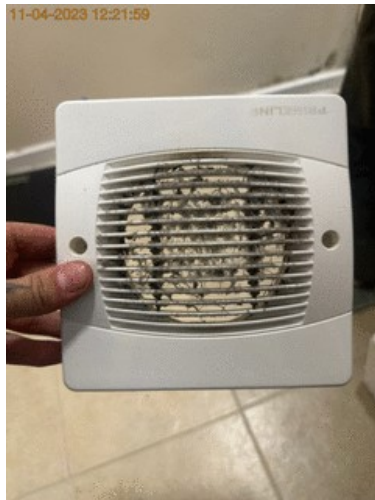
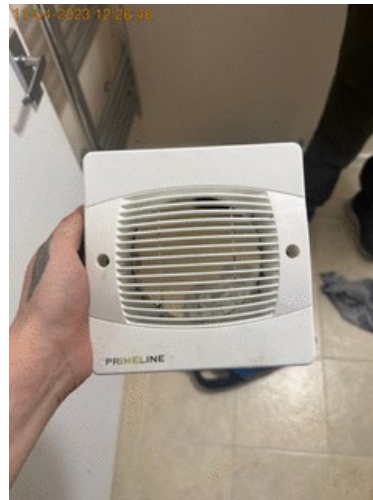
Goulden House - Entrance A Level 4 Flat 156 - bathroom extract. No access to the ducting. No access to the vertical ducting riser from this Flat. The unit has been cleaned.

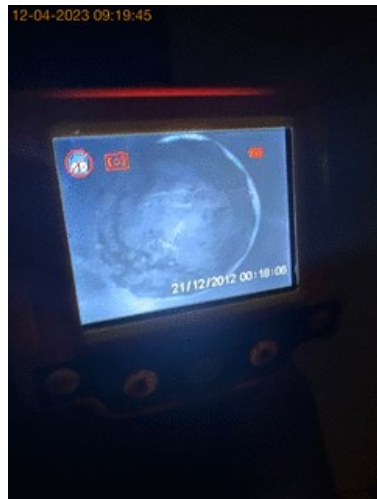
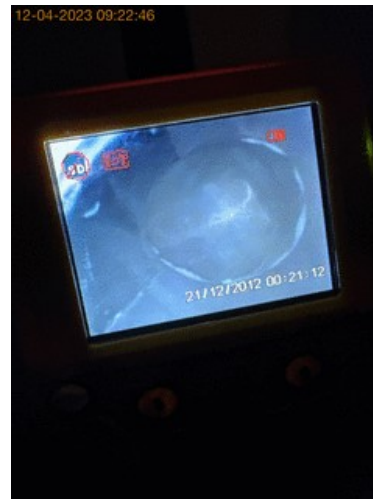
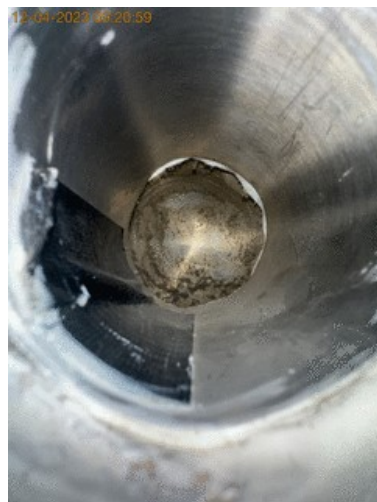
Goulden House - Entrance A Level 4 Flat 163. Solid ducting in good condition (visual and borescope camera inspection). We can not reach vertical riser duct from this grille to see if any fire dampers fitted. No access to vertical ducting riser from this Flat. This Flat has also window fan fitted.

Air flow reading:  
1.60 – before clean  
2.10 – after clean

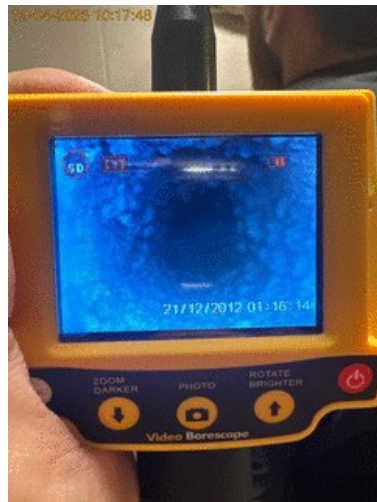
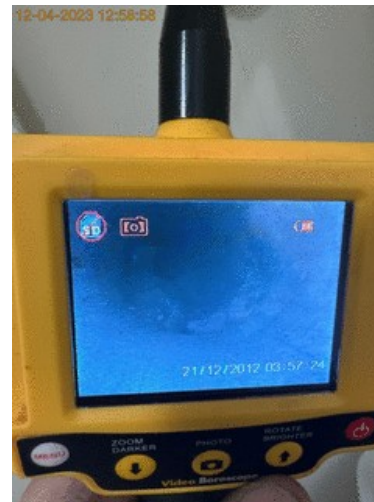
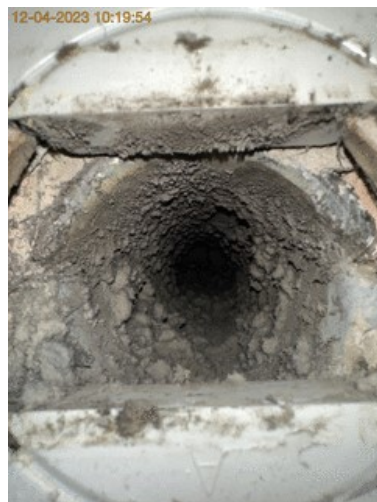
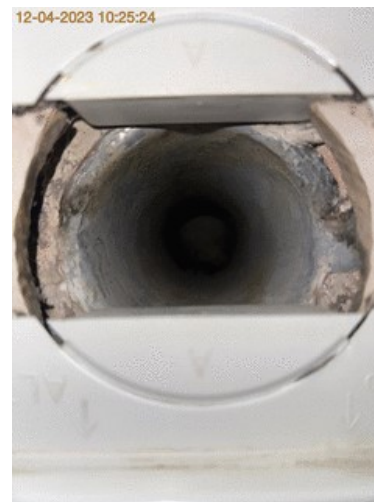
Goulden House - Entrance A Level 4 Flat 142 - Solid ducting in good condition (visual and borescope camera inspection).  
We can not reach vertical riser duct from this grille to see if any fire dampers fitted. No access to vertical ducting riser from this Flat.

Air flow reading:  
5.60 – before clean  
5.93 – after clean

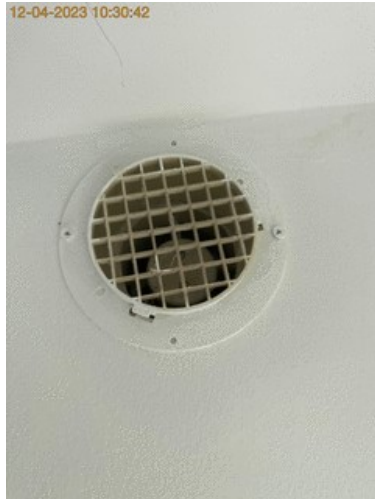
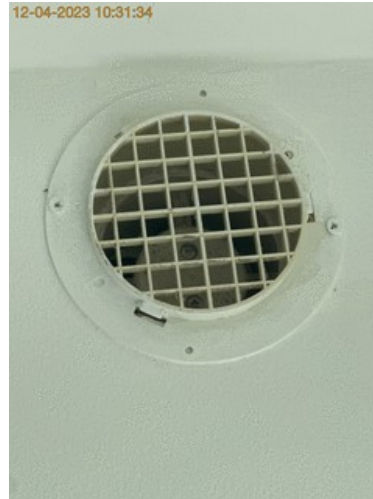
Goulden House - Entrance A Level 4 Flat 149 bathroom extract. No access to the ducting as the unit is sealed. No access to the vertical ducting riser from this Flat. The unit has been cleaned.

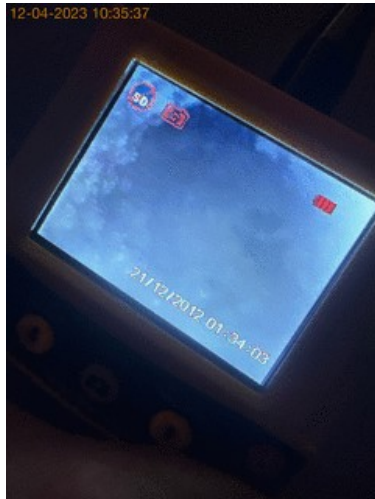
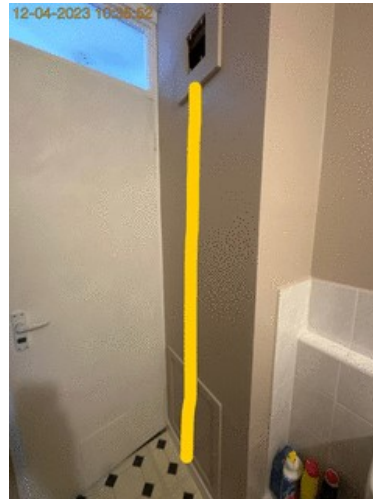
Goulden House - Entrance A Level 4 Flat 161 - bathroom extract. No access to the ducting as the unit is sealed. No access to the vertical ducting riser from this Flat. The unit has been cleaned.

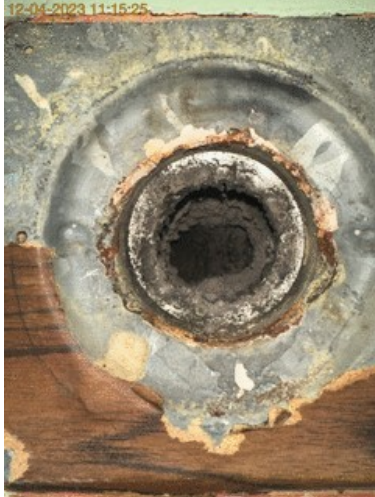
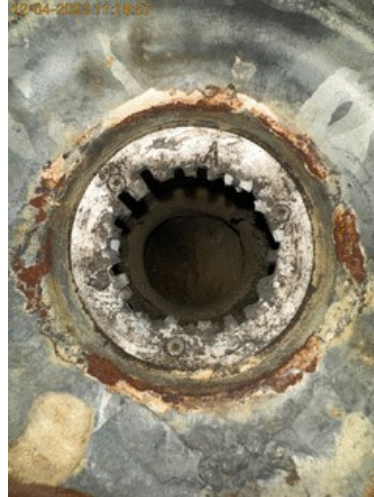
Goulden House - Entrance A Level 4 Flat 143 bathroom extract. Solid ducting in good condition (visual and borescope camera inspection). We can not reach vertical riser duct from this grille to see if any fire dampers fitted. No access to vertical ducting riser from this Flat.

Air flow reading:  
5.60 – before clean  
5.93 – after clean

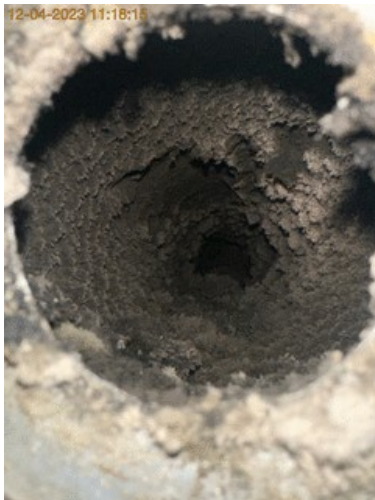
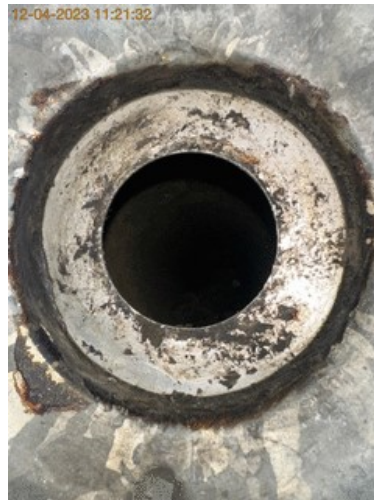
Goulden House - Flat 143 toilet extract. Solid ducting in good condition (visual and borescope camera inspection). We can not reach vertical riser duct from this grille to see if any fire dampers fitted. No access to vertical ducting riser from this Flat.

Air flow reading:  
5.08 – before clean  
6.03 – after clean

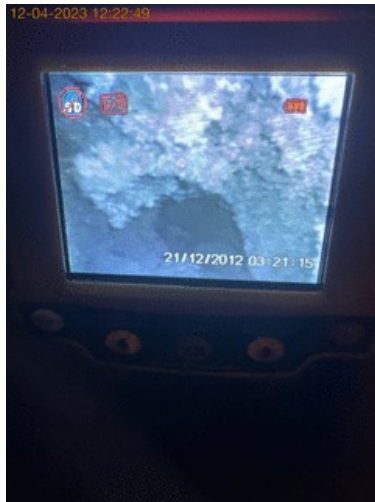
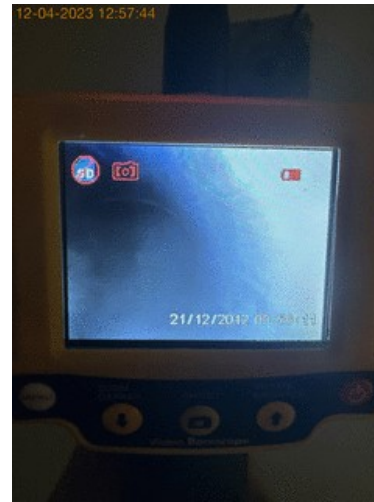
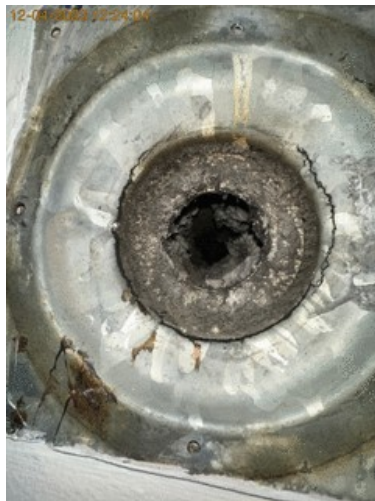
Goulden House - Entrance A Level 4 Flat 171 – bathroom extract. Solid ducting in good condition (visual and borescope camera inspection). We can not reach vertical riser duct from this grille to see if any fire dampers fitted. No access to vertical ducting riser from this Flat

Air flow reading:  
4.24 – before clean  
5.79 – after clean
