## VENTILATION HYGIENE REPORT

Site Name: Goulden House

Overclean Job Ref: 33331

Completion Date: 05/05/2023

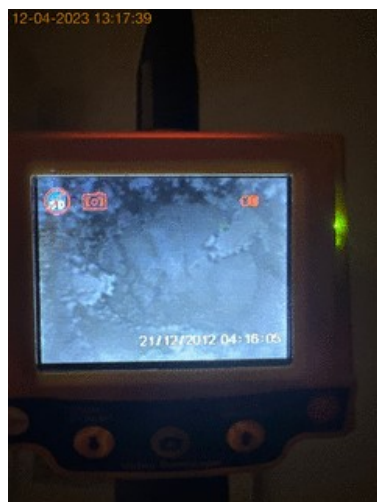
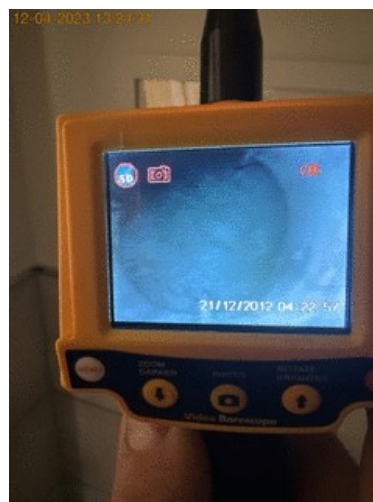
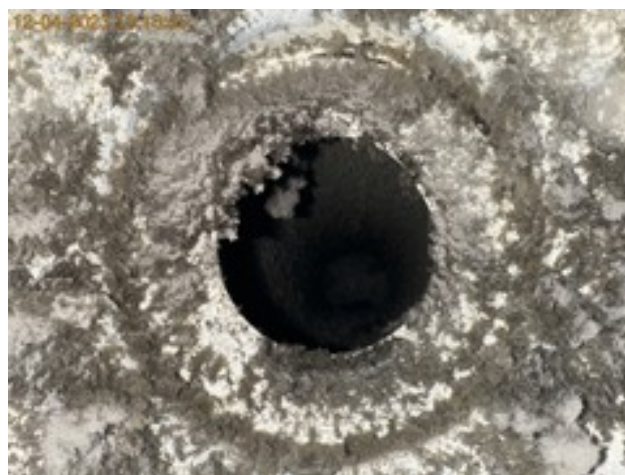
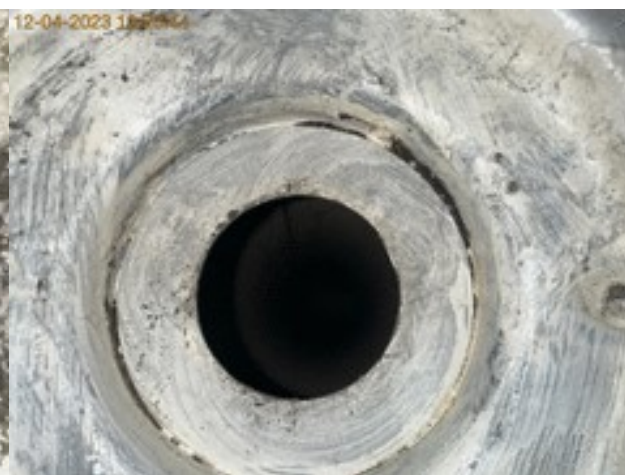
Goulden House - Entrance A Level 4 Flat 172 - bathroom. Solid ducting in good condition (visual and borescope camera inspection). We can not reach vertical riser duct from this grille to see if any fire dampers fitted. No access to vertical ducting riser from this Flat.

4.28 – after clean

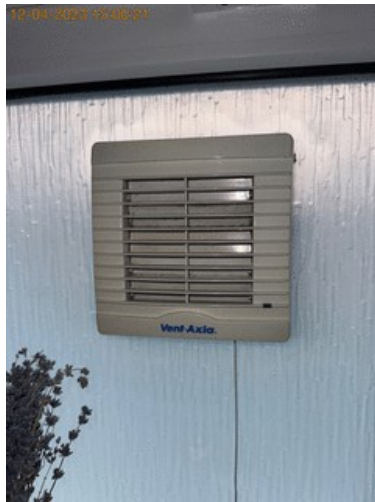
Goulden House - Entrance A Level 4 Flat 173 – window based unit – no fan and the wire is cut.

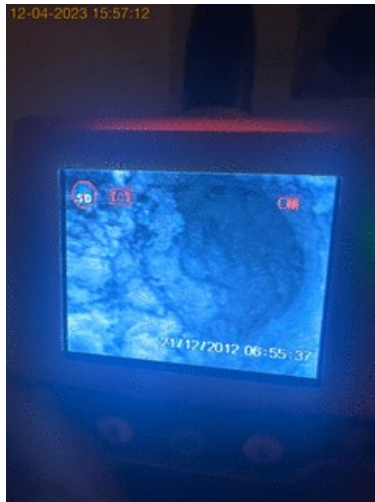
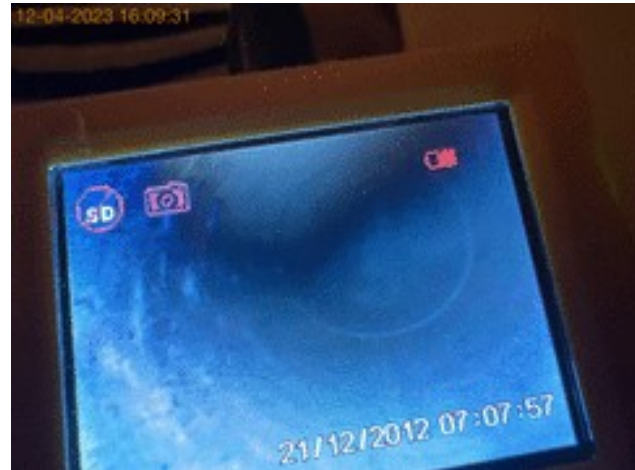
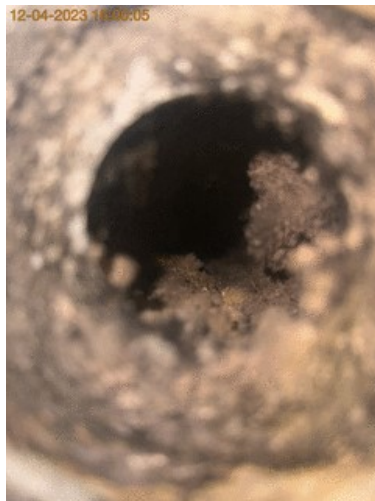
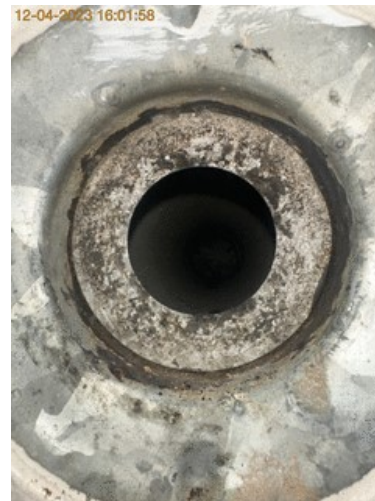
Goulden House - Entrance A Level 4 Flat 162 bathroom extract. Solid ducting in good condition(visual and borescope camera inspection). We can not reach vertical riser duct from this grille to see if any fire dampers fitted. No access to vertical ducting riser from this Flat.

Air flow reading:  
4.09 – before clean  
4.27 – after clean

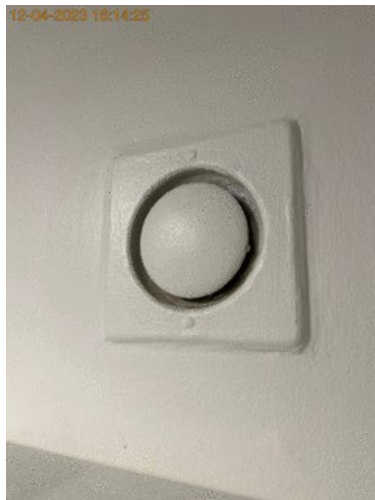
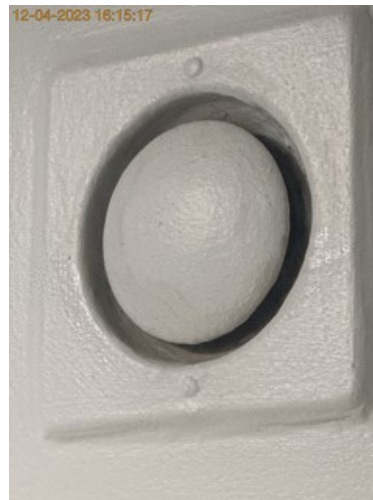
Goulden House - Entrance A Level 4 Flat 153 - bathroom. No access to the ducting as the unit is sealed. No access to the vertical ducting riser from this Flat. The unit has been cleaned.

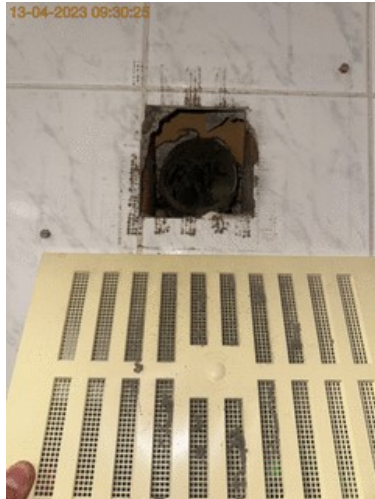
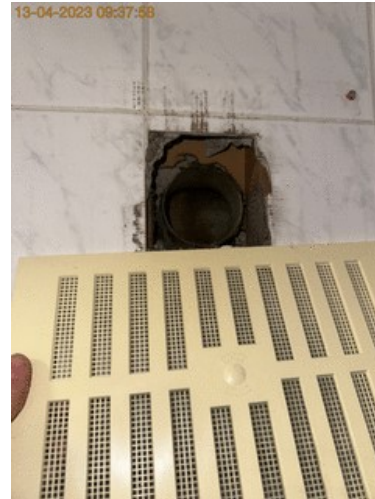
Gouldon House - Flat 148 single toilet extract. Solid ducting in good condition (visual and borescope camera inspection). We can not reach vertical riser duct from this grille to see if any fire dampers fitted. No access to vertical ducting riser from this Flat.

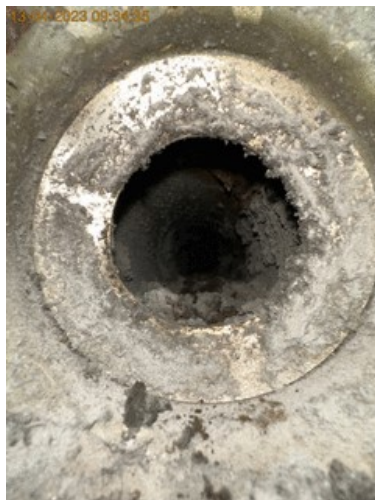
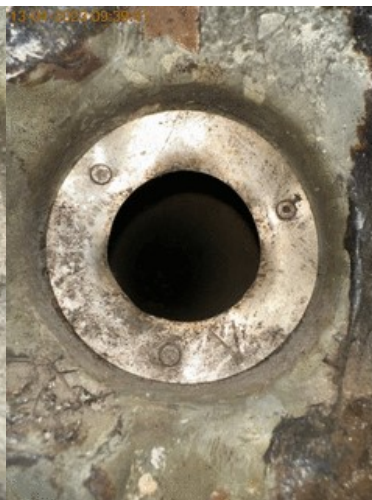
Goulden House - Entrance A Flat 32 - bathroom extract. Solid ducting in good condition (visual and borescope camera inspection). We can not reach vertical riser duct from this grille to see if any fire dampers fitted. No access to vertical ducting riser from this Flat

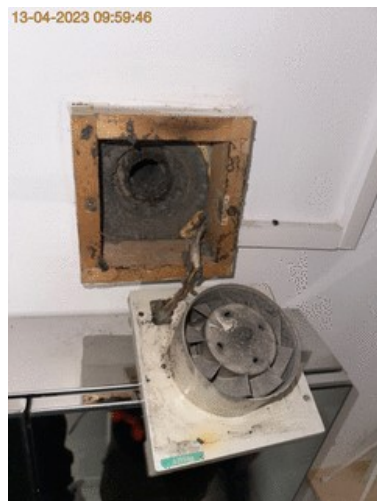
Goulden House - Entrance A Flat 28 - bathroom extract. Solid ducting in good condition (visual and borescope camera inspection). We can not reach vertical riser duct from this grille to see if any fire dampers fitted. No access to vertical ducting riser from this Flat.

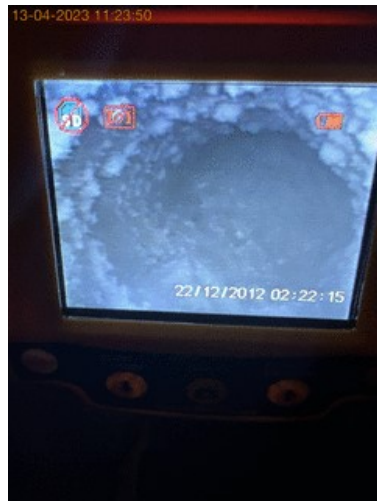
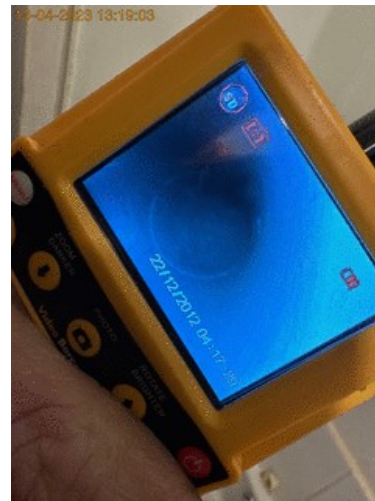
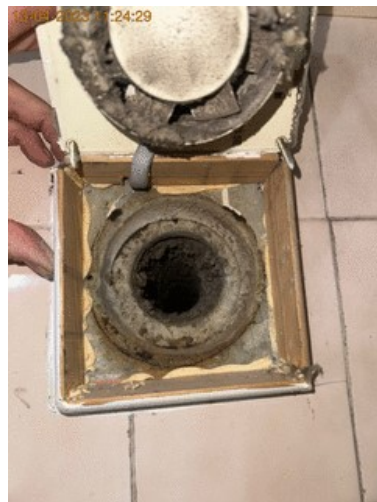
Goulden House - Entrance A Flat 27 - bathroom extract. Solid ducting in good condition (visual and borescope camera inspection). We can not reach vertical riser duct from this grille to see if any fire dampers fitted. No access to vertical ducting riser from this Flat.

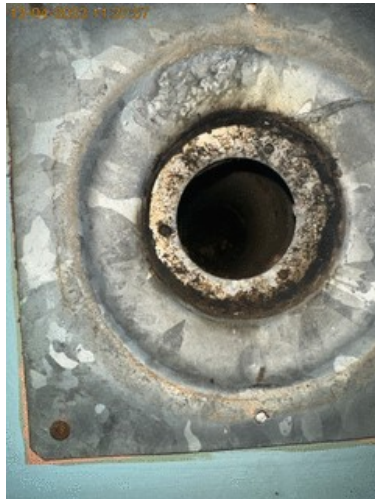
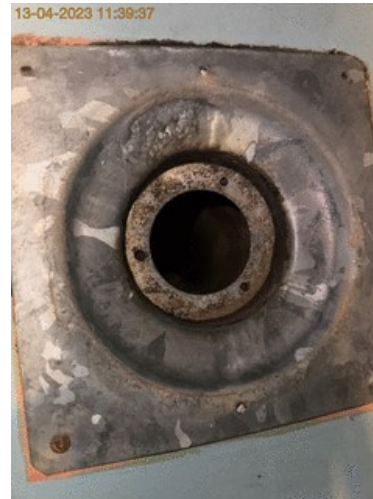
Goulden House - Flat 27 - toilet extract. Solid ducting in good condition (visual and borescope camera inspection). We can not reach vertical riser duct from this grille to see if any fire dampers fitted. No access to vertical ducting riser from this Flat.

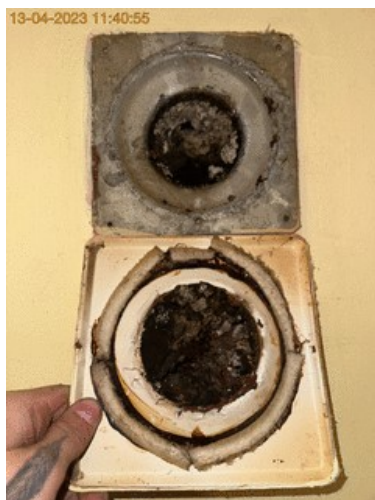
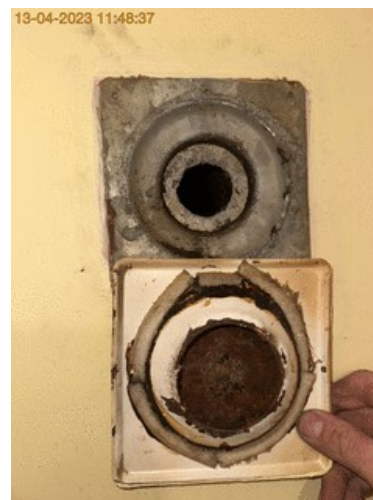
Goulden House - Entrance A Flat 38 bathroom extract. Solid ducting in bad condition (visual and borescope camera inspection). We can not reach vertical riser duct from this grille to see if any fire dampers fitted. No access to vertical ducting riser from this Flat.

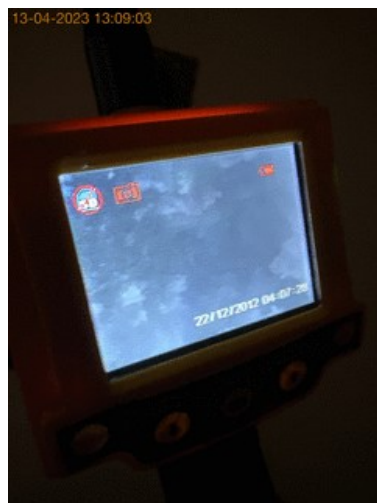
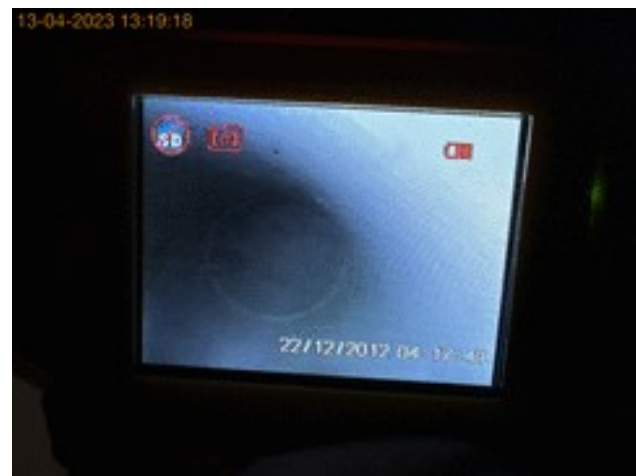
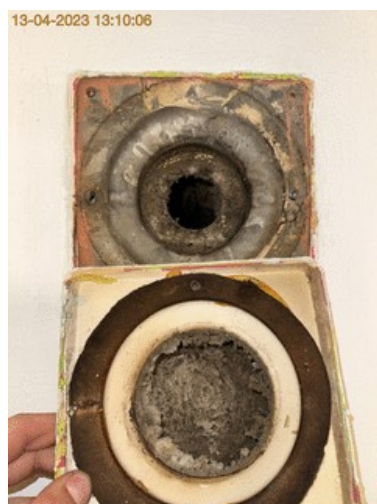
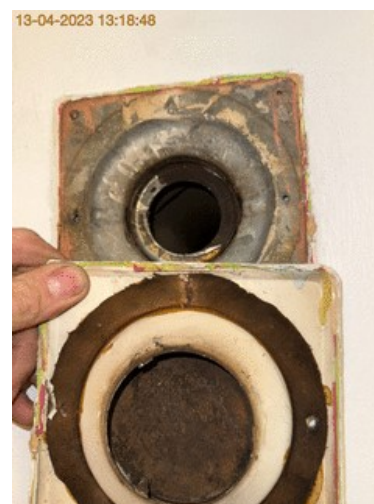
Goulden House - Entrance A Flat 39 - bathroom extract. Solid ducting in good condition (visual and borescope camera inspection). We can not reach vertical riser duct from this grille to see if any fire dampers fitted. No access to vertical ducting riser from this Flat.

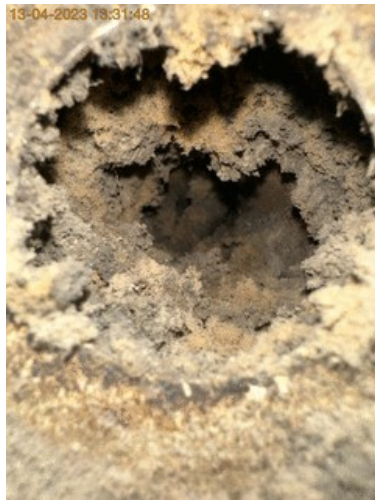
Goulden House - Entrance A Level 4 Flat 155 - bathroom extract. Solid ducting in good condition (visual and borescope camera inspection). We can not reach vertical riser duct from this grille to see if any fire dampers fitted. No access to vertical ducting riser from this Flat.

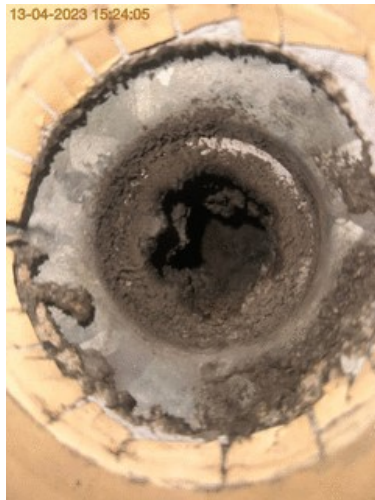
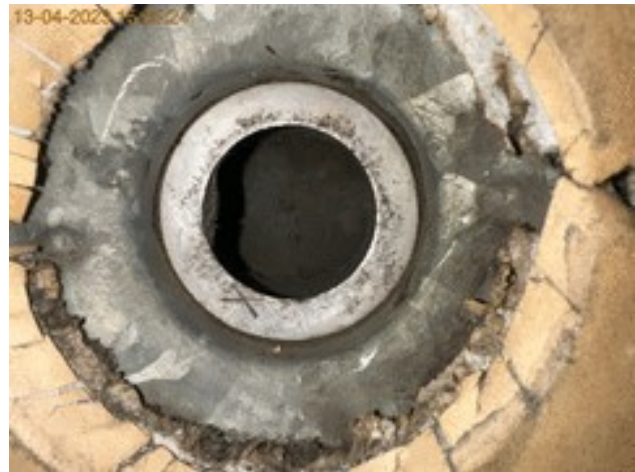
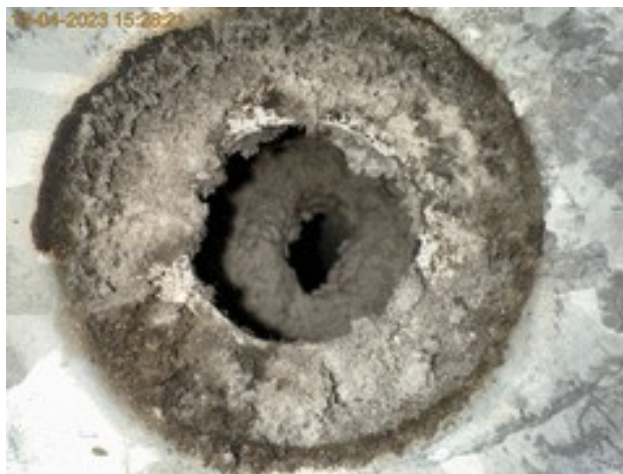
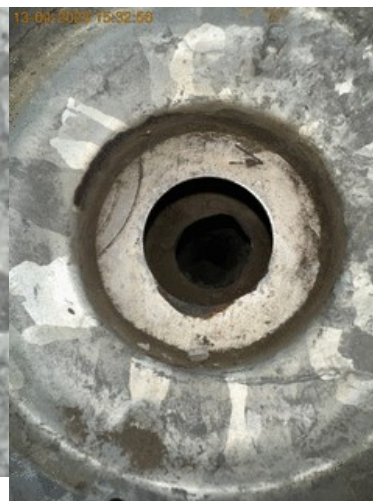
Goulden House - Entrance A Level 4 Flat 163 – bathroom extract. Flexible ducting in good condition (visual and borescope camera inspection). We can not reach vertical riser duct from this grille to see if any fire dampers fitted. No access to vertical ducting riser from this Flat. Also window based fan unit at this Flat.

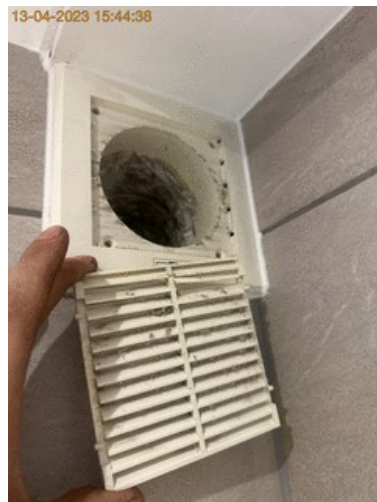
Goulden House - Entrance A Level 4 Flat 151 bathroom extract. Solid ducting in bad condition (visual and borescope camera inspection). We can not reach vertical riser duct from this grille to see if any fire dampers fitted. No access to vertical ducting riser from this Flat.

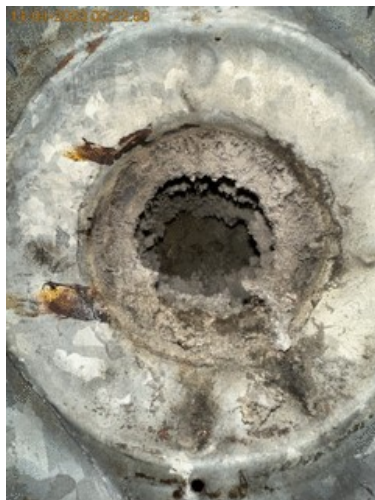
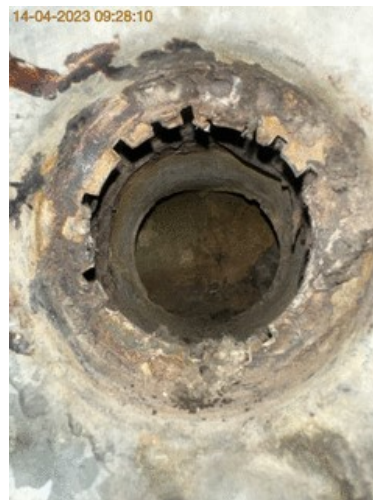
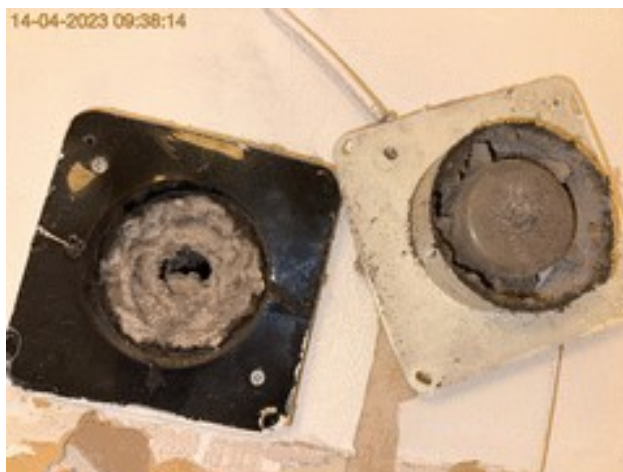
Goulden House - Entrance A Flat 151 - bathroom extract. Solid ducting in good condition (visual and borescope camera inspection). We can not reach vertical riser duct from this grille to see if any fire dampers fitted. No access to vertical ducting riser from this Flat.

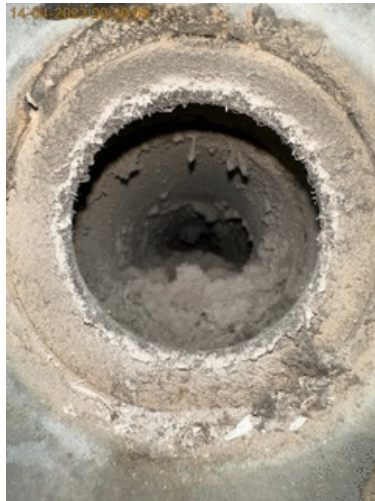
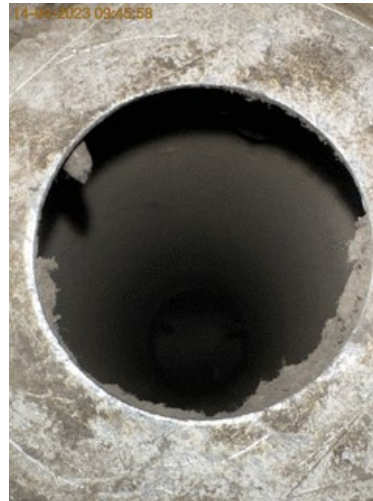
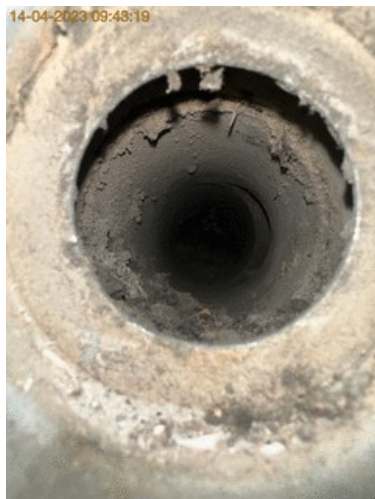
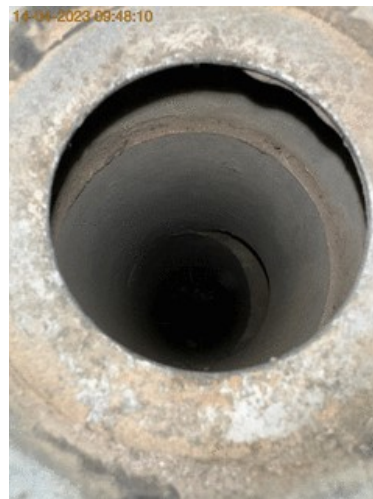
Goulden House - Entrance A Level 4 Flat 176 - bathroom extract. Solid ducting in good condition (visual and borescope camera inspection). We can not reach vertical riser duct from this grille to see if any fire dampers fitted. No access to vertical ducting riser from this Flat.

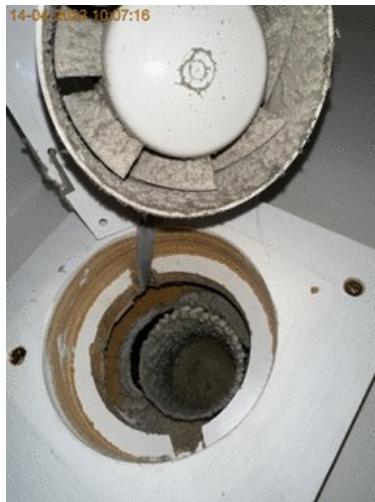
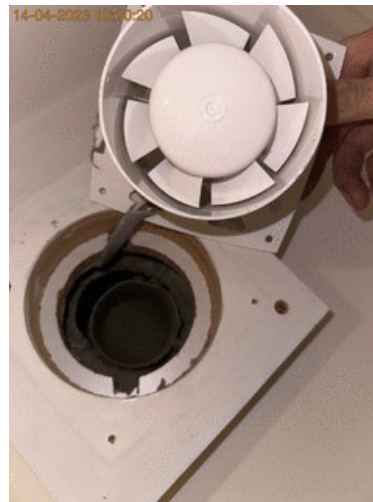
Goulden House - Entrance A Level 4 Flat 165 - bathroom extract. Fan unit extracting to void area, no ducting connected. No access to vertical ducting riser from this Flat.

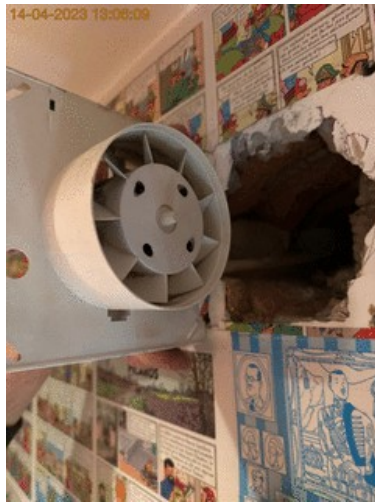
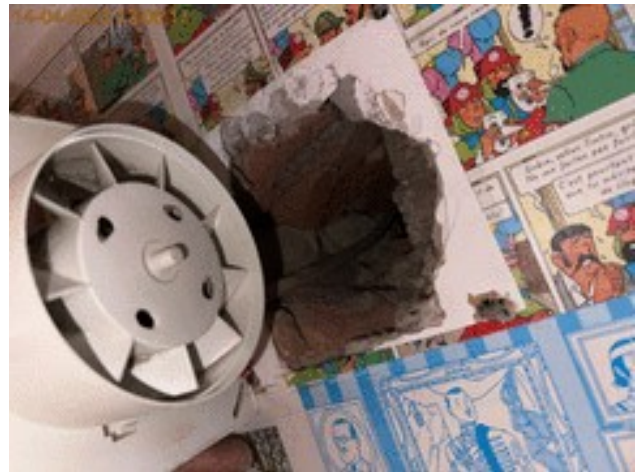
Goulden House - bathroom extract flat 165. Fan unit extracting to void area, no ducting connected. No access to vertical ducting riser from this Flat

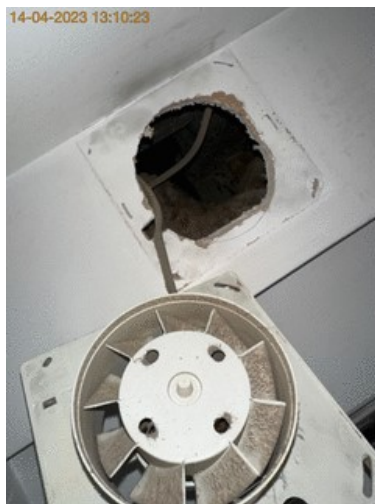
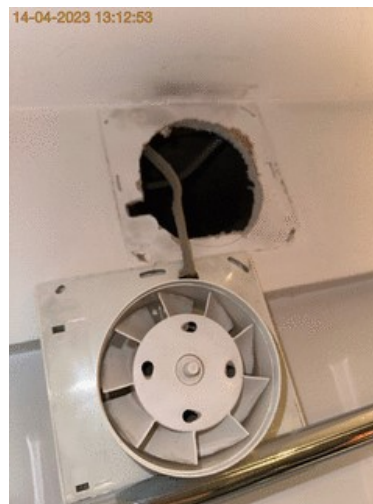
Goulden House - Entrance A Flat 41 - bathroom extract. No access to the ducting as the unit is sealed. No access to the vertical ducting riser from this Flat. The unit has been cleaned.

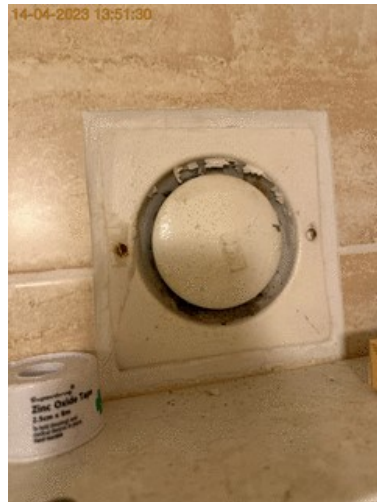
Goulden House - Entrance A Flat 41 - bathroom extract. Solid ducting in good condition (visual and borescope camera inspection). We can not reach vertical riser duct from this grille to see if any fire dampers fitted. No access to vertical ducting riser from this Flat.

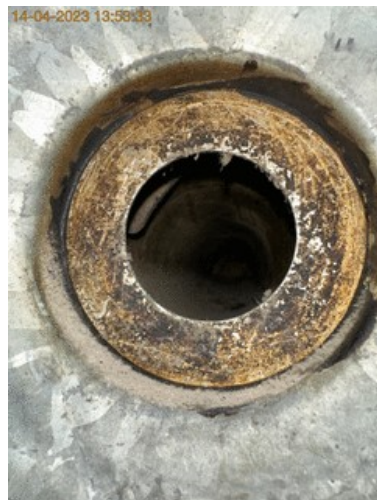
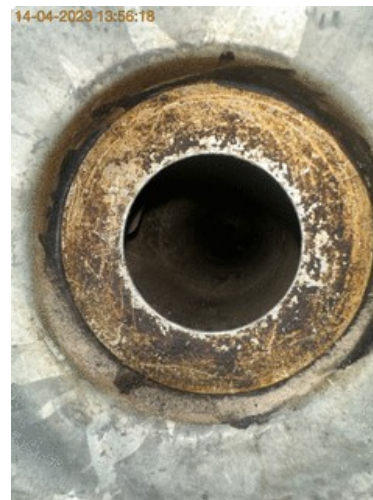
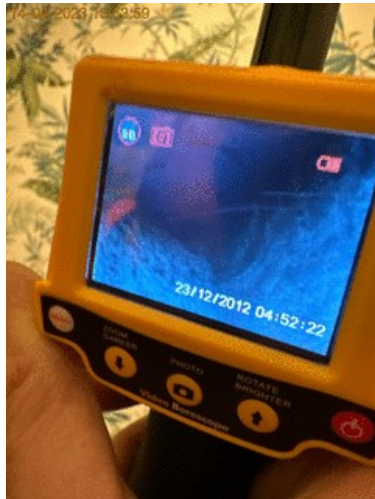
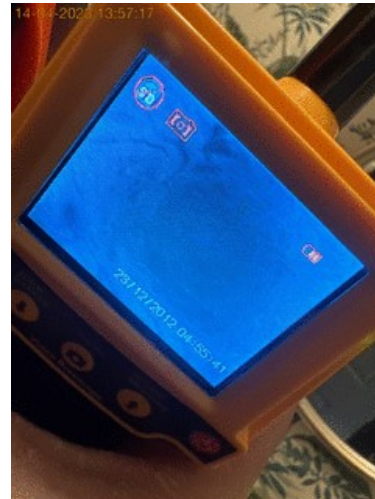
Goulden House - Entrance A Flat 48 - bathroom extract. Solid ducting in bad condition (visual and borescope camera inspection). We can not reach vertical riser duct from this grille to see if any fire dampers fitted. No access to vertical ducting riser from this Flat.

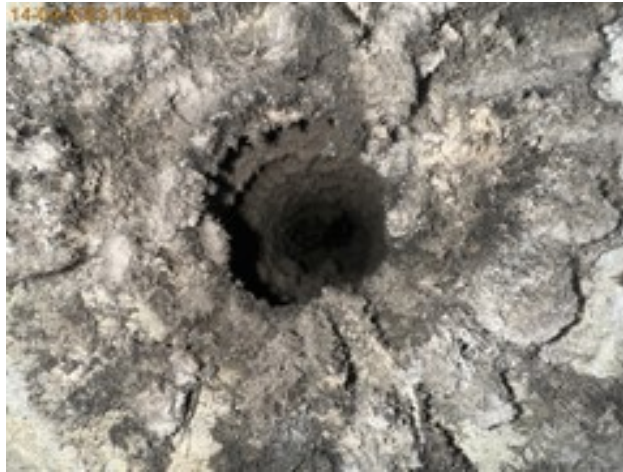
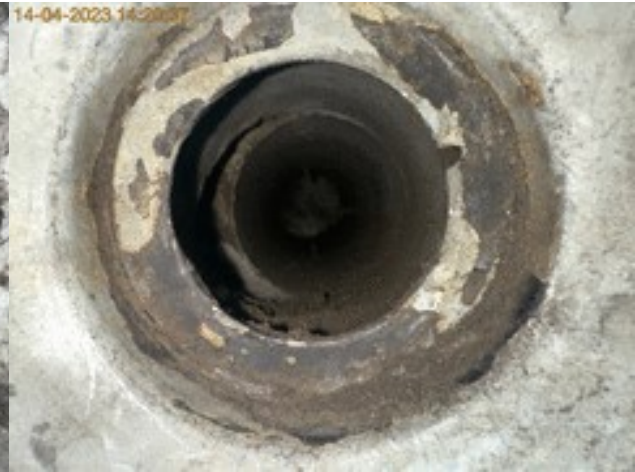
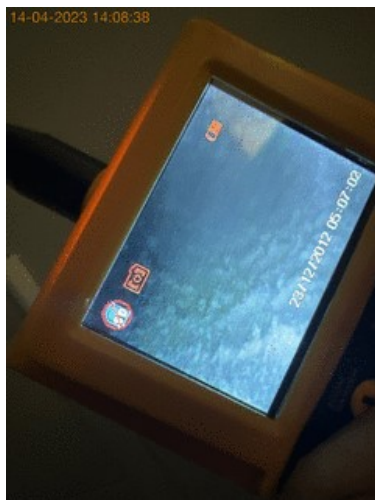
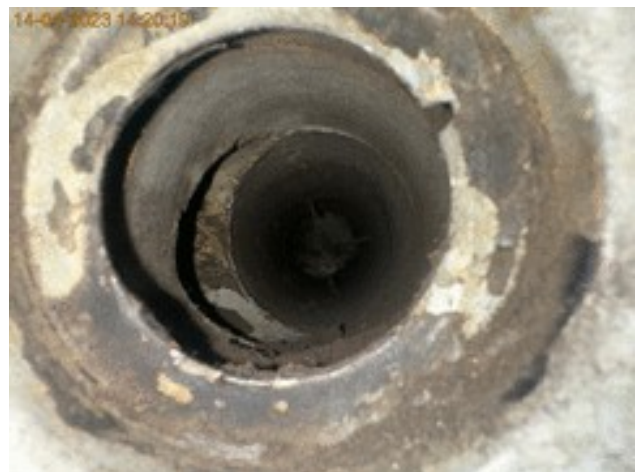
Air flow reading:  
3.16 – before clean  
4.28 – after clean

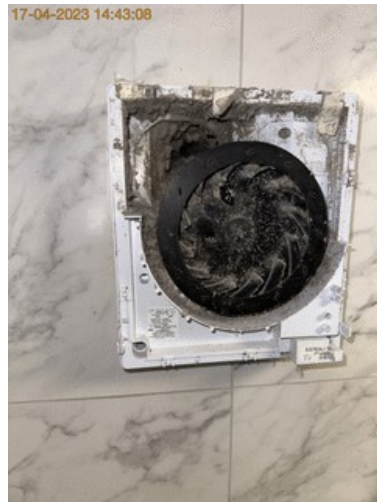
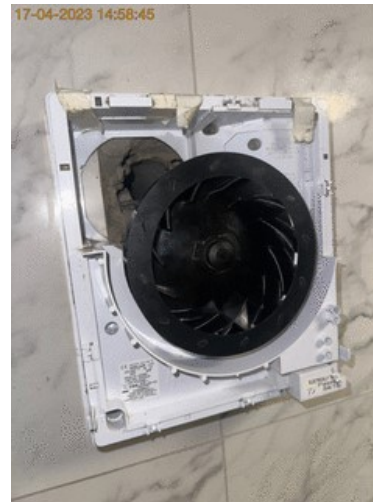
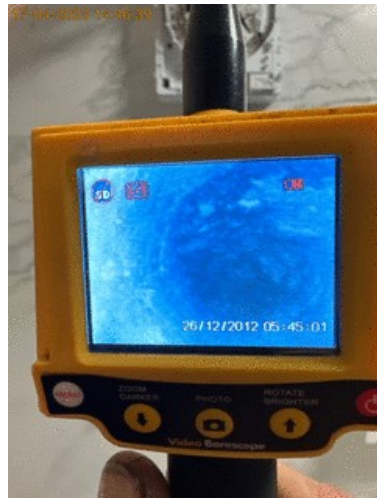
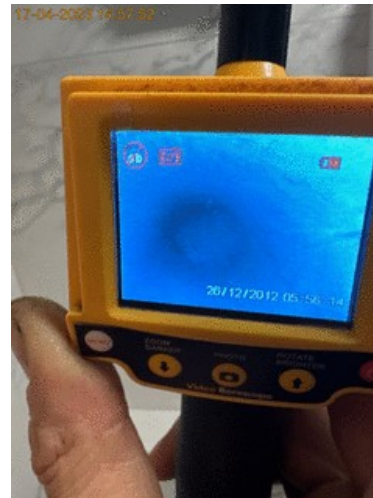
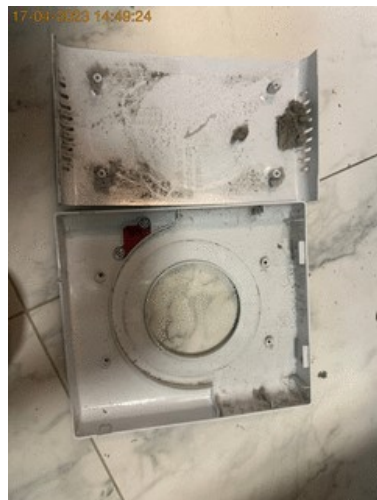
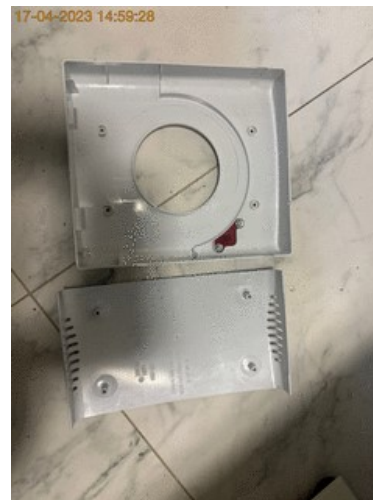
Goulden House - Entrance B Level 0 Flat 132 - bathroom extract fan. No access to the ducting as the unit is sealed. No access to the vertical ducting riser from this Flat. The unit has been cleaned.

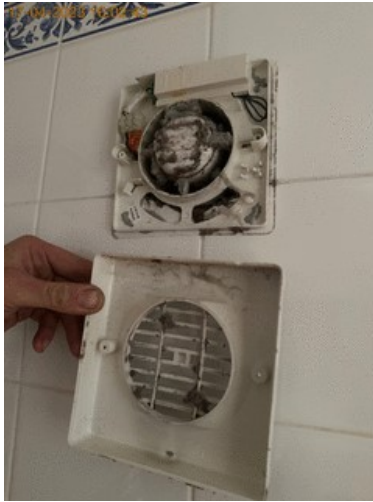
Goulden House - Flat 17 bathroom extract. No access to the ducting as the unit is sealed. No access to the vertical ducting riser from this Flat. The unit has been cleaned.

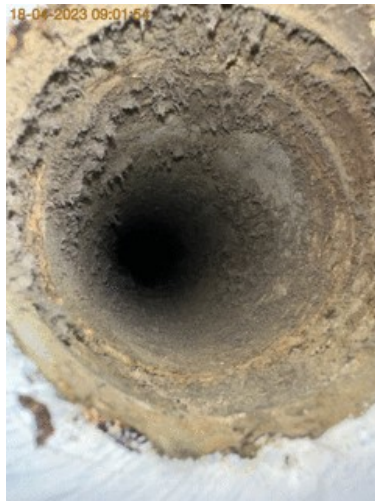
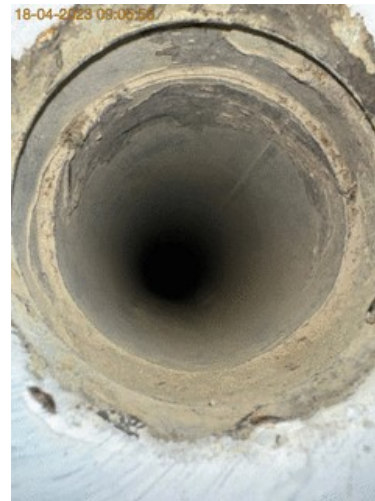
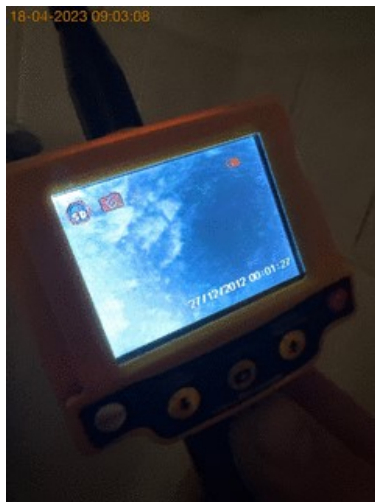
Goulden House - Entrance B Level 0 Flat 77 - bathroom extract. Solid ducting in good condition (visual and borescope camera inspection). We can not reach vertical riser duct from this grille to see if any fire dampers fitted. No access to vertical ducting riser from this Flat.

Air flow reading:  
3.01 – before clean  
3.77 – after clean

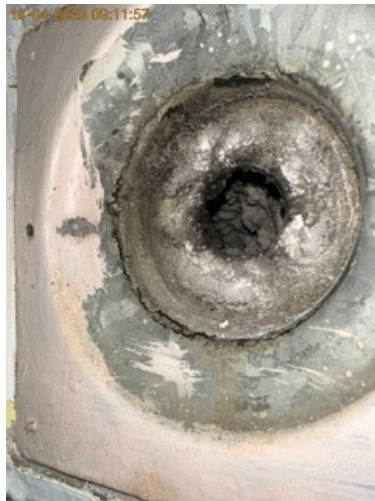
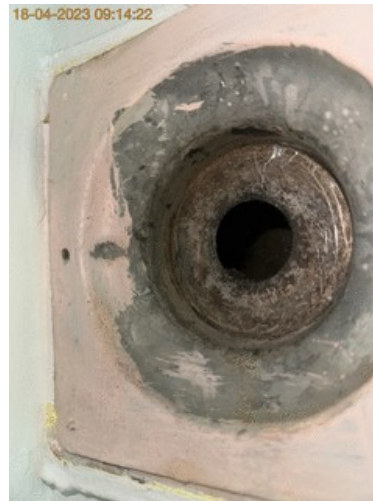
Goulden House - Flat 77 - toilet extract. Solid ducting in good condition ((visual and borescope camera inspection). We can not reach vertical riser duct from this grille to see if any fire dampers fitted. No access to vertical ducting riser from this Flat.

Air flow reading:  
3.20 – before clean  
3.84 – after clean

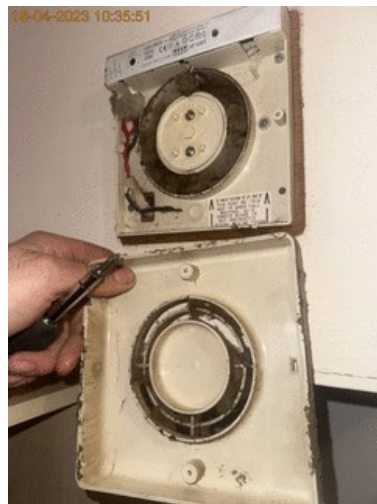
Goulden House - Entrance B Level 0 Flat 128 - bathroom extract. No access to the ducting as the unit is sealed. No access to the vertical ducting riser from this Flat. The unit has been cleaned.

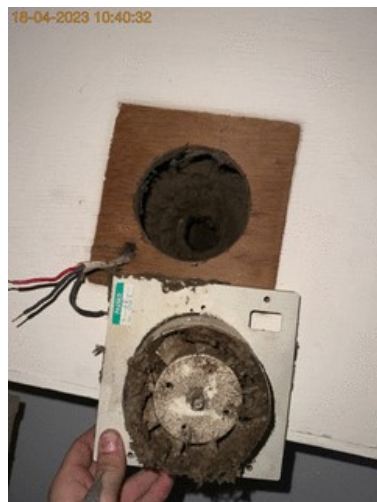
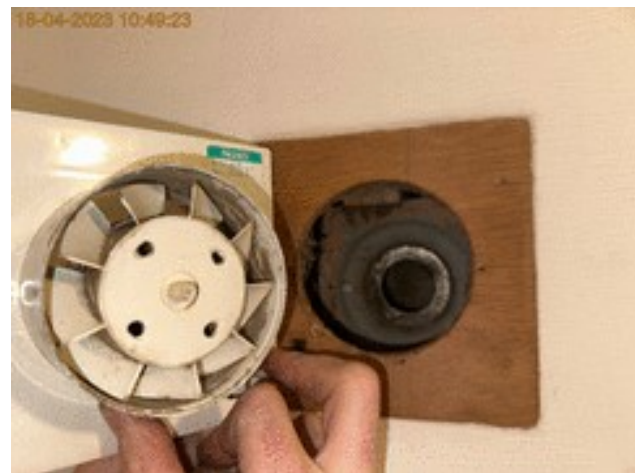
Goulden House - Flat 128- bathroom extract. Solid ducting in good condition (visual and borescope camera inspection). We can not reach vertical riser duct from this grille to see if any fire dampers fitted. No access to vertical ducting riser from this Flat.

4.29 – after clean

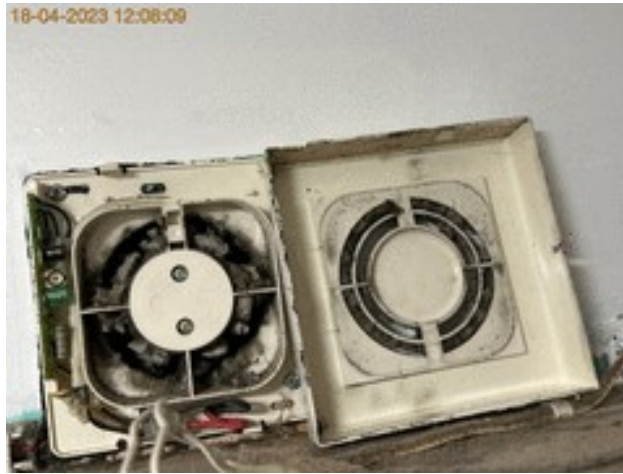
Goulden House - Entrance B Level 0 Flat 131 – bathroom extract. No access to the vertical ducting riser from this Flat. The unit has been cleaned.

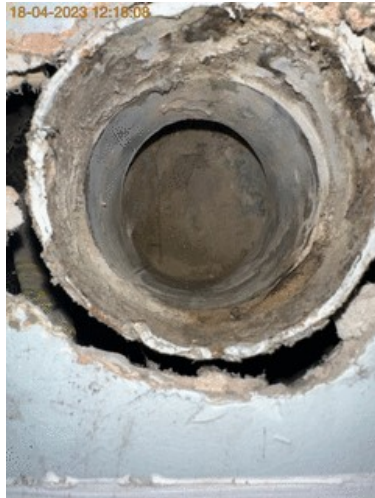
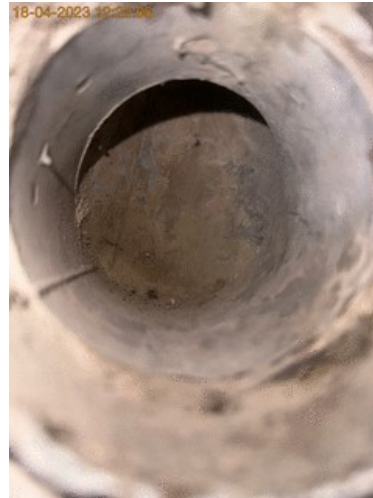
Gouldon House - Entrance B Level 0 Flat 133 - bathroom extract. Solid ducting in good condition (visual and borescope camera inspection). We can not reach vertical riser duct from this grille to see if any fire dampers fitted. No access to vertical ducting riser from this Flat.

4.37 – after clean

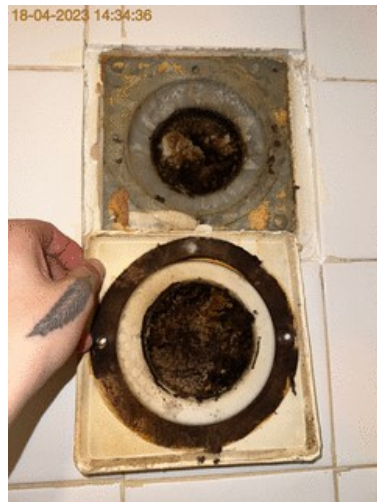
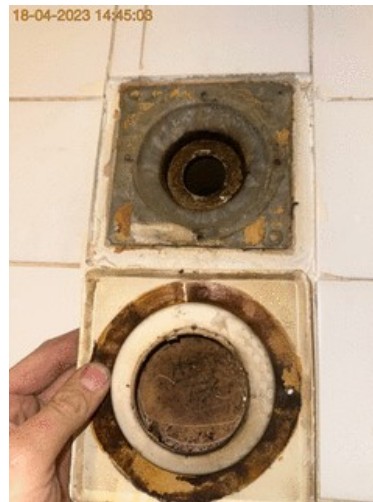
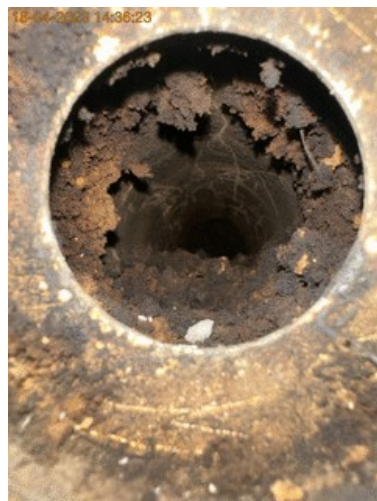
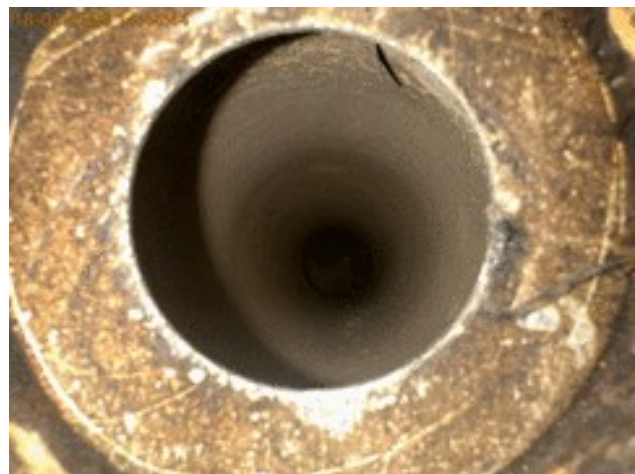
Goulden House - Entrance A Level 0 Flat 61 - bathroom extract. Solid ducting in good condition (visual and borescope camera inspection). We can not reach vertical riser duct from this grille to see if any fire dampers fitted. No access to vertical ducting riser from this Flat.

Air flow reading:  
3.10 – before clean  
3.70 – after clean

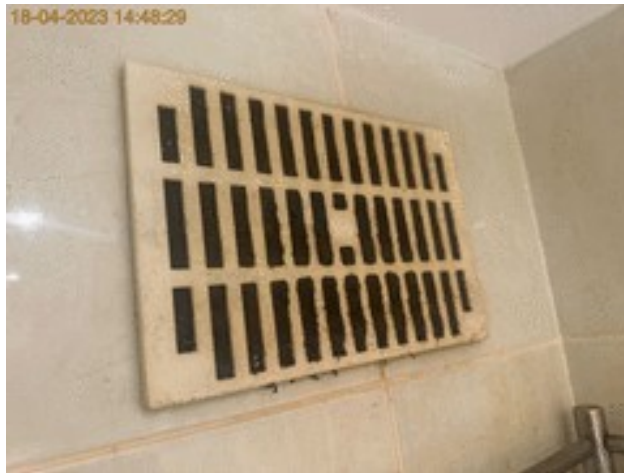
Goulden House - Flat 61 - bathroom extract. No access to the ducting as the unit is sealed. No access to the vertical ducting riser from this Flat. The unit has been cleaned.

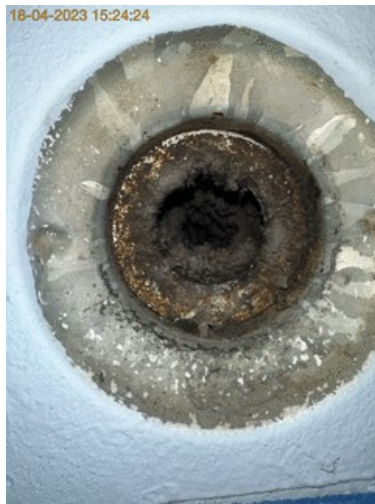
Goulden House - Flat 56 - bathroom extract. Solid ducting in good condition (visual and borescope camera inspection). We can not reach vertical riser duct from this grille to see if any fire dampers fitted. No access to vertical ducting riser from this Flat.

Air flow reading:  
2.11 – before clean  
3.44 – after clean

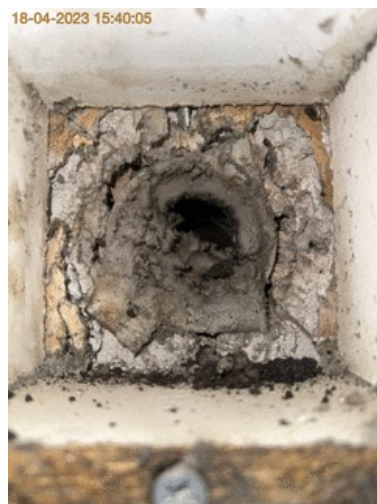
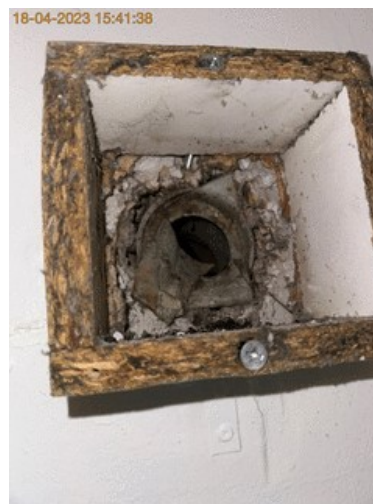
Goulden House - Flat 45 bathroom. Ducting in bad condition (visual and borescope camera inspection). We can not reach vertical riser duct from this grille to see if any fire dampers fitted. No access to vertical ducting riser from this Flat.

Air flow reading:  
2.11 – before clean  
3.46 – after clean

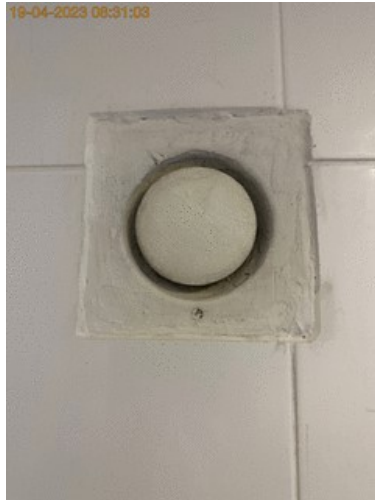
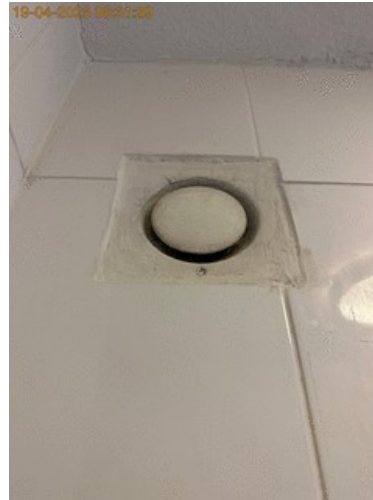
Goulden House - Entrance A Level 4 Flat 154 - bathroom extract. No access to the ducting as the unit is sealed. No access to the vertical ducting riser from this Flat. The unit has been cleaned.

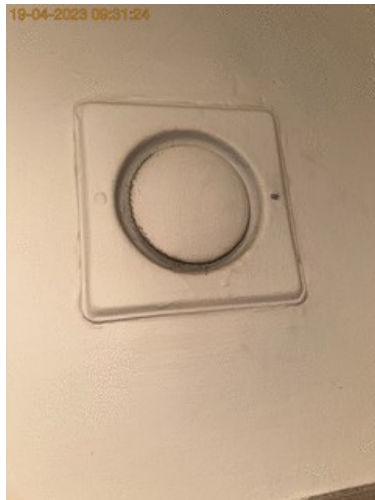
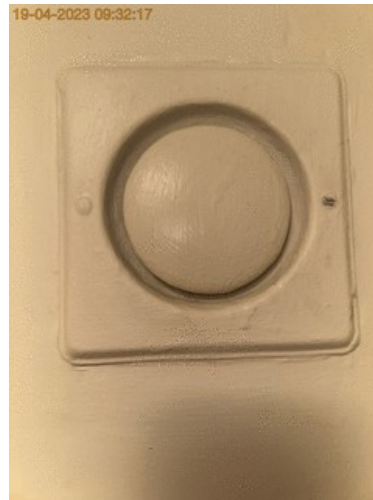
Goulden House - Flat 49 - bathroom extract. No access to the ducting as the unit is sealed. No access to the vertical ducting riser from this Flat. The unit has been cleaned.

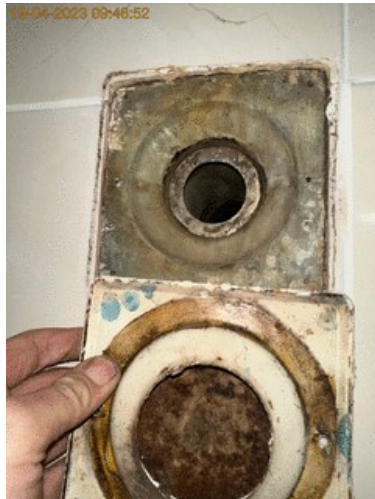
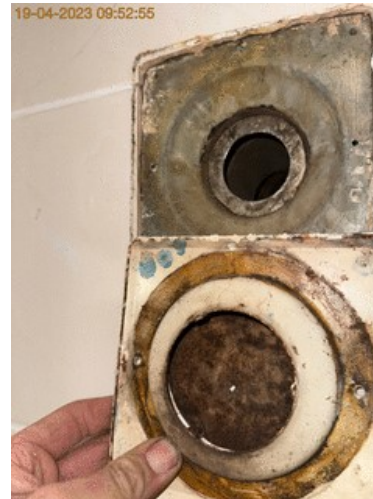
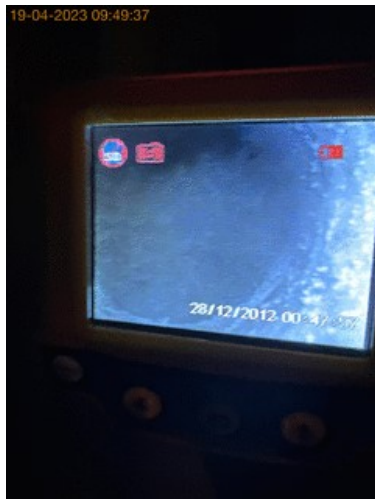
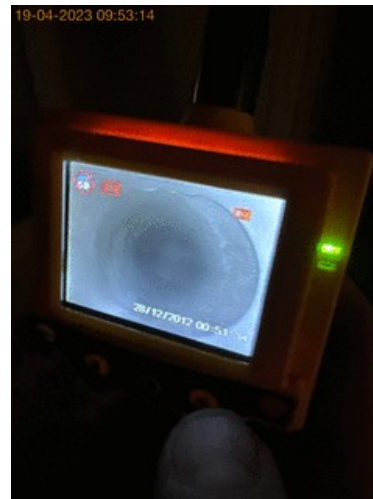
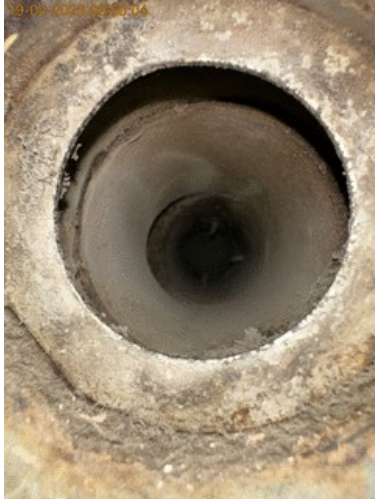
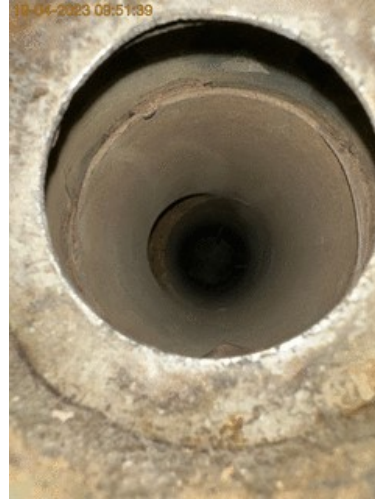
Gouldon House - Flat 56 - bathroom extract. Solid ducting in good condition. We can not reach vertical riser duct from this grille to see if any fire dampers fitted. No access to vertical ducting riser from this Flat.

Air flow reading:  
3.55 – before clean  
4.77 – after clean

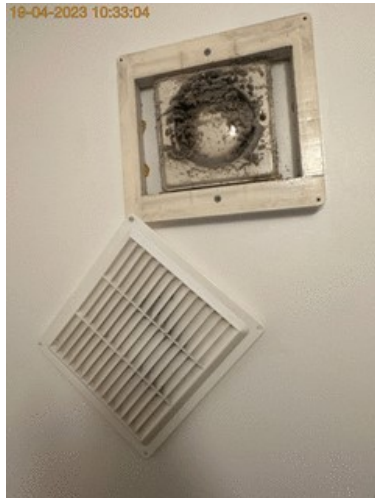
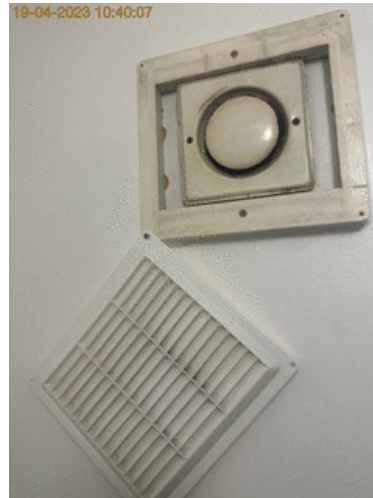
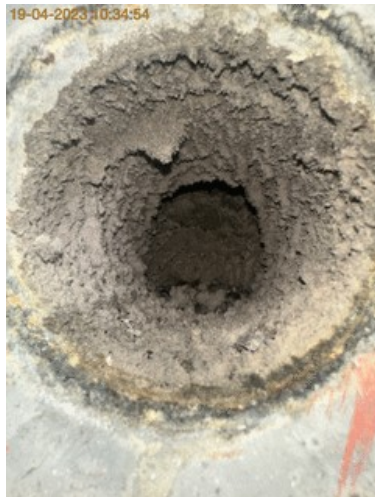
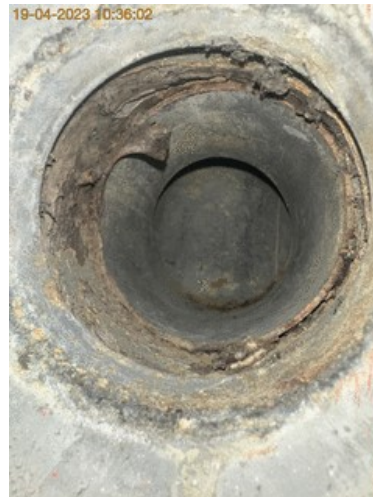
Goulden House - Entrance B Level 1 Flat 75 - bathroom extract. Solid ducting in bad condition (visual and borescope camera inspection). We can not reach vertical riser duct from this grille to see if any fire dampers fitted. No access to vertical ducting riser from this Flat.

Air flow reading:  
3.77 – before clean  
4.56 – after clean

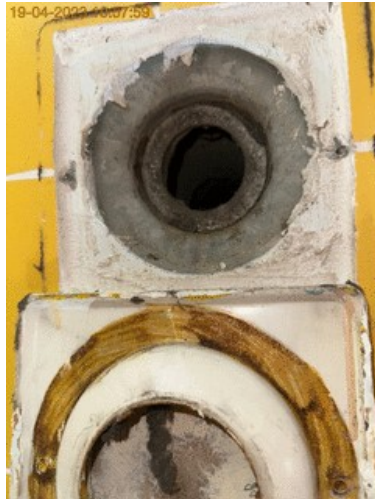
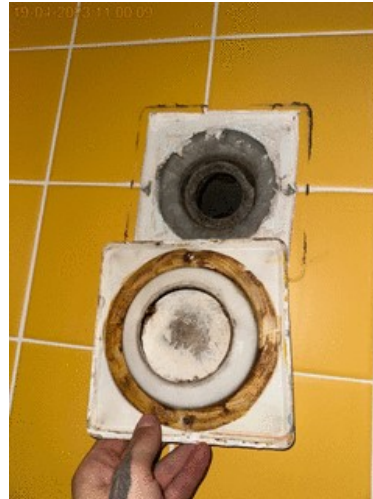
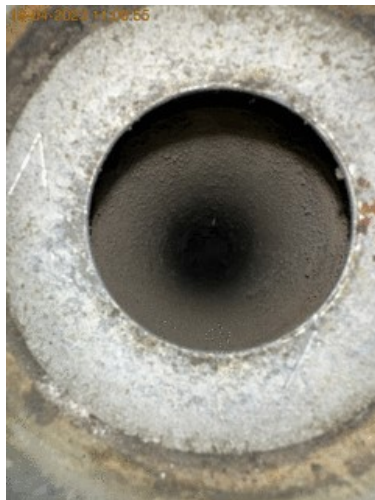
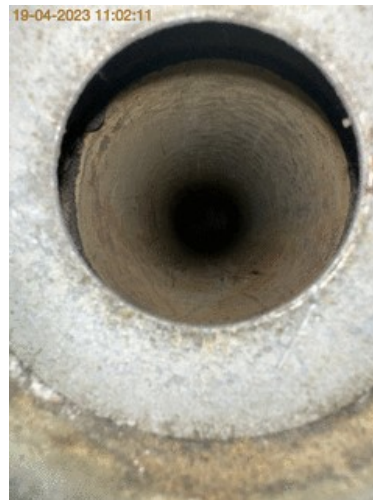
Goulden House - Flat 42 bathroom extract. Solid ducting in bad condition (visual and borescope camera inspection). We can not reach vertical riser duct from this grille to see if any fire dampers fitted. No access to vertical ducting riser from this Flat.

Air flow reading:  
3.66 – before clean  
4.55 – after clean
