## VENTILATION HYGIENE REPORT

Site Name: Goulden House

Overclean Job Ref: 33331

Completion Date: 05/05/2023

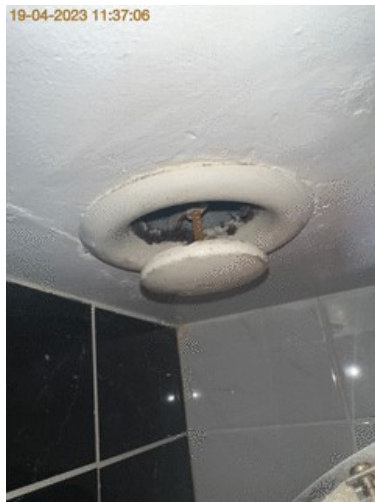
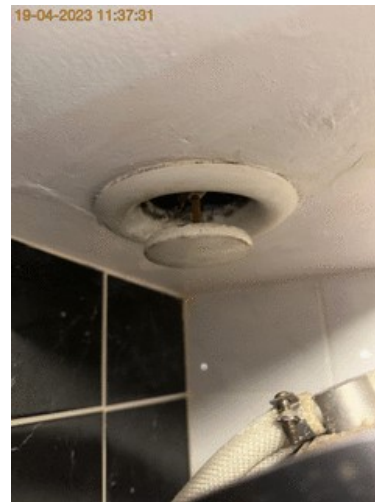
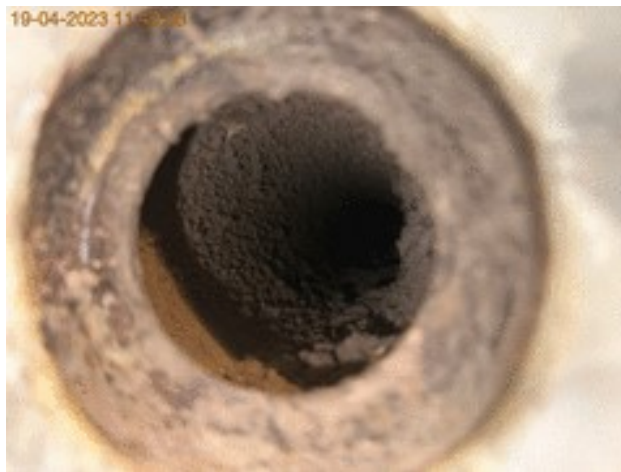
Goulden House – Enrrance B Flat 71 bathroom extract. Solid ducting in GOOD condition(visual and borescope camera inspection). We can not reach vertical riser duct from this grille to see if any fire dampers fitted. No access to vertical ducting riser from this Flat.

Air flow reading:  
2.88 – before clean  
3.55 – after clean

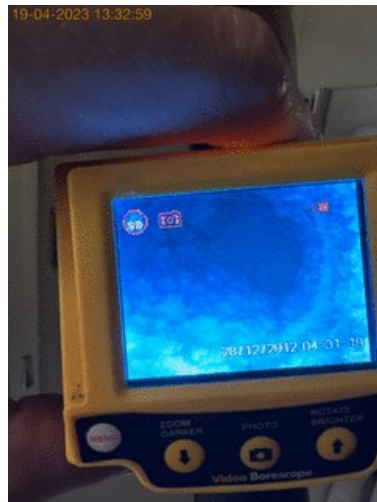
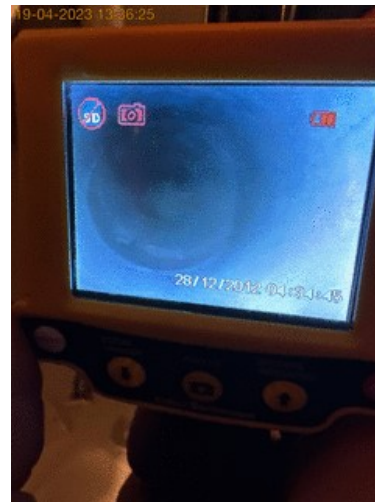
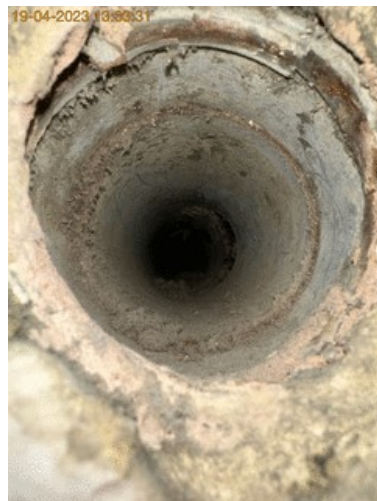
Goulden House - Flat 35 - bathroom extract. Solid ducting in good condition (visual and borescope camera inspection). We can not reach vertical riser duct from this grille to see if any fire dampers fitted. No access to vertical ducting riser from this Flat.

Air flow reading:  
3.44 – before clean  
5.66 – after clean

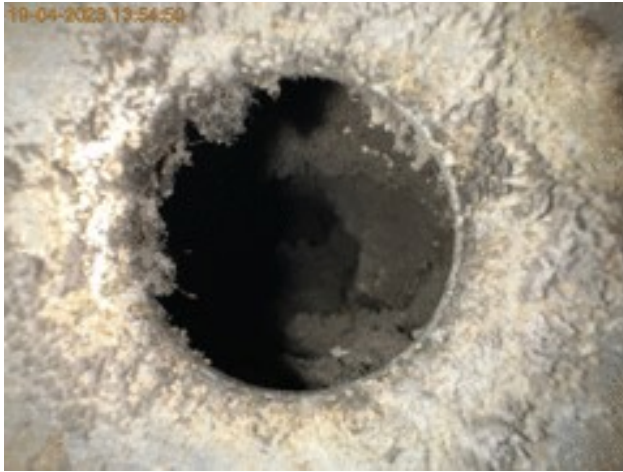
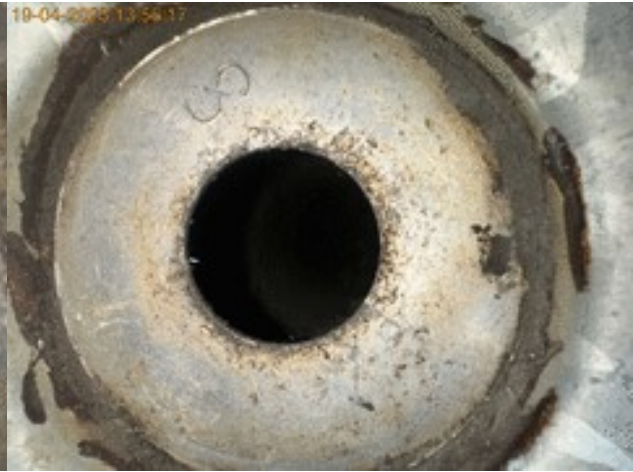
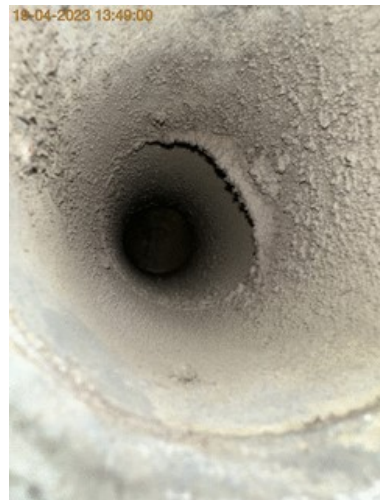
Goulden House - Entrance B Level 0 Flat 129 - bathroom extract. Solid ducting in bad condition (visual and borescope camera inspection). We can not reach vertical riser duct from this grille to see if any fire dampers fitted. No access to vertical ducting riser from this Flat.

4.55 – after clean

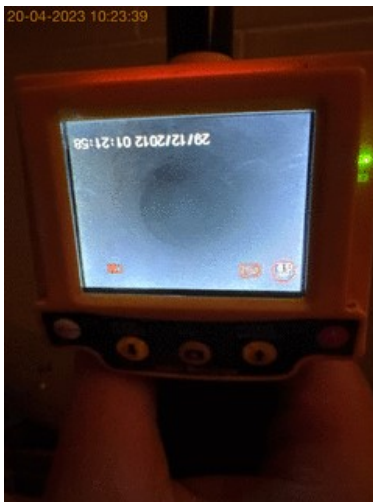
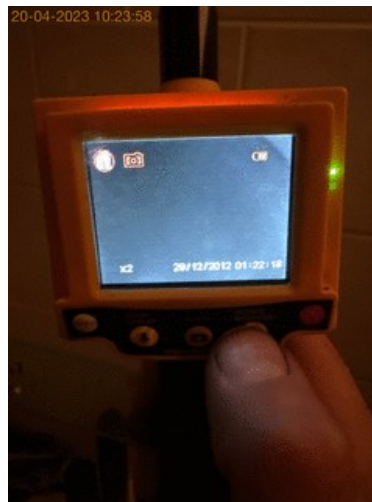
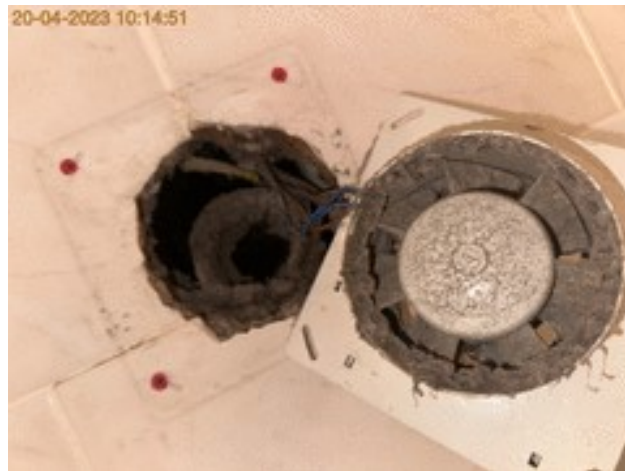
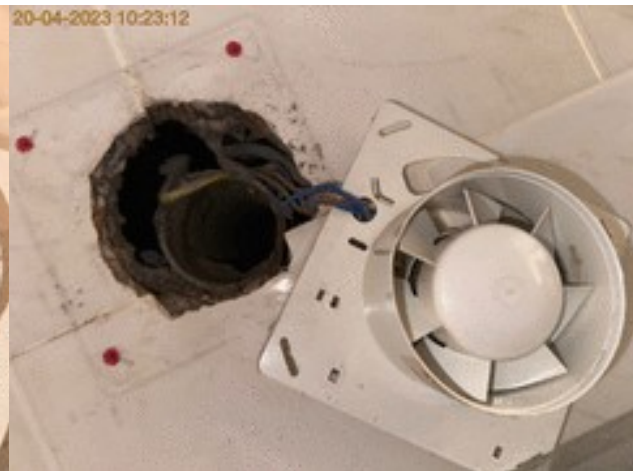
Goulden House - Entrance B Level 4 Flat 163 - bathroom extract. Flexible ducting in bad condition (visual and borescope camera inspection). We can not reach vertical riser duct from this grille to see if any fire dampers fitted. No access to vertical ducting riser from this Flat.

Air flow reading:  
2.44 – before clean  
3.67 – after clean

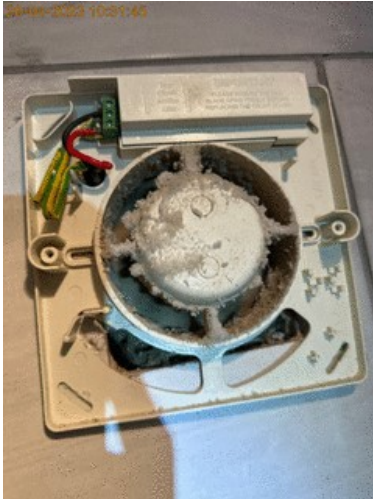
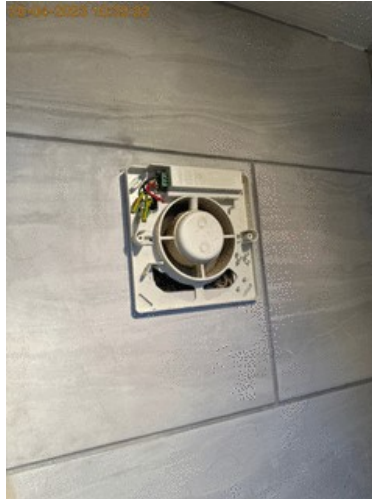
Goulden House - Flat 163 - bathroom extract. No access to the ducting as the unit is sealed. No access to the vertical ducting riser from this Flat. The unit has been cleaned.

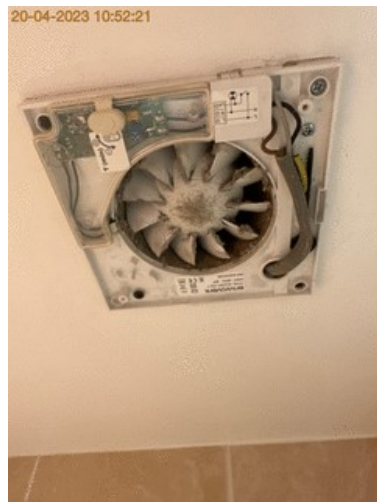
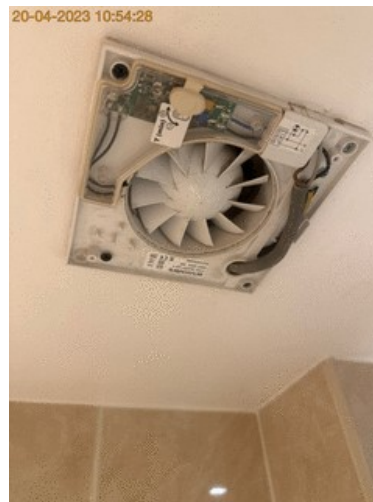
Goulden House – Flat 157 - bathroom extract. No access to the ducting as the unit is sealed. No access to the vertical ducting riser from this Flat. The unit has been cleaned.

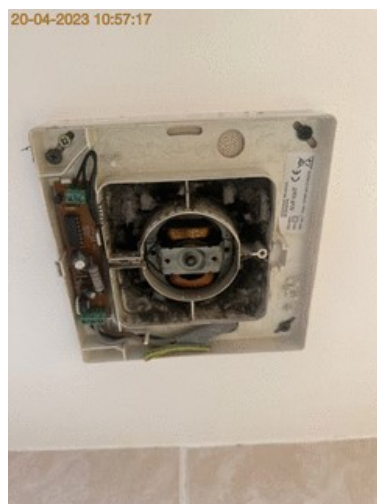
Goulden House - Flat 157 - bathroom extract. No access to the ducting as the unit is sealed. No access to the vertical ducting riser from this Flat. The unit has been cleaned. - Extract

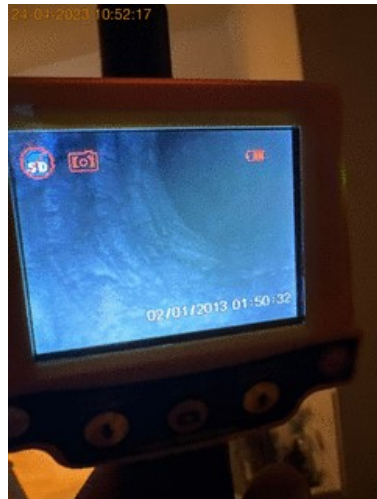
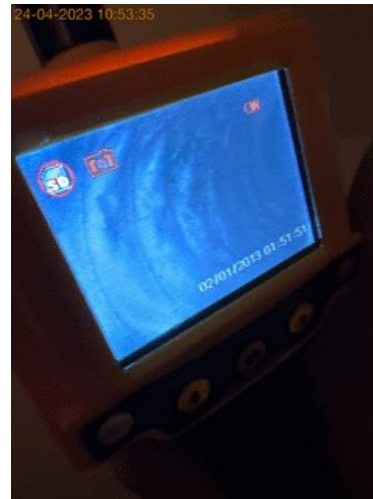
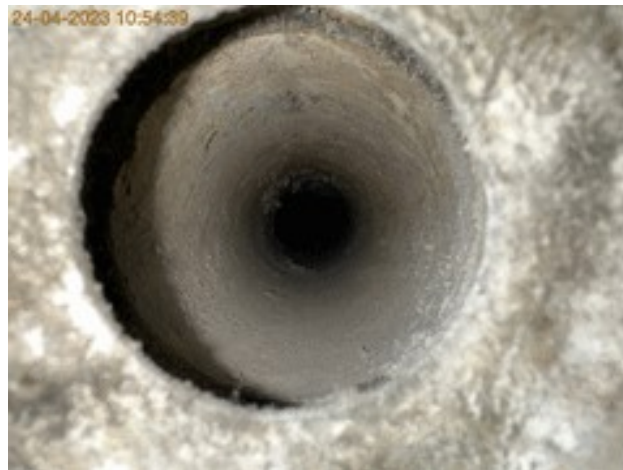
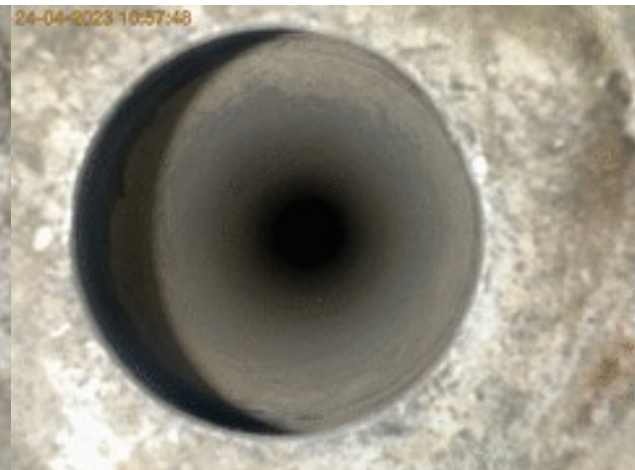
Goulden House - Entrance B Level 3 Flat 68 - bathroom extract. Flexible ducting in good condition (visual and borescope camera inspection). We can not reach vertical riser duct from this grille to see if any fire dampers fitted. No access to vertical ducting riser from this Flat.

Air flow reading:  
3.66 – before clean  
4.20 – after clean

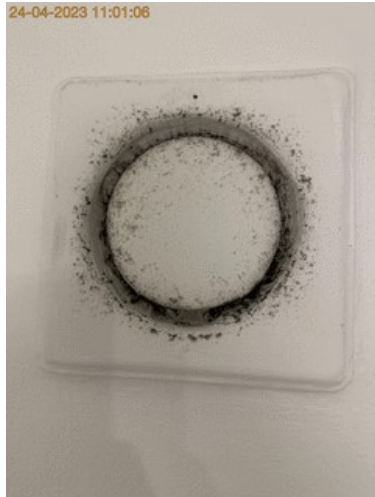
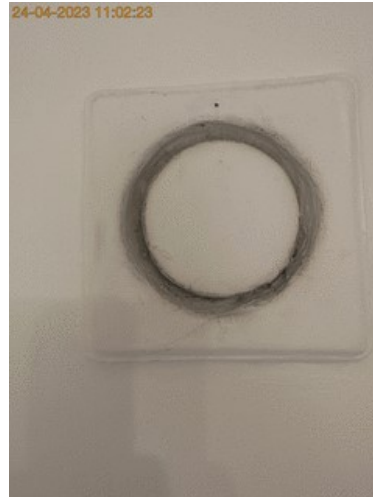
Goulden House - Entrance B Level 3 Flat 69 - bathroom extract. No access to the ducting as the unit is sealed. No access to the vertical ducting riser from this Flat. The unit has been cleaned.

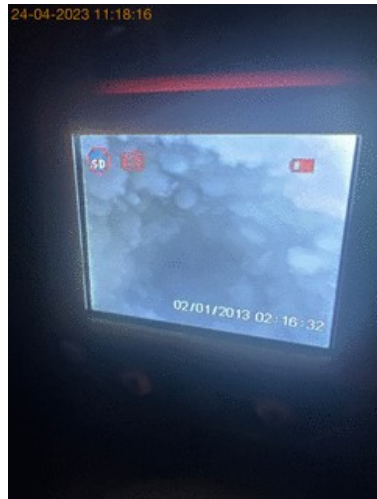
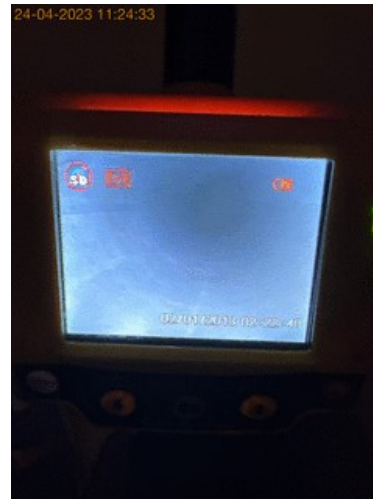
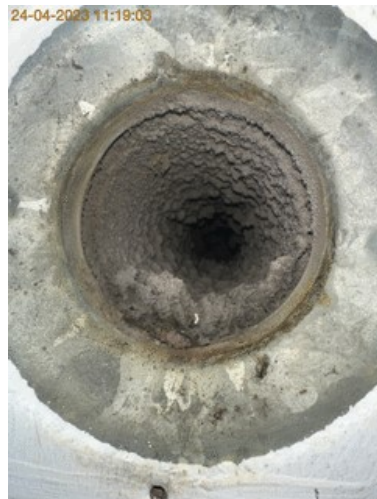
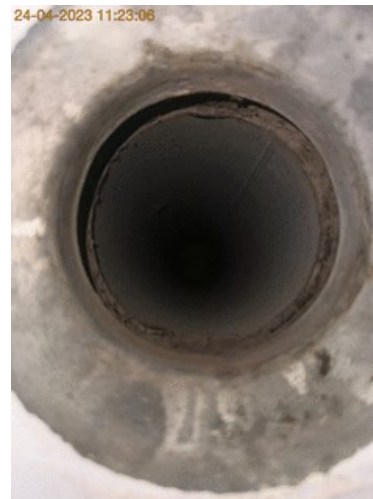
Goulden House - Entrance B Level 3 Flat 70 - bathroom extract. Solid ducting in good condition (visual and borescope camera inspection). We can not reach vertical riser duct from this grille to see if any fire dampers fitted. No access to vertical ducting riser from this Flat.

Air flow reading:  
4.55 – before clean  
5.88 – after clean

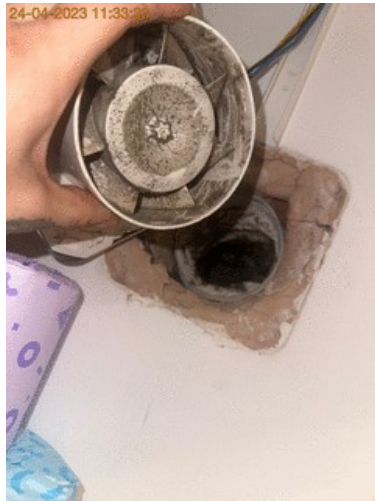
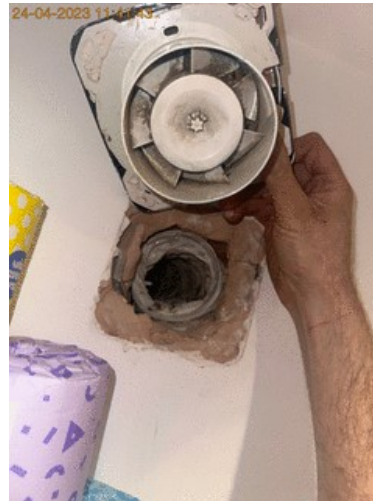
Goulden House - Entrance B Level 4 Flat 178 - bathroom extract. Flexible ducting in good condition (visual and borescope camera inspection). We can not reach vertical riser duct from this grille to see if any fire dampers fitted. No access to vertical ducting riser from this Flat.

Air flow reading:  
3.12 – before clean  
3.29 – after clean

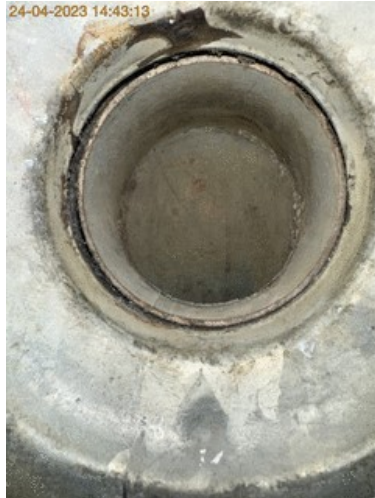
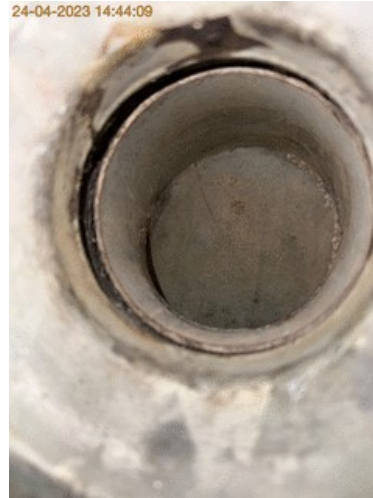
Goulden House - Entrance B Level 4 Flat 182 - bathroom extract. Solid ducting in good condition (visual and borescope camera inspection). We can not reach vertical riser duct from this grille to see if any fire dampers fitted. No access to vertical ducting riser from this Flat.

Air flow reading:  
3.09 – before clean  
4.01 – after clean

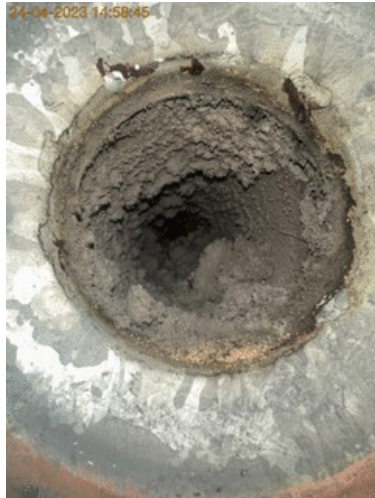
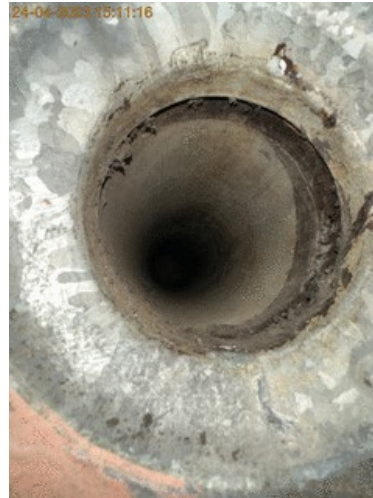
Goulden House - Entrance B Level 0 Flat 78 - bathroom extract. Solid ducting in good condition (visual and borescope camera inspection). We can not reach vertical riser duct from this grille to see if any fire dampers fitted. No access to vertical ducting riser from this Flat.

Air flow reading:  
2.89 – before clean  
3.87 – after clean

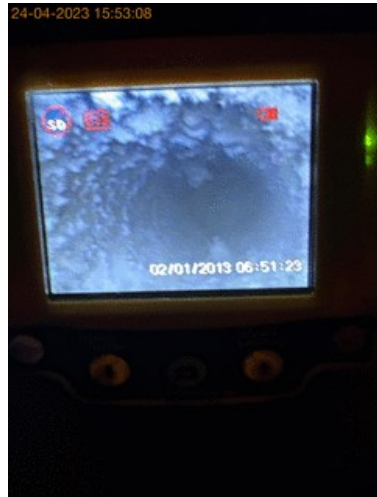
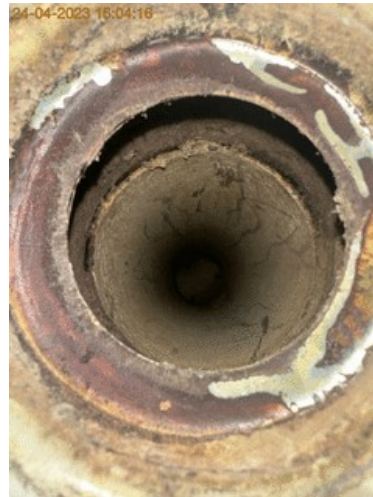
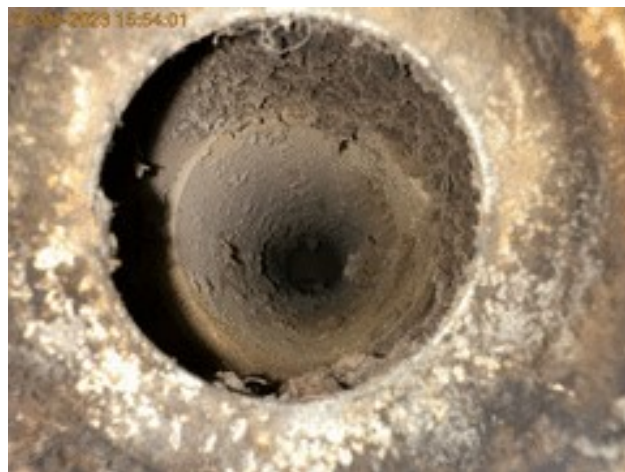
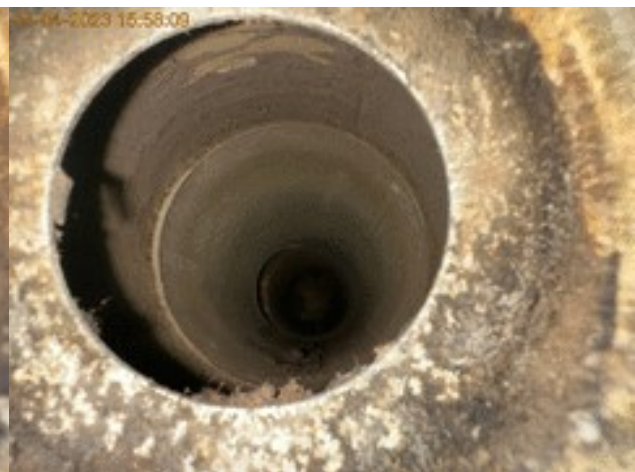
Goulden House - Entrance A Level 0 Flat 29 – bathroom extract. Solid ducting in good condition (visual and borescope camera inspection). We can not reach vertical riser duct from this grille to see if any fire dampers fitted. No access to vertical ducting riser from this Flat.

Air flow reading:  
3.66 – before clean  
4.77 – after clean

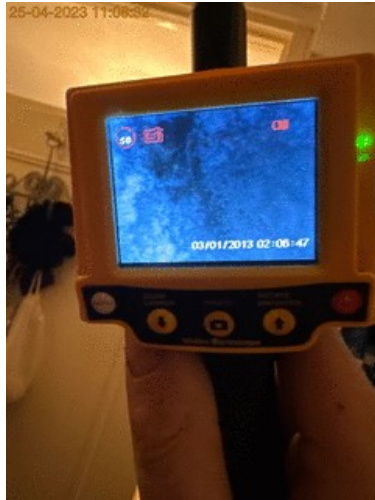
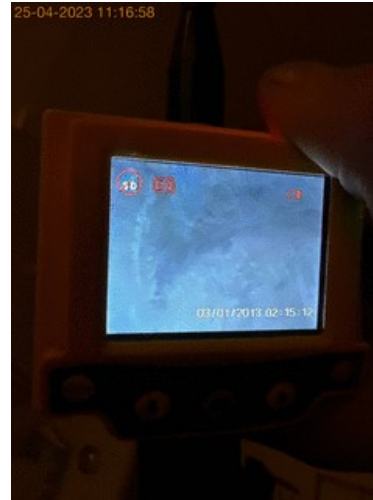
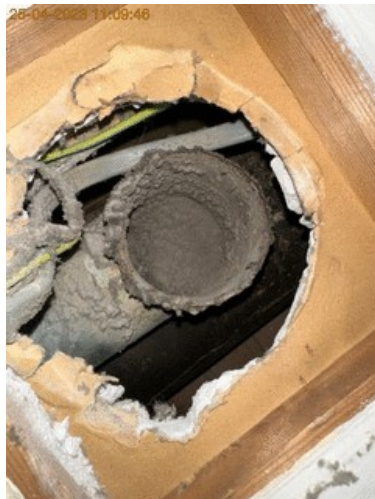
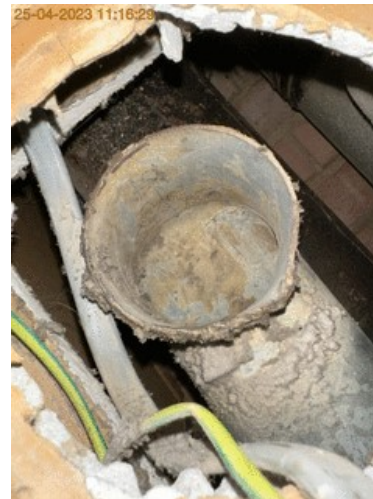
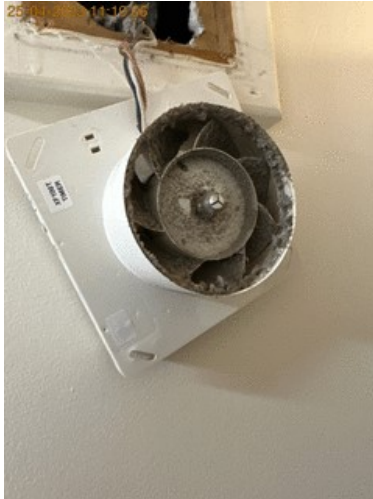
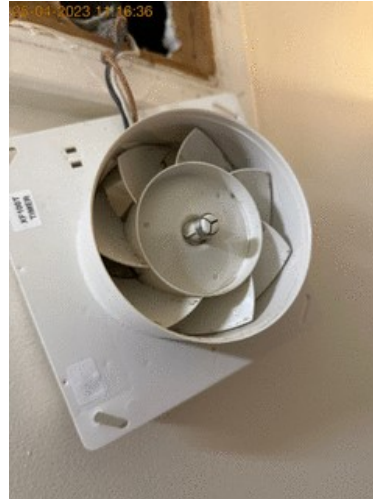
Goulden House - Entrance B Level 4 Flat 188 bathroom extract. Solid ducting in bad condition (visual and borescope camera inspection). We can not reach vertical riser duct from this grille to see if any fire dampers fitted. No access to vertical ducting riser from this Flat.

Air flow reading:  
3.12 – before clean  
3.38 – after clean

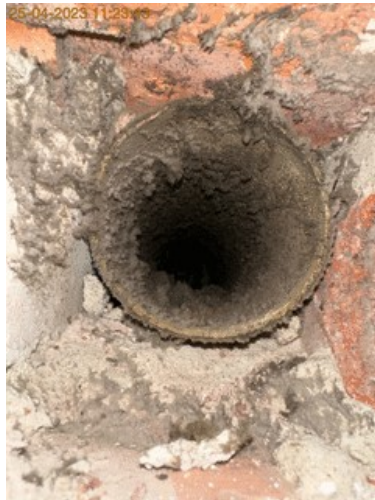
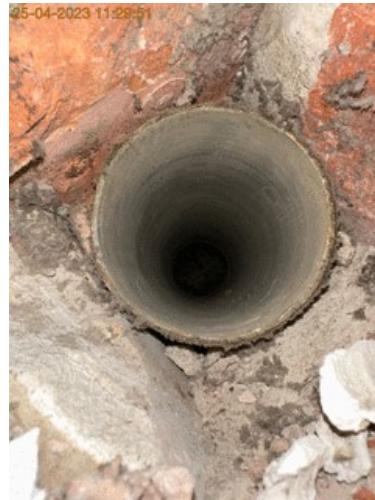
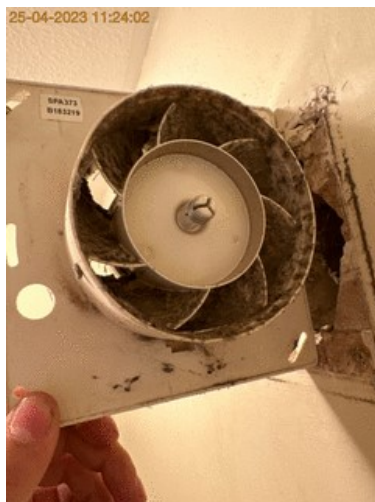
Goulden House - Entrance B Level 4 flat 189 - bathroom extract. Solid ducting in good condition (visual and borescope camera inspection). We can not reach vertical riser duct from this grille to see if any fire dampers fitted. No access to vertical ducting riser from this Flat.

Air flow reading:  
4.12 – before clean  
4.28 – after clean

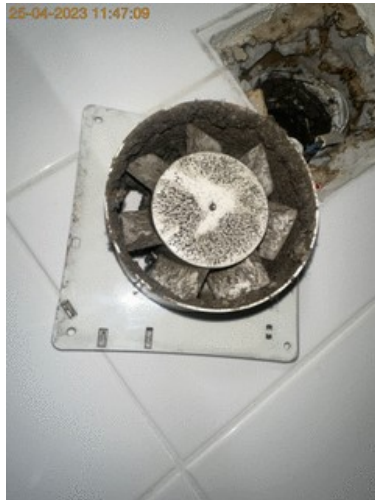
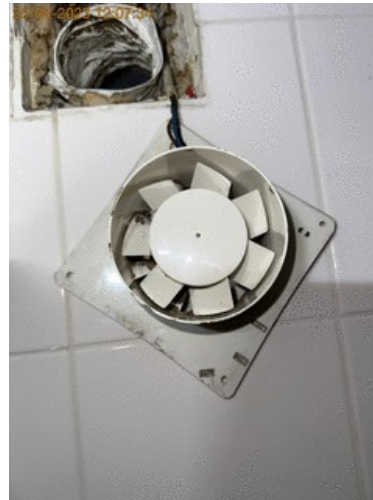
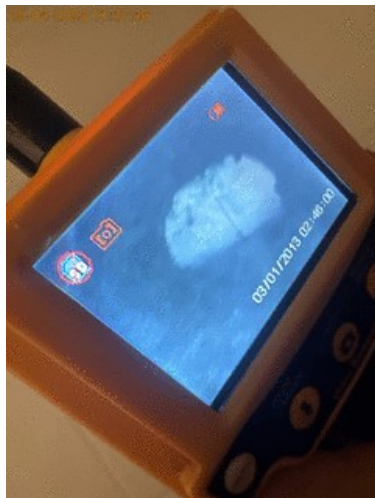
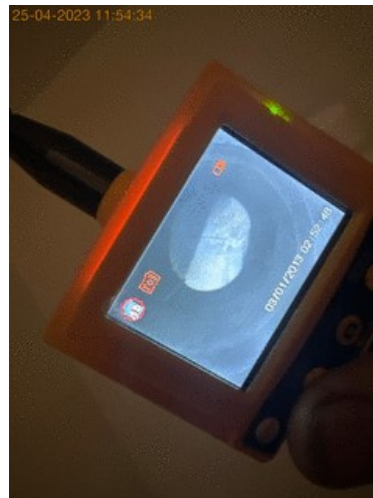
Goulden House - Flat 190 - bathroom extract

Goulden House - Flat 190 - bathroom extract. Flexible ducting in bad condition (visual and borescope camera inspection). We can not reach vertical riser duct from this grille to see if any fire dampers fitted. No access to vertical ducting riser from this Flat.

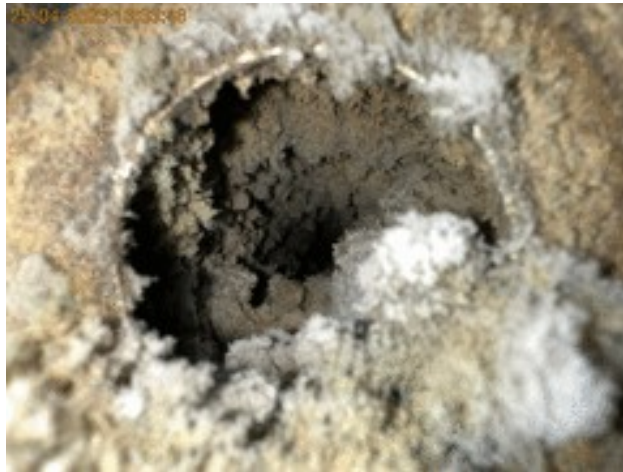
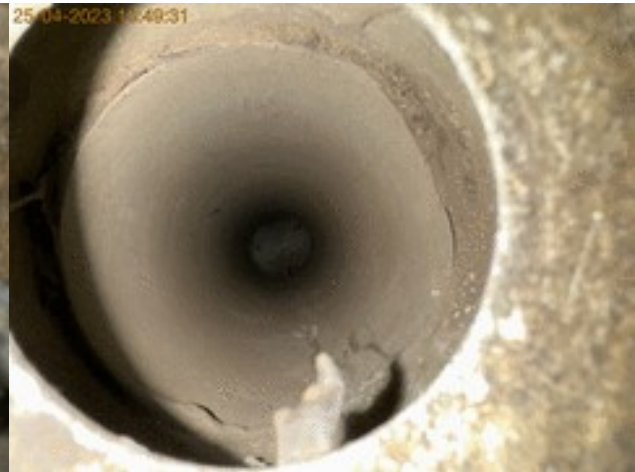
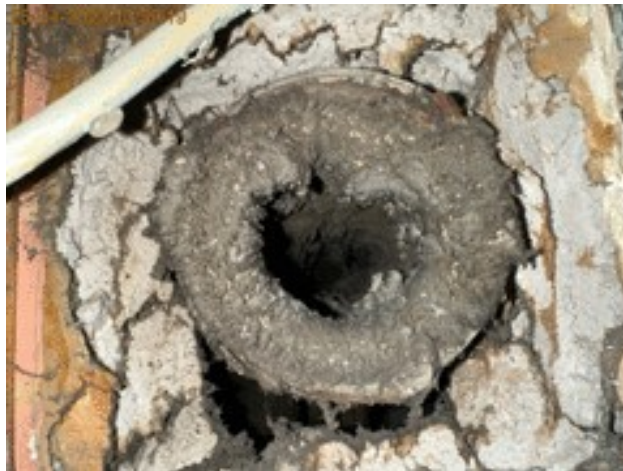
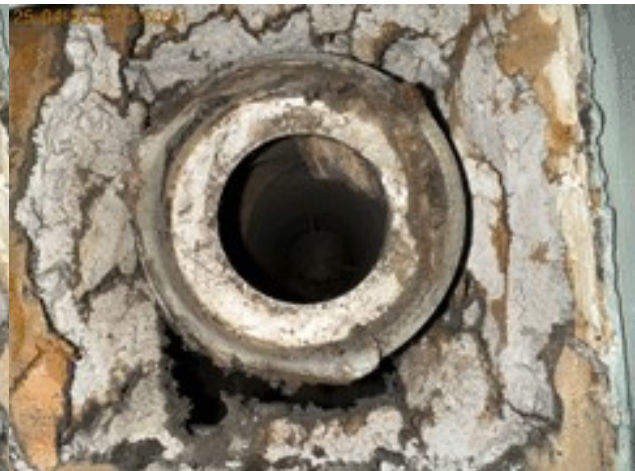
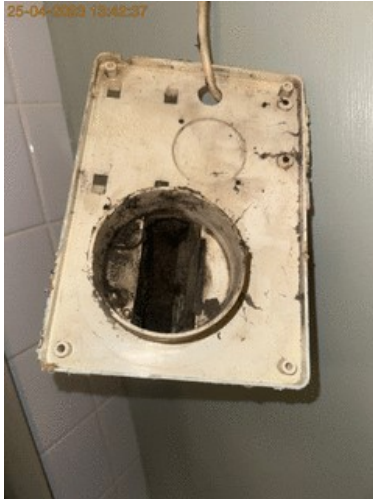
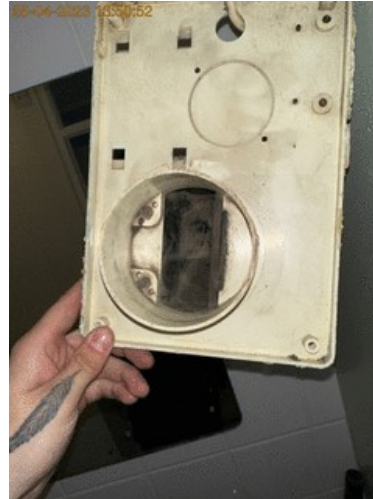
Goulden House - Entrance A Flat 44 bathroom extract. Solid ducting in bad condition (visual and borescope camera inspection). We can not reach vertical riser duct from this grille to see if any fire dampers fitted. No access to vertical ducting riser from this Flat.

Air flow reading:  
2.03 – before clean  
4.33 – after clean

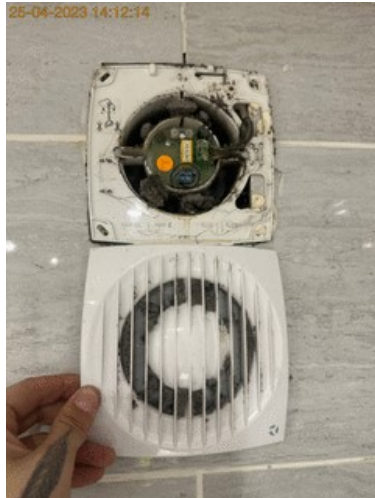
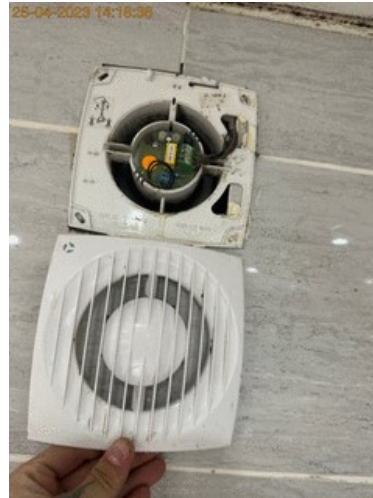
Goulden House - Entrance B Level 4 Flat 195 - bathroom extract. No access to the ducting as the unit is sealed. No access to the vertical ducting riser from this Flat. The unit has been cleaned.

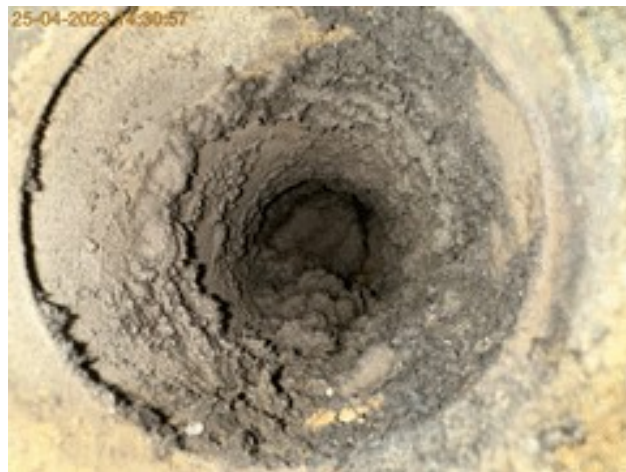
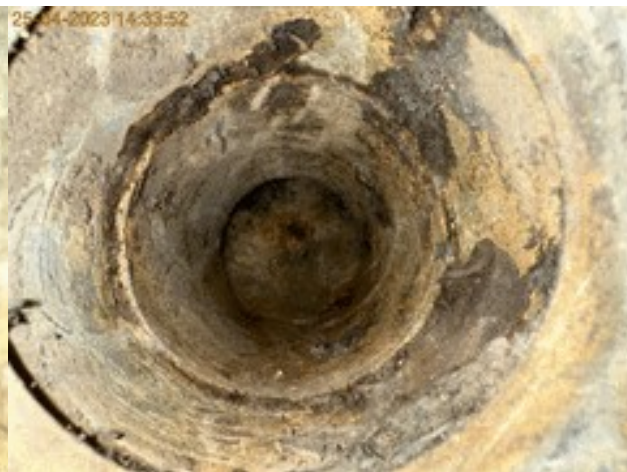
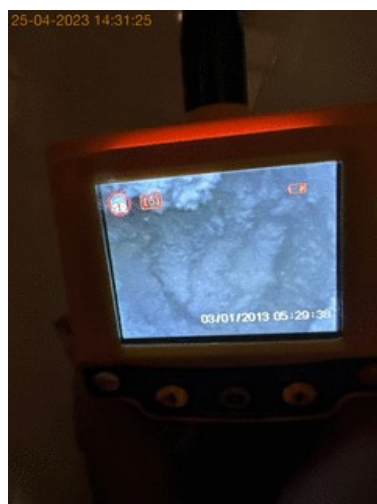
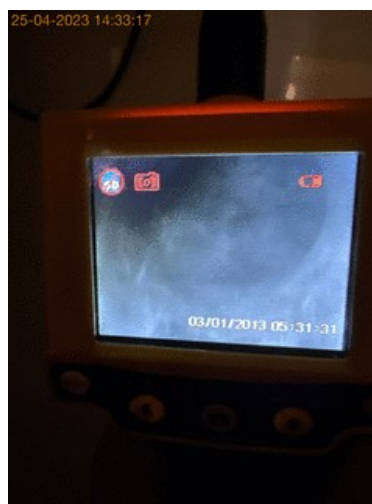
Gouldon House - Entrance B Level 4 Flat 202 - bathroom extract. Solid ducting in bad condition (visual and borescope camera inspection). We can not reach vertical riser duct from this grille to see if any fire dampers fitted. No access to vertical ducting riser from this Flat.

Air flow reading:  
3.66 – before clean  
4.94 – after clean

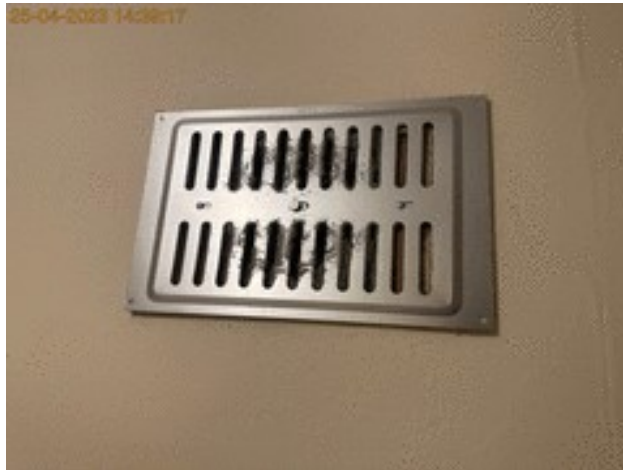
Goulden House - Entrance B Level 4 Flat 203 - bathroom extract. No access to the ducting as the unit is sealed. No access to the vertical ducting riser from this Flat. The unit has been cleaned.

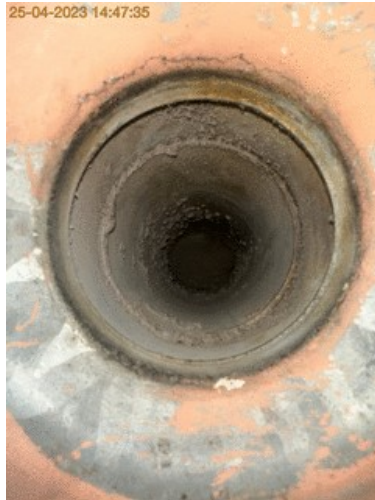
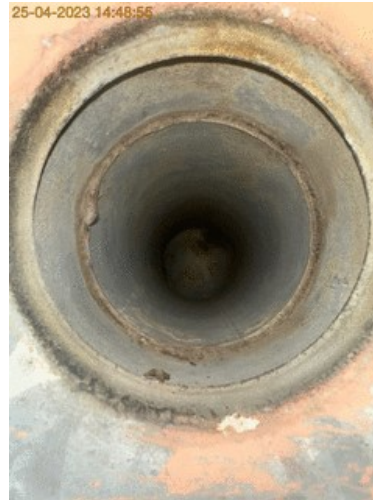
Goulden House - Entrance B Level 4 Flat 207 bathroom extract. Solid ducting in good condition (visual and borescope camera inspection). We can not reach vertical riser duct from this grille to see if any fire dampers fitted. No access to vertical ducting riser from this Flat.

Air flow reading:  
3.88 – before clean  
4.77 – after clean

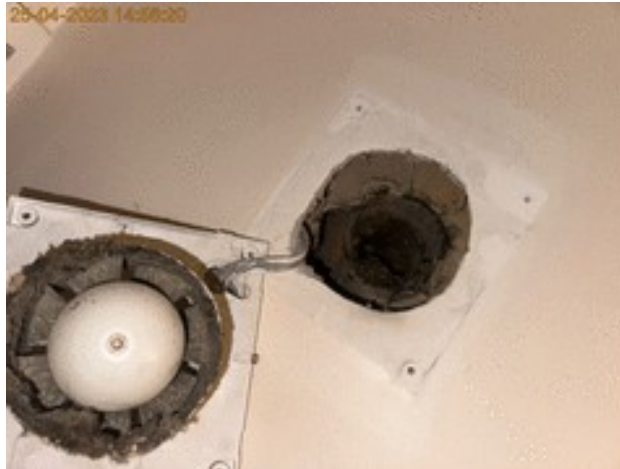
Goulden House - Entrance B Level 4flat 197 - bathroom extract. Solid ducting in bad condition (visual and borescope camera inspection). We can not reach vertical riser duct from this grille to see if any fire dampers fitted. No access to vertical ducting riser from this Flat.

Air flow reading:  
2.33 – before clean  
3.22 – after clean

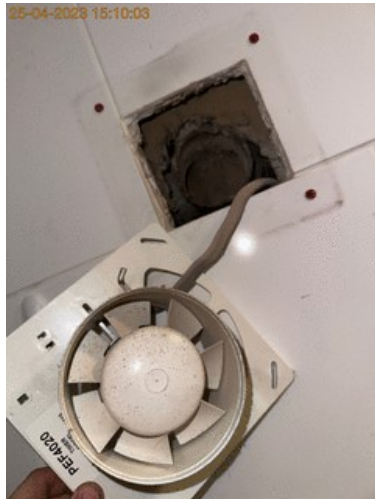
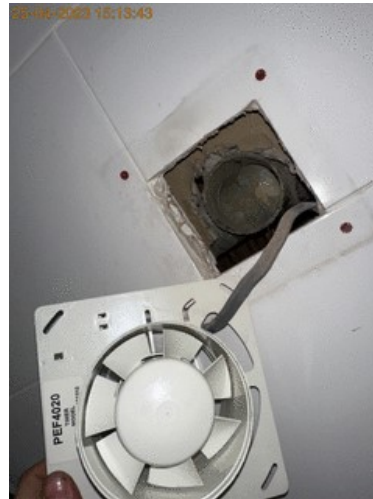
Goulden House - Entrance B Level 4 Flat 208 - bathroom extract. Solid ducting in bad condition (visual and borescope camera inspection). We can not reach vertical riser duct from this grille to see if any fire dampers fitted. No access to vertical ducting riser from this Flat.

Air flow reading:  
3.21 – before clean  
4.33 – after clean

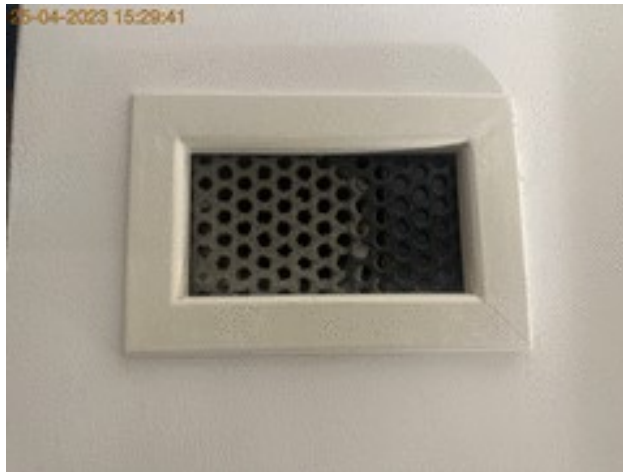
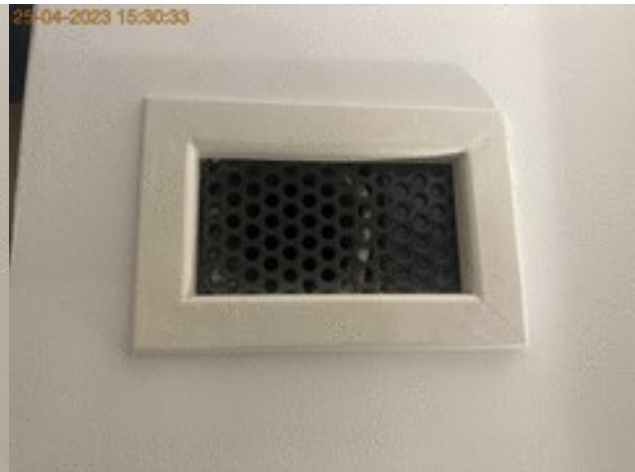
Goulden House - Entrance B Level 4 Flat 206 - bathroom extract. No access to the ducting as the unit is sealed. No access to the vertical ducting riser from this Flat. The unit has been cleaned.

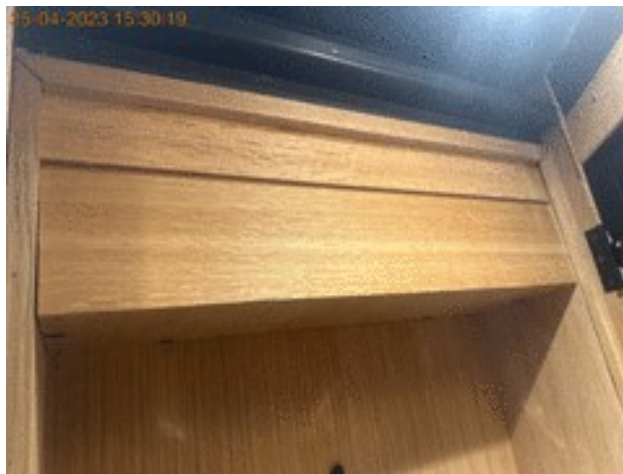
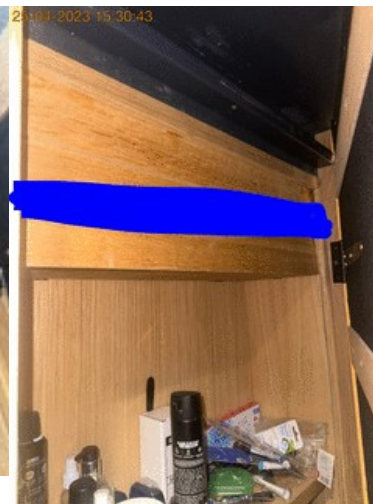
Access to below duct section is obstructed.

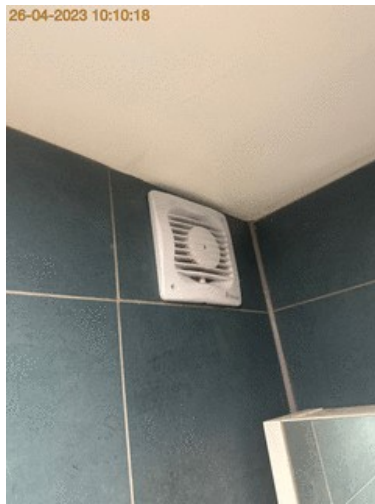
Goulden House - Entrance B Level 4 Flat 210 - bathroom extract new fan. No access to the ducting as the unit is sealed.  
No access to the vertical ducting riser from this Flat. The unit has been cleaned.

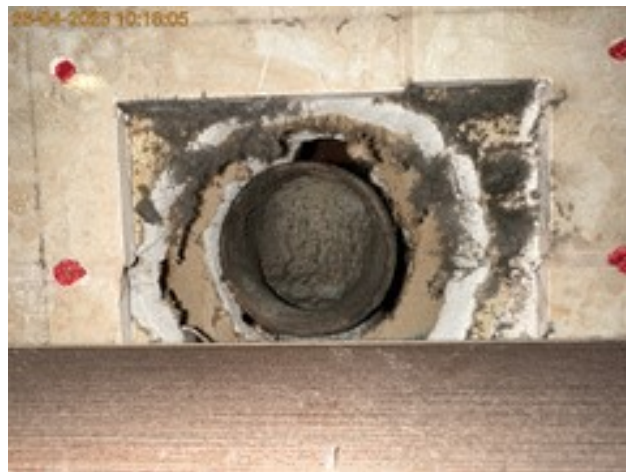
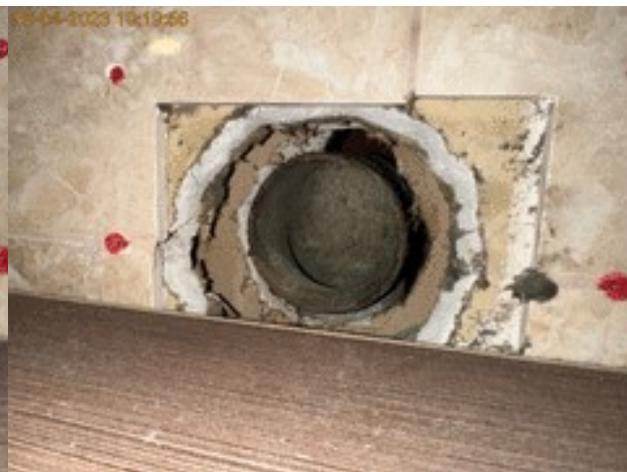
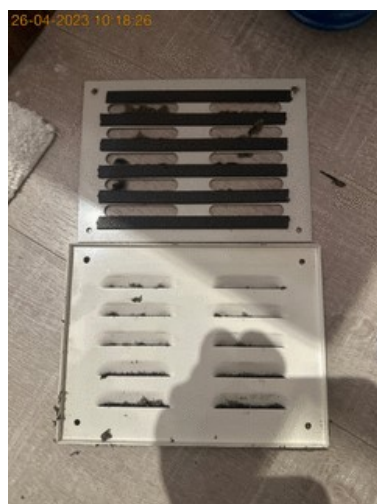
Goulden House - Entrance B Level 4 Flat 215 - bathroom extract. Solid ducting in bad condition (visual and borescope camera inspection). We can not reach vertical riser duct from this grille to see if any fire dampers fitted. No access to vertical ducting riser from this Flat.

Air flow reading:  
3.22 – before clean  
3.28 – after clean

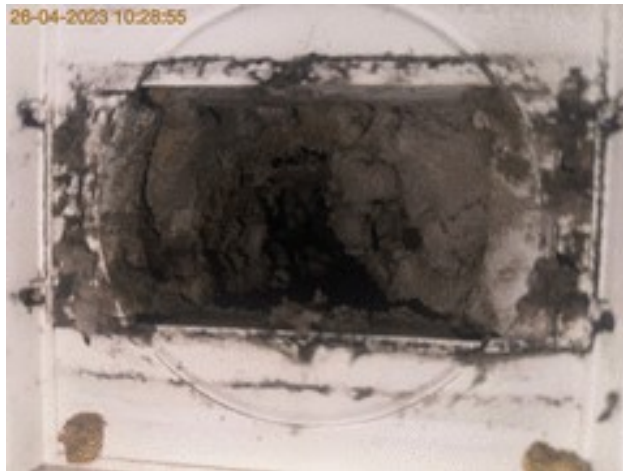
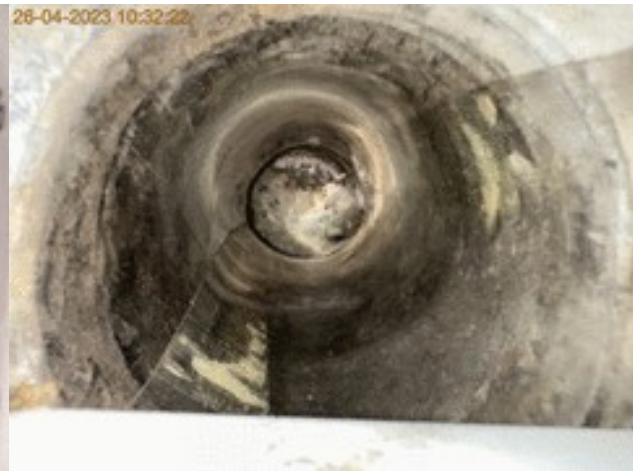
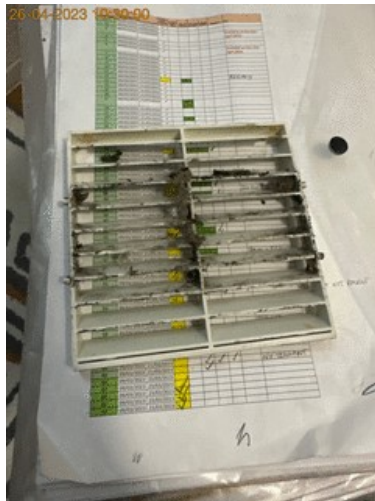
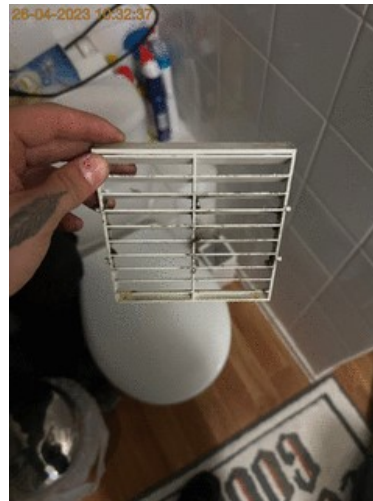
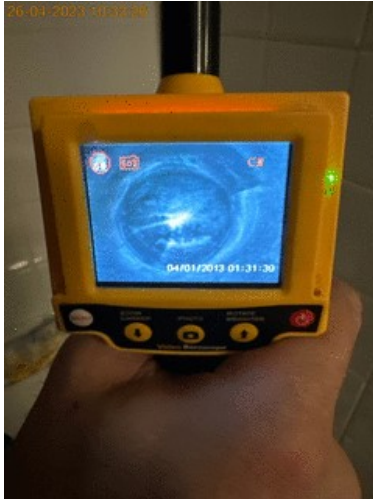
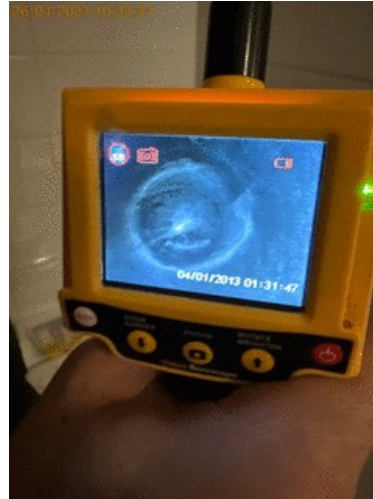
Goulden House - Entrance B Level 4 Flat 217 - bathroom extract. Solid ducting in bad condition (visual and borescope camera inspection). We can not reach vertical riser duct from this grille to see if any fire dampers fitted. No access to vertical ducting riser from this Flat.

Air flow reading:  
2.98 – before clean  
3.45 – after clean

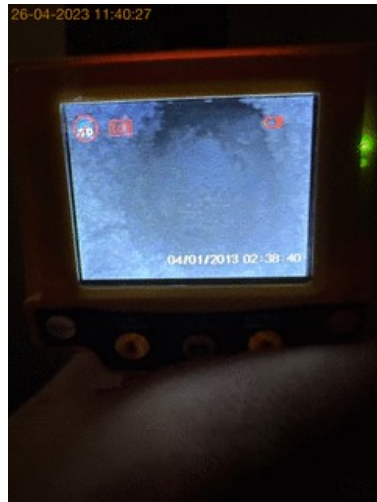
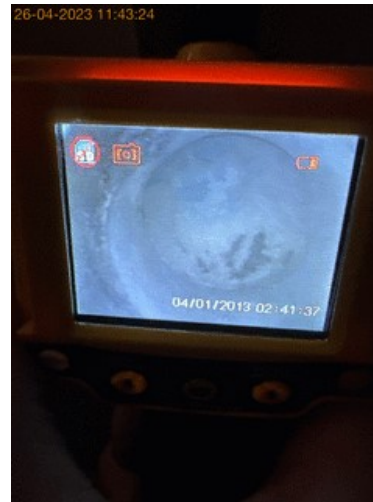
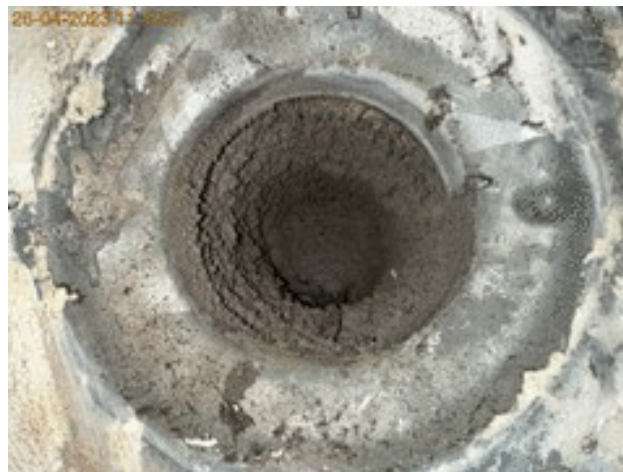
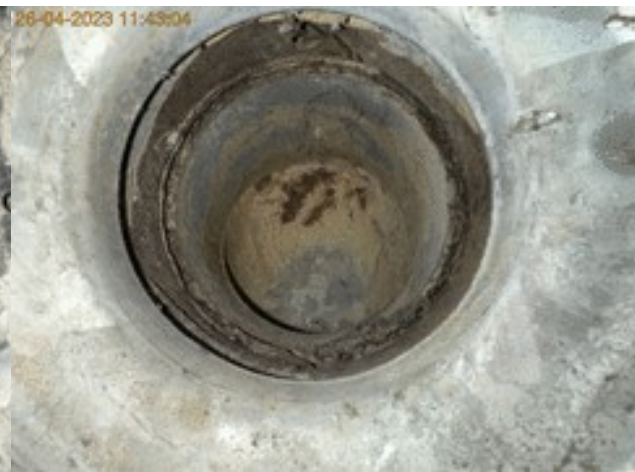
Goulden House - Entrance B Level 4 flat 187 – bathroom extract. Solid ducting in good condition (visual and borescope camera inspection). We can not reach vertical riser duct from this grille to see if any fire dampers fitted. No access to vertical ducting riser from this Flat.

Air flow reading:  
3.33 – before clean  
4.55 – after clean

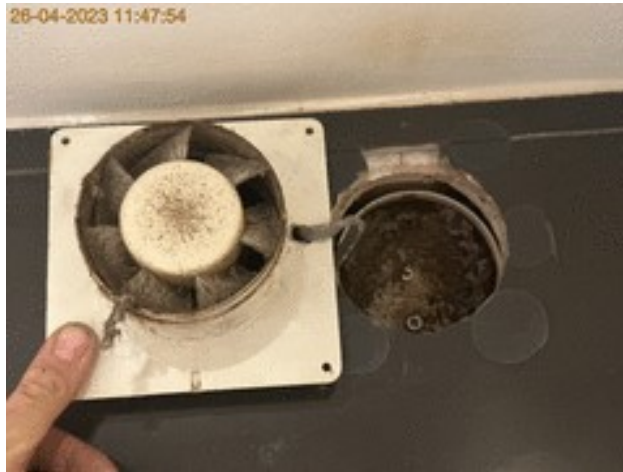
Goulden House - Entrance B Level 4 Flat 191 - bathroom extract. No access to the ducting as the unit is sealed. No access to the vertical ducting riser from this Flat. The unit has been cleaned. Window based fan is at this Flat.

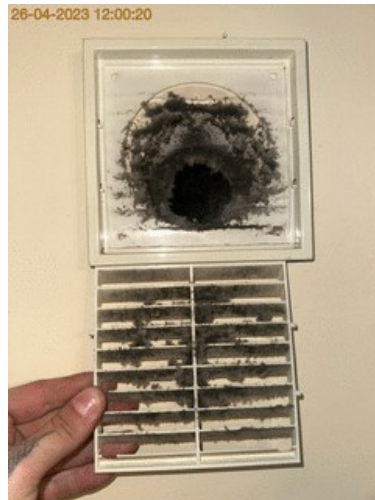
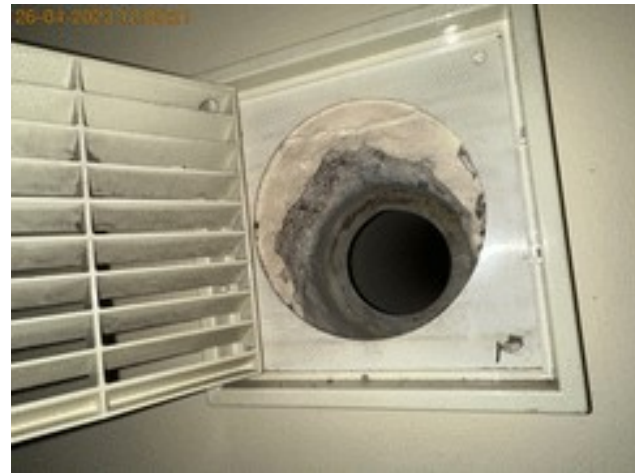
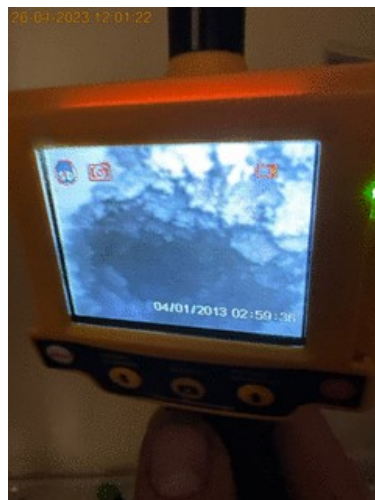
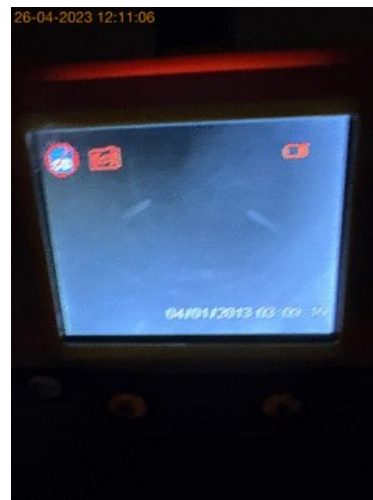
Goulden House - Entrance B Level 4 Flat 198 - bathroom extract. Solid ducting in good condition (visual and borescope camera inspection). We can not reach vertical riser duct from this grille to see if any fire dampers fitted. No access to vertical ducting riser from this Flat.

Air flow reading:  
2.89 – before clean  
4.44 – after clean
