## VENTILATION HYGIENE REPORT

Site Name: Goulden House

Overclean Job Ref: 33331

Completion Date: 05/05/2023

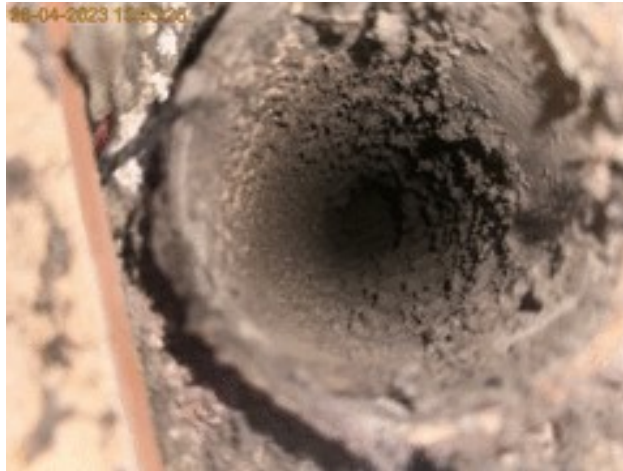
Goulden House - Entrance B Level 0 Flat 130 - bathroom extract. Solid ducting in good condition (visual and borescope camera inspection). We can not reach vertical riser duct from this grille to see if any fire dampers fitted. No access to vertical ducting riser from this Flat.

Air flow reading:  
2.96 – before clean  
3.48– after clean

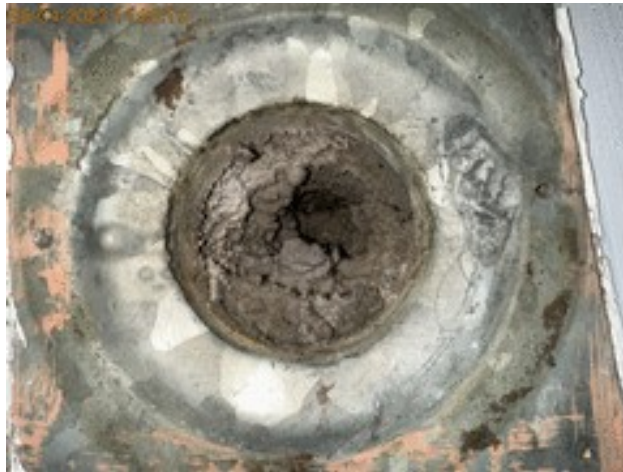
Goulden House - Entrance B Level 4 Flat 209 - bathroom extract. Solid ducting in bad condition (visual and borescope camera inspection). We can not reach vertical riser duct from this grille to see if any fire dampers fitted. No access to vertical ducting riser from this Flat.

Air flow reading:  
3.22 – before clean  
3.38 – after clean

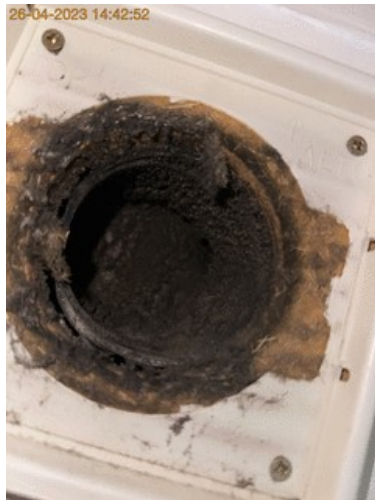
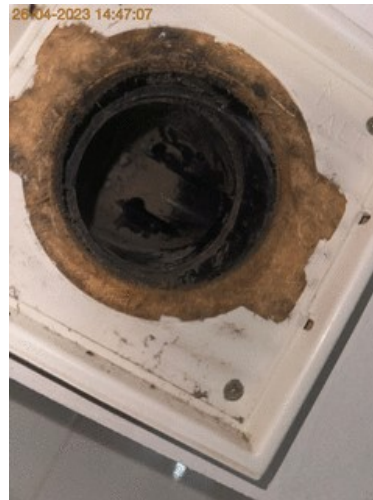
Goulden House - Entrance B Level 4 Flat 212 - bathroom extract. Solid ducting in bad condition (visual and borescope camera inspection). We can not reach vertical riser duct from this grille to see if any fire dampers fitted. No access to vertical ducting riser from this Flat.

Air flow reading:  
2.35 – before clean  
2.59 – after clean

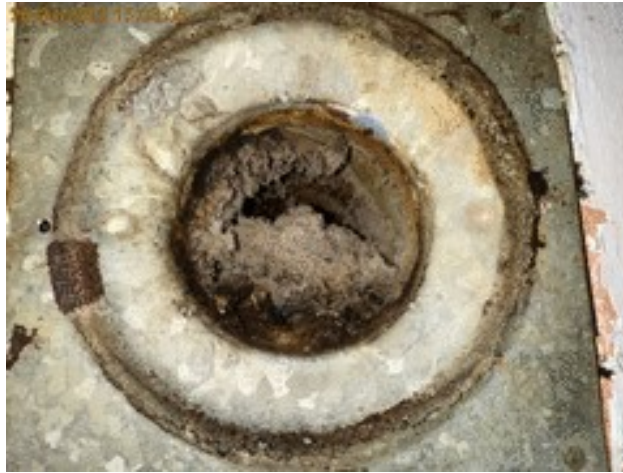
Goulden House - Entrance C Level 0 Flat 98 - bathroom extract. Solid ducting in good condition (visual and borescope camera inspection). We can not reach vertical riser duct from this grille to see if any fire dampers fitted. No access to vertical ducting riser from this Flat.

Air flow reading:  
0.12 – before clean  
4.48 – after clean

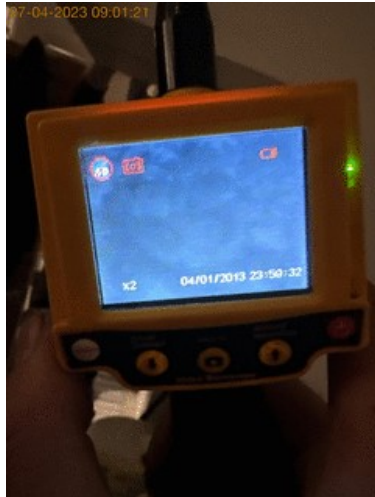
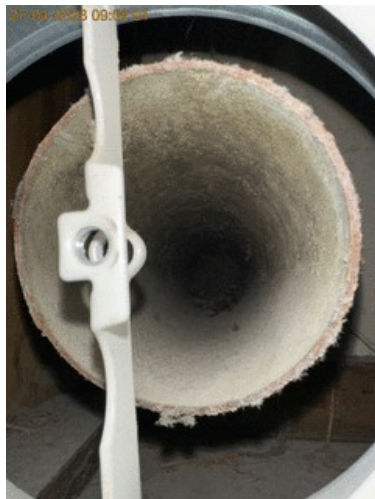
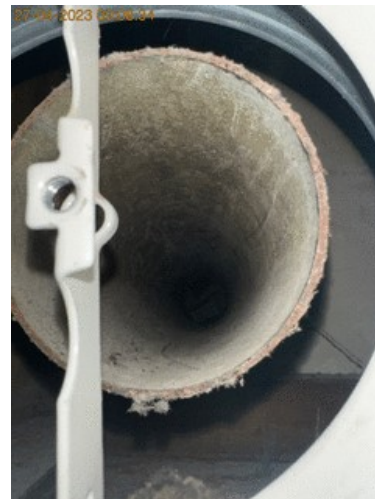
Goulden House - Entrance C Level 1 Flat 96 – bathroom extract. Solid ducting in good condition (visual and borescope camera inspection). We can not reach vertical riser duct from this grille to see if any fire dampers fitted. No access to vertical ducting riser from this Flat

Air flow reading:  
0.00 – before clean  
2.33 – after clean

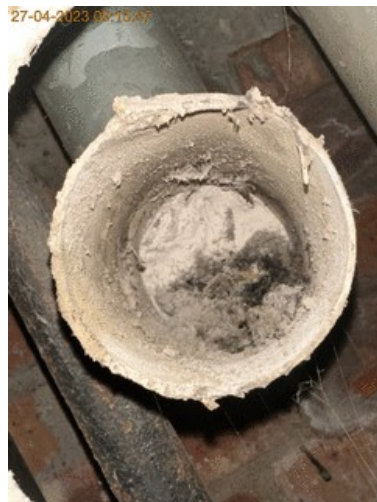
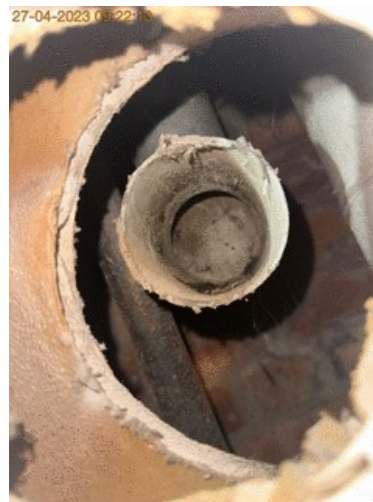
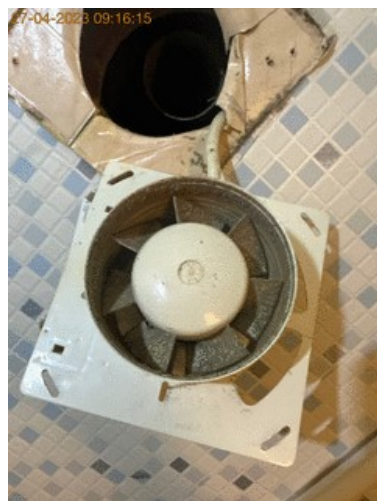
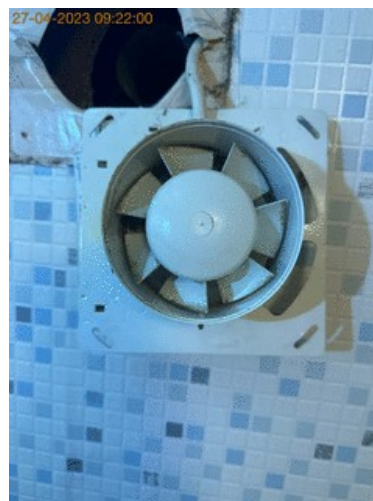
Goulden House - Entrance C Level 2 Flat 92 - bathroom extract. Solid ducting in bad condition (visual and borescope camera inspection). We can not reach vertical riser duct from this grille to see if any fire dampers fitted. No access to vertical ducting riser from this Flat.

Air flow reading:  
0.00 – before clean  
0.00 – after clean

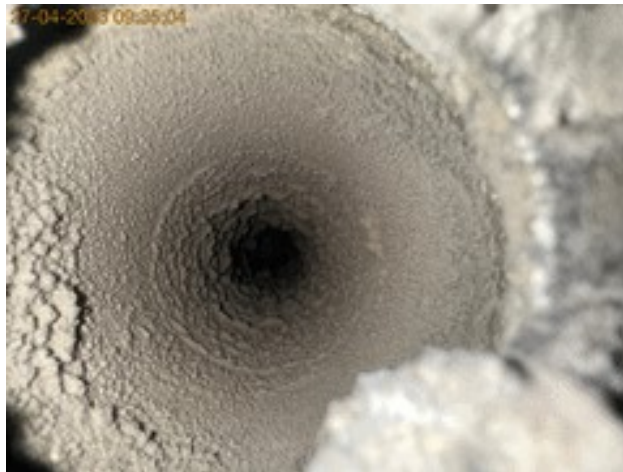
Goulden House - Entrance C Level 2 Flat 93 - bathroom extract. Solid ducting in good condition (visual and borescope camera inspection). We can not reach vertical riser duct from this grille to see if any fire dampers fitted. No access to vertical ducting riser from this Flat.

Air flow reading:  
3.55 – before clean  
4.66 – after clean

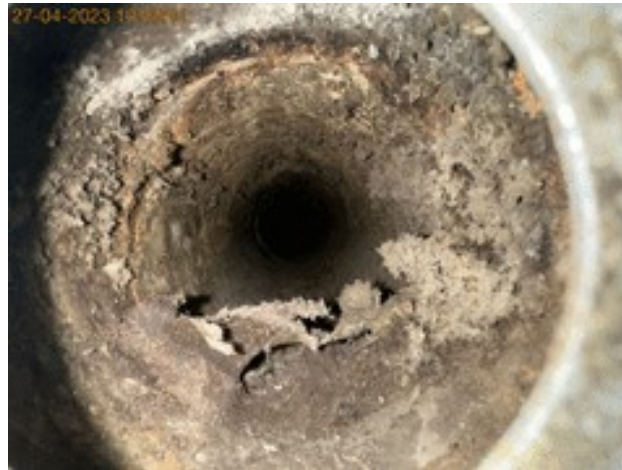
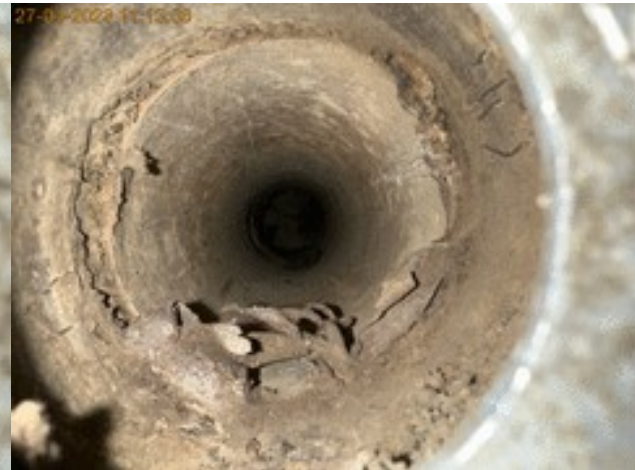
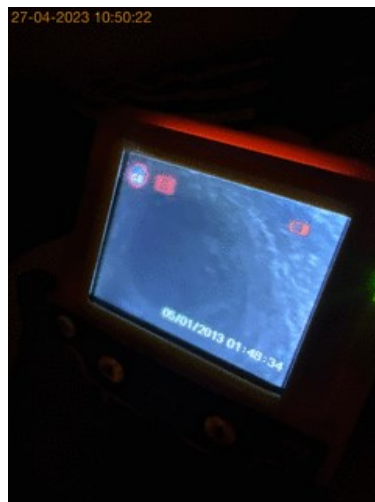
Goulden House - Entrance C Level 3 Flat 88 - bathroom extract. Solid ducting in bad condition (visual and borescope camera inspection). We can not reach vertical riser duct from this grille to see if any fire dampers fitted. No access to vertical ducting riser from this Flat.

Air flow reading:  
2.34 – before clean  
3.12 – after clean

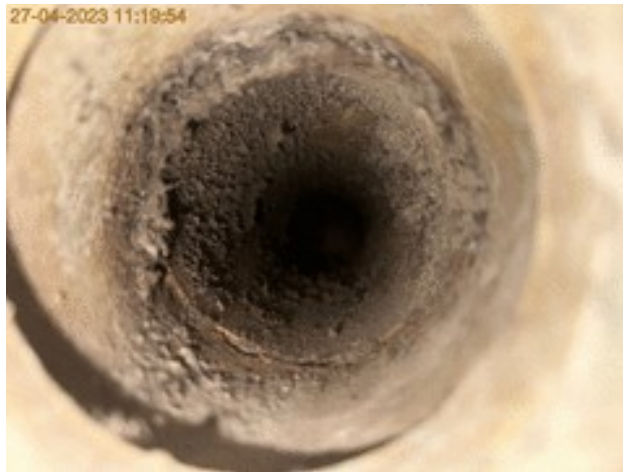
Goulden House - Entrance C Level 3 Flat 90 - bathroom extract. Solid ducting in bad condition (visual and borescope camera inspection). We can not reach vertical riser duct from this grille to see if any fire dampers fitted. No access to vertical ducting riser from this Flat.

Air flow reading:  
0.00 – before clean  
2.33 – after clean

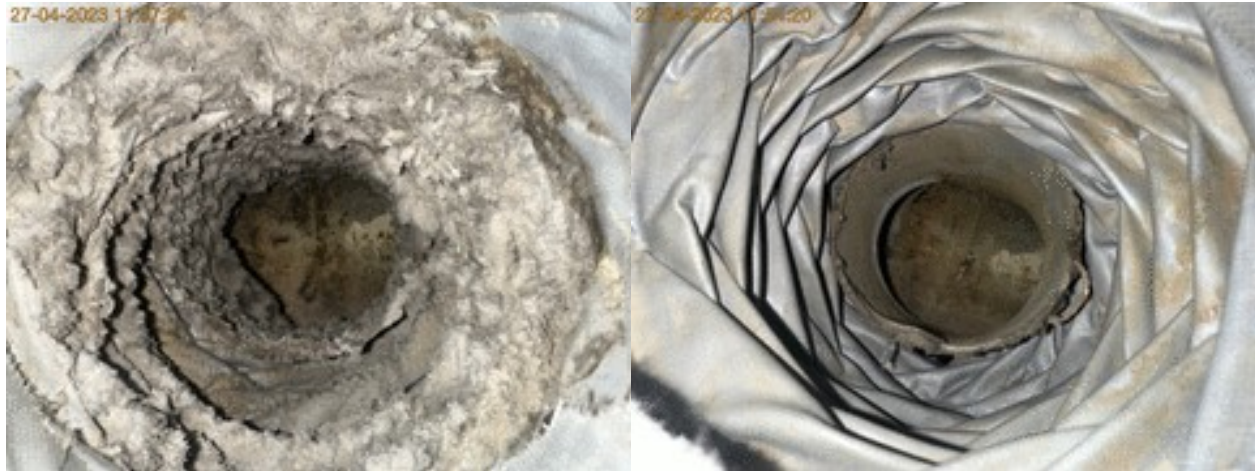
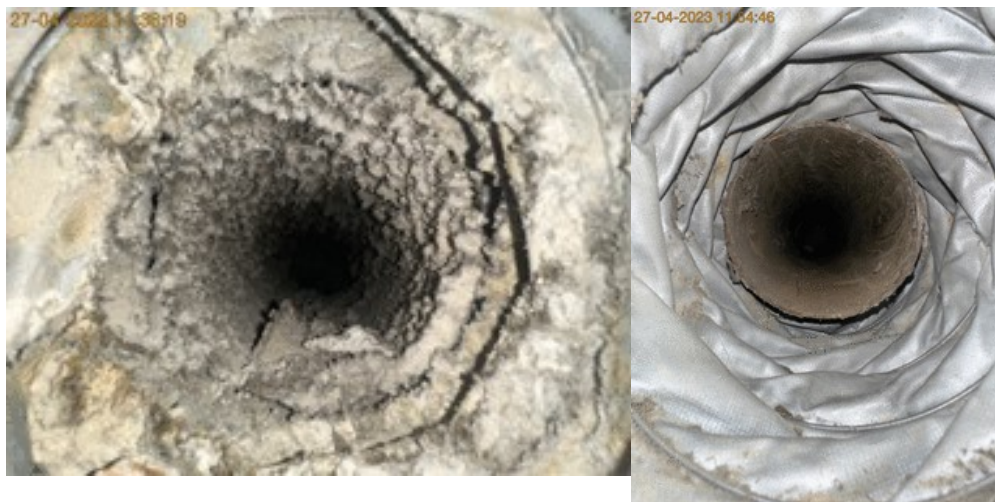
Goulden House - Entrance C Level 4 Flat 239 - bathroom extract. Flexible to solid ducting after flexible section in bad condition (visual and borescope camera inspection). We can not reach vertical riser duct from this grille to see if any fire dampers fitted. No access to vertical ducting riser from this Flat.

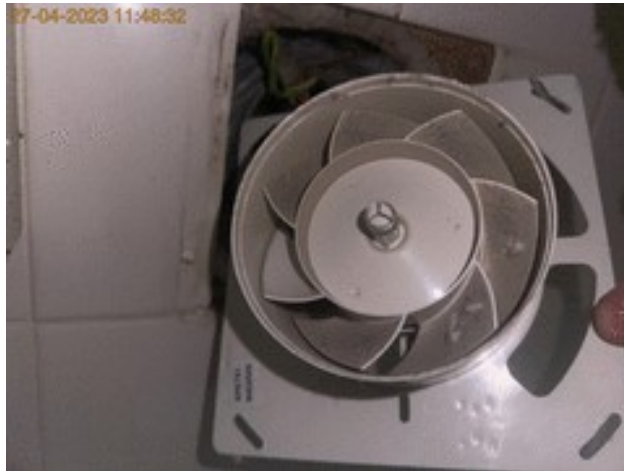
Goulden House - Entrance C Level 4 Flat 239 – bathroom extract fan.

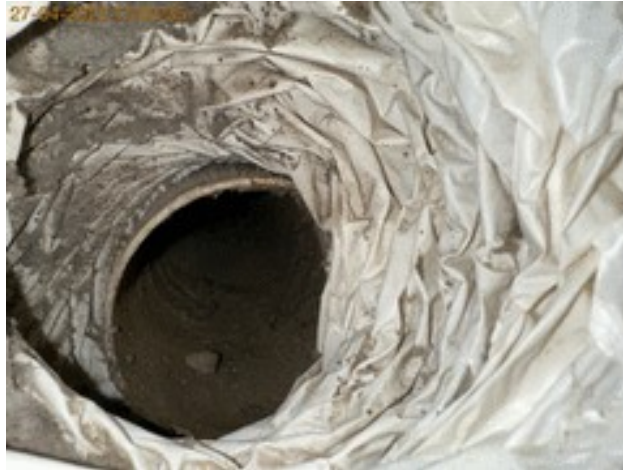
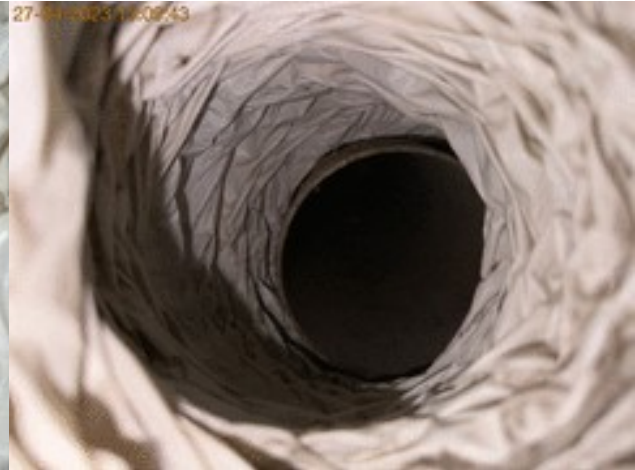
Goulden House - Entrance C Level 2 Flat 91 - bathroom extract. Flexible to solid ducting in good condition (visual and borescope camera inspection). We can not reach vertical riser duct from this grille to see if any fire dampers fitted. No access to vertical ducting riser from this Flat.

Air flow reading:  
1.97 – before clean  
3.44 – after clean

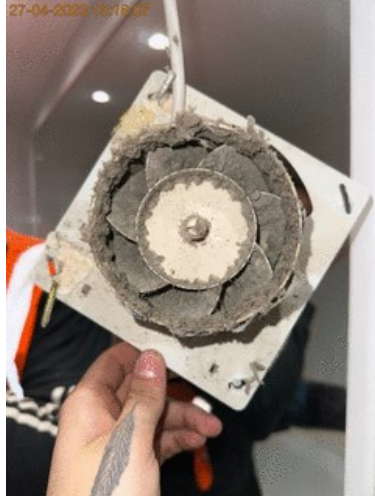
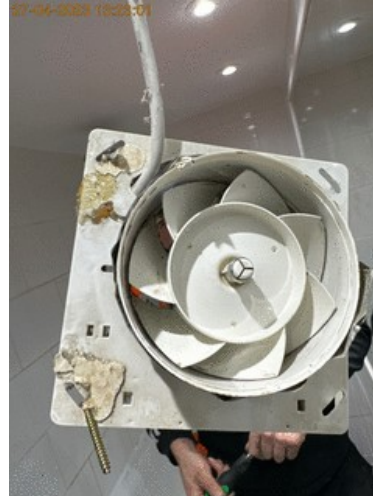
Goulden House - Entrance C Level 5 Flat 86 - bathroom extract. No access to the ducting. No access to the vertical ducting riser from this Flat. The unit has been cleaned.

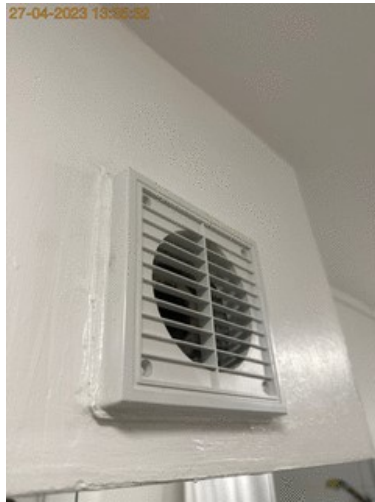
Goulden House - Flat 100. No access to the ducting as the unit is sealed. No access to the vertical ducting riser from this Flat. The unit has been cleaned.

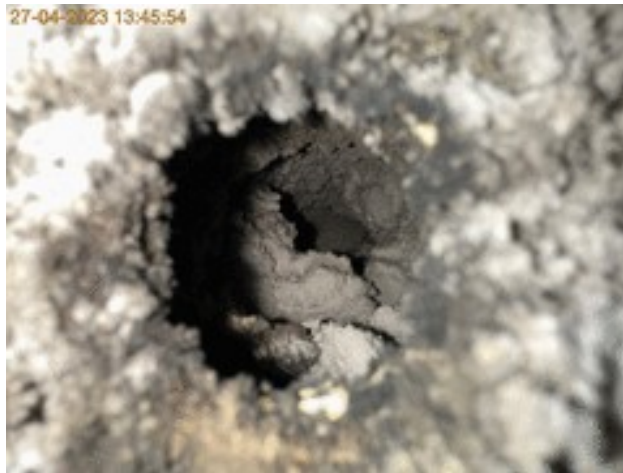
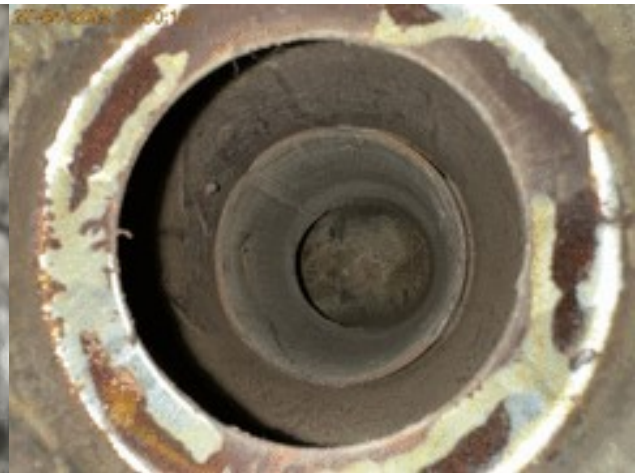
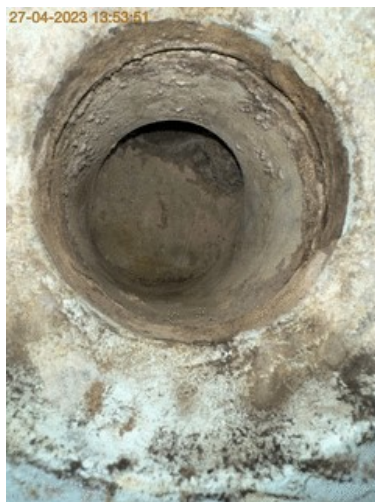
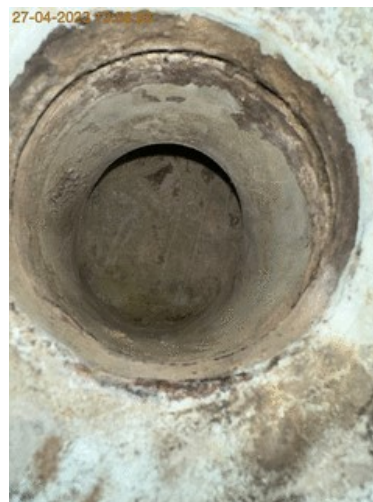
Goulden House - Flat 105 - bathroom extract. Solid ducting in good condition (visual and borescope camera inspection). We can not reach vertical riser duct from this grille to see if any fire dampers fitted. No access to vertical ducting riser from this Flat.

Air flow reading:  
3.12 – before clean  
3.52 – after clean

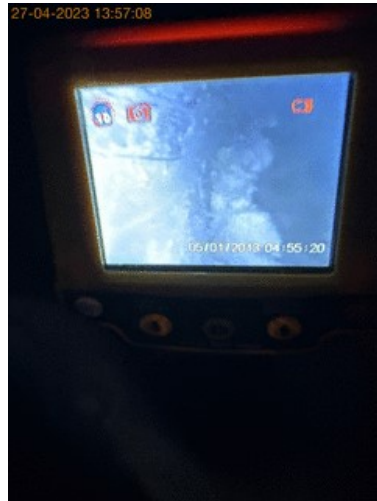
Goulden House - Flat 105 bathroom extract – borescope camera view

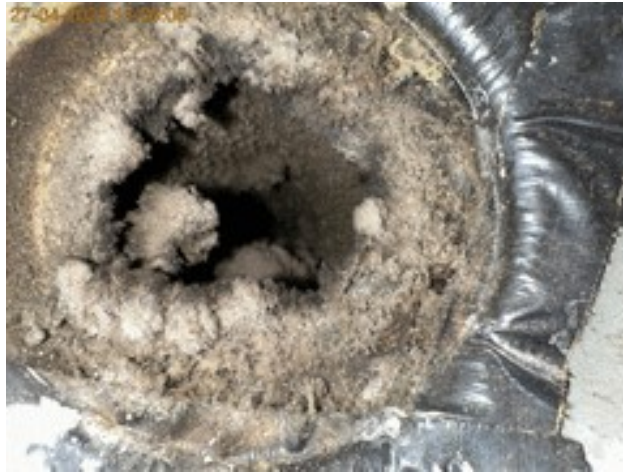
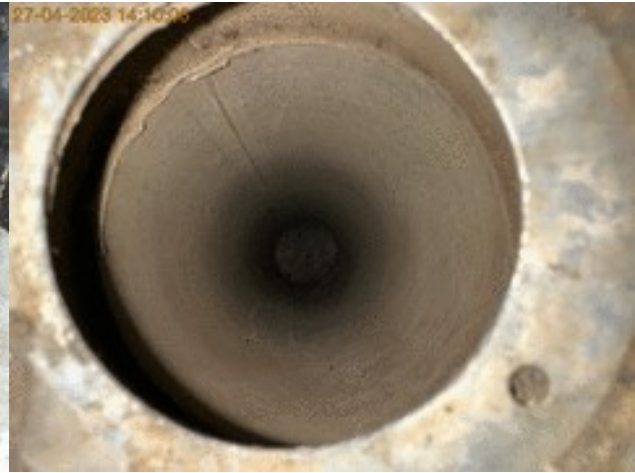
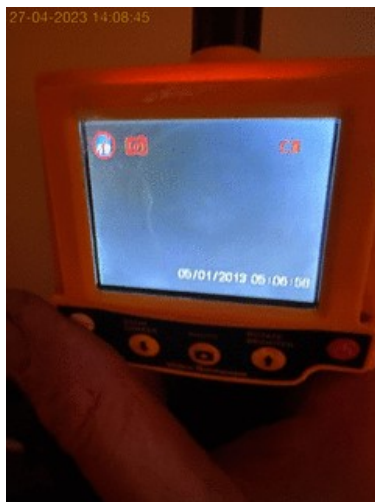
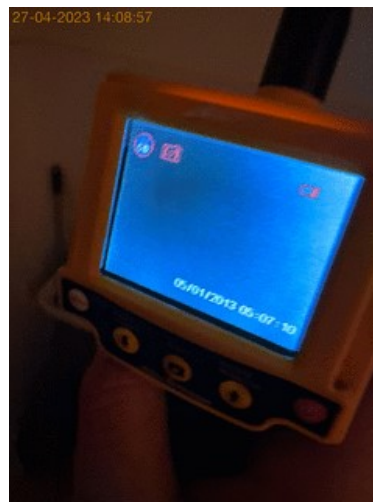
Goulden House - Flat 108 - bathroom extract. Solid ducting in good condition (visual and borescope camera inspection). We can not reach vertical riser duct from this grille to see if any fire dampers fitted. No access to vertical ducting riser from this Flat.

Air flow reading:  
2.44 – before clean  
4.55 – after clean

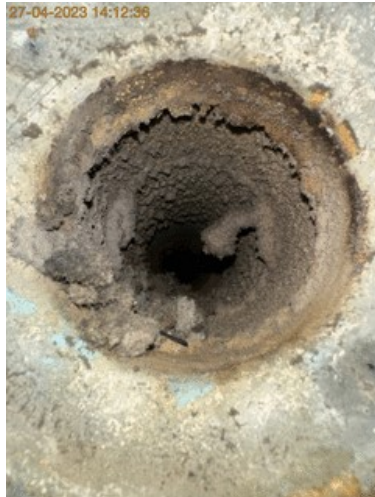
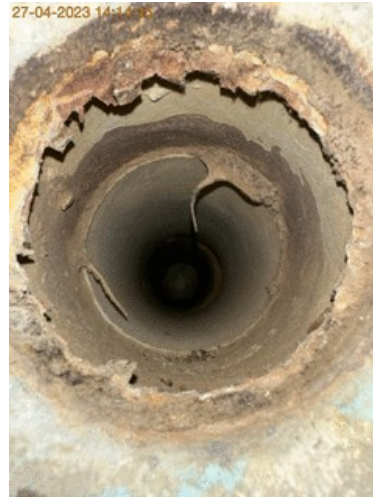
Goulden House - flat 108 - bathroom extract. Solid ducting in bad condition (visual and borescope camera inspection). We can not reach vertical riser duct from this grille to see if any fire dampers fitted. No access to vertical ducting riser from this Flat.

Air flow reading:  
2.60 – before clean  
3.41 – after clean

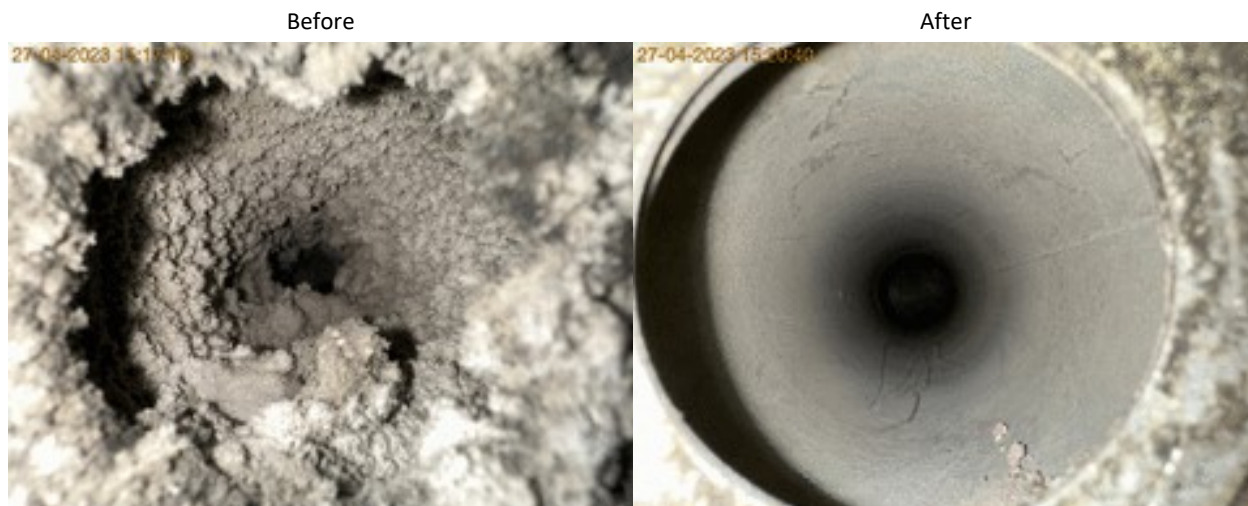
Goulden House - Flat 112 - bathroom extract. Solid ducting in good condition (visual and borescope camera inspection). We can not reach vertical riser duct from this grille to see if any fire dampers fitted. No access to vertical ducting riser from this Flat.

Air flow reading:  
2.12 – before clean  
3.28 – after clean

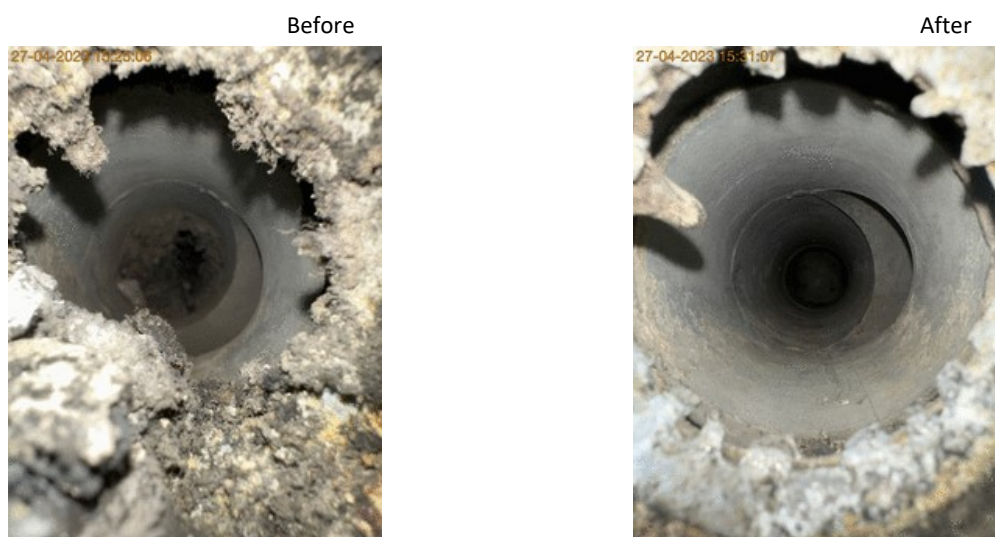
Goulden House - Flat 112 - bathroom extract. Solid ducting in good condition (visual and borescope camera inspection). We can not reach vertical riser duct from this grille to see if any fire dampers fitted. No access to vertical ducting riser from this Flat.

Air flow reading:  
2.42 – before clean  
3.20 – after clean

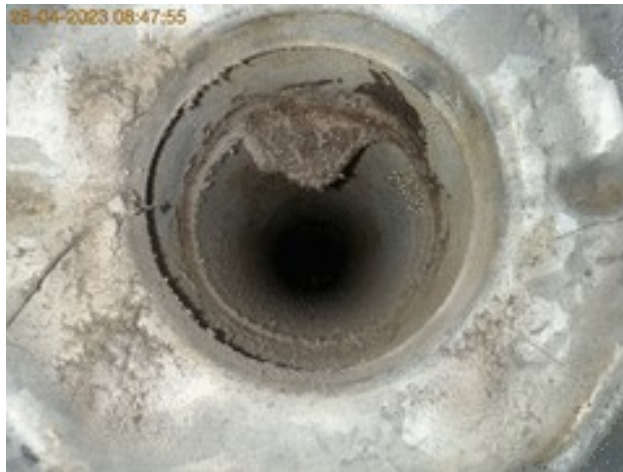
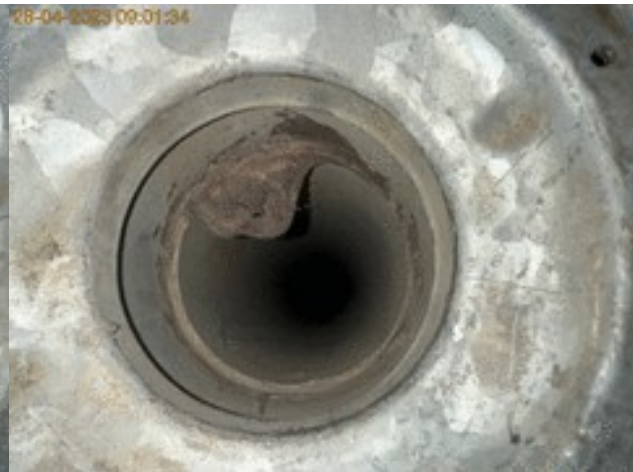
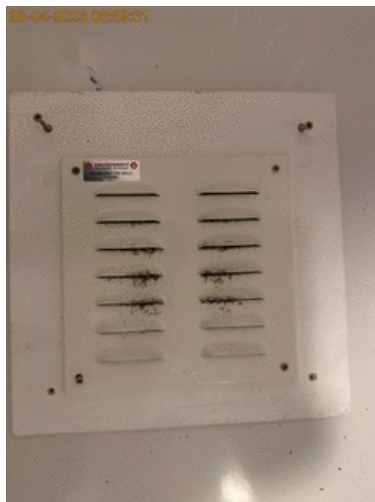
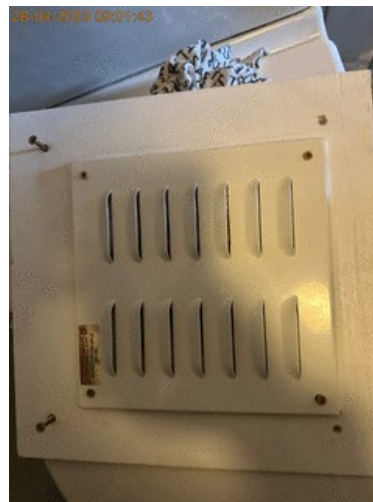
Goulden House - Entrance B Level 4 Flat 213 - bathroom extract. Solid ducting in bad condition (visual and borescope camera inspection). We can not reach vertical riser duct from this grille to see if any fire dampers fitted. No access to vertical ducting riser from this Flat.

Air flow reading:  
2.45 – before clean  
3.77 – after clean

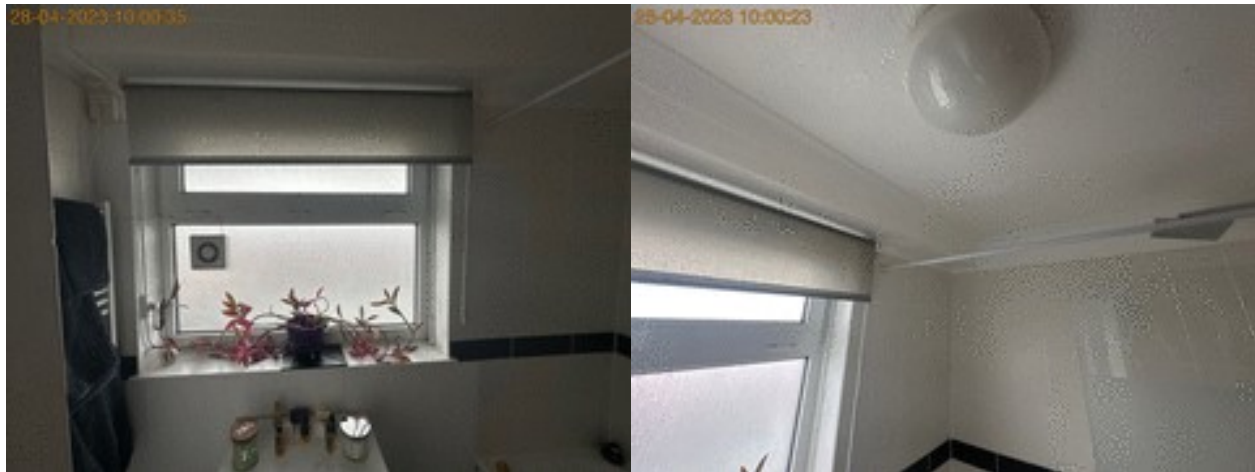
Goulden House - Entrance B Level 4 Flat 186 – no ducting along with fan unit. Window based fan only.

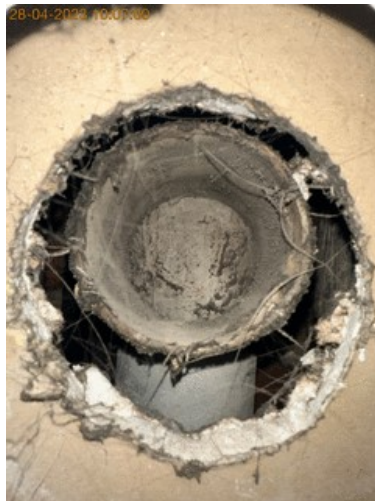
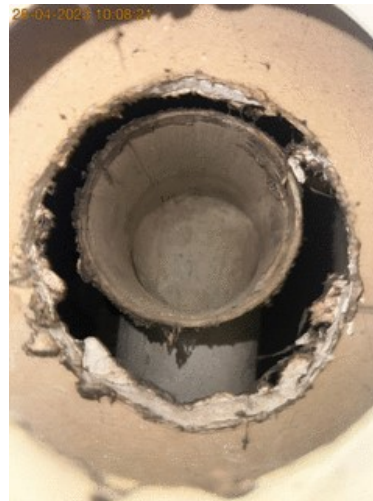
Goulden House - Entrance B Level 4 Flat 200 - bathroom extract. Solid ducting in bad condition (visual and borescope camera inspection). We can not reach vertical riser duct from this grille to see if any fire dampers fitted. No access to vertical ducting riser from this Flat.

3.57 – after clean

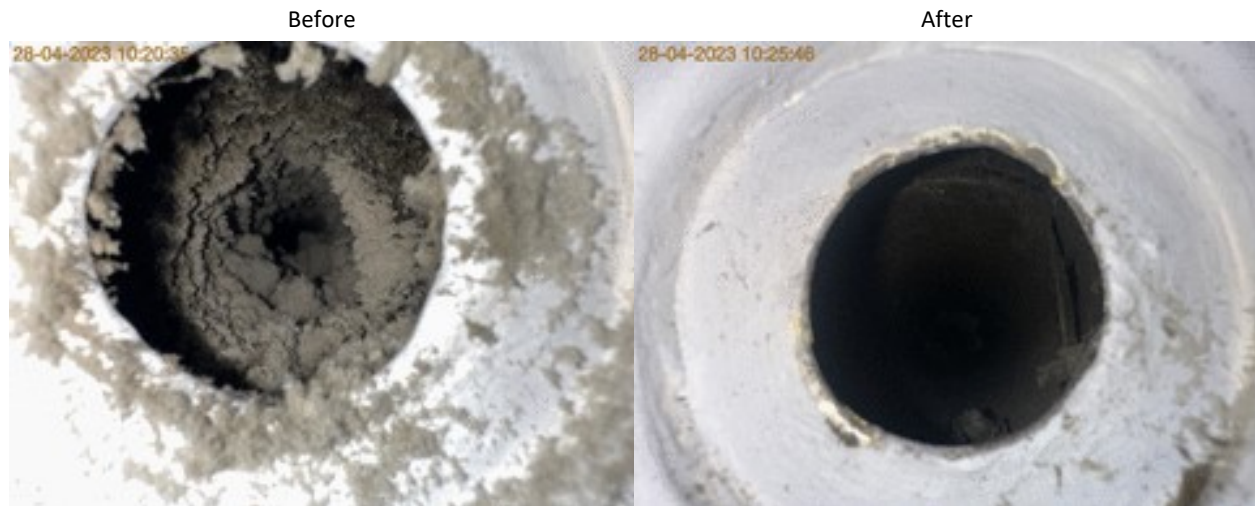
Goulden House - Entrance B Level 4 Flat 216 bathroom extract. Solid ducting in bad condition (visual and borescope camera inspection). We can not reach vertical riser duct from this grille to see if any fire dampers fitted. No access to vertical ducting riser from this Flat.

Air flow reading:  
3.12 – before clean  
4.28 – after clean

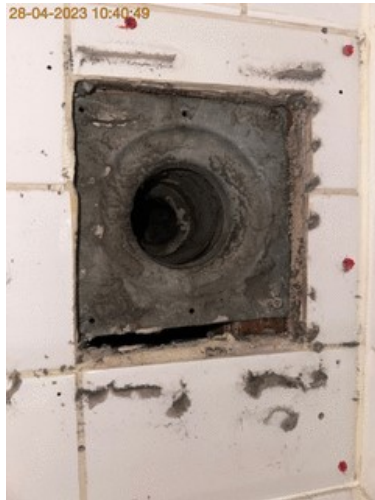
Goulden House - Entrance C Level 4 Flat 222 - bathroom extract. Solid ducting in good condition (visual and borescope camera inspection). We can not reach vertical riser duct from this grille to see if any fire dampers fitted. No access to vertical ducting riser from this Flat.

Air flow reading:  
3.17 – before clean  
4.23 – after clean

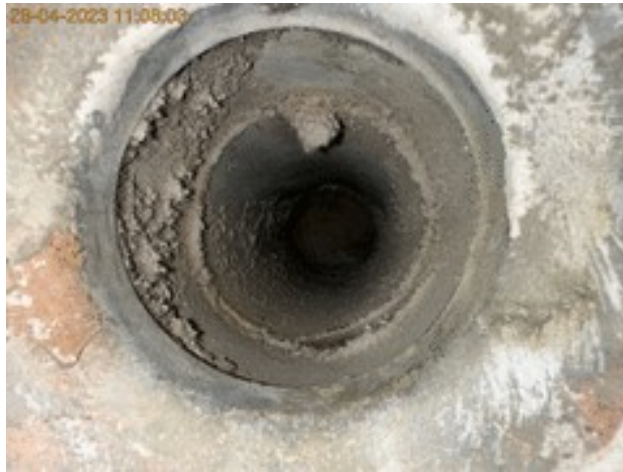
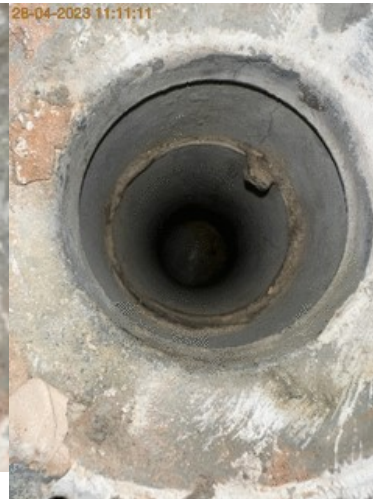
Goulden House - Entrance C Level 4 Flat 223. Solid ducting in good condition (visual and borescope camera inspection). We can not reach vertical riser duct from this grille to see if any fire dampers fitted. No access to vertical ducting riser from this Flat.

Air flow reading:  
3.03 – before clean  
3.29 – after clean

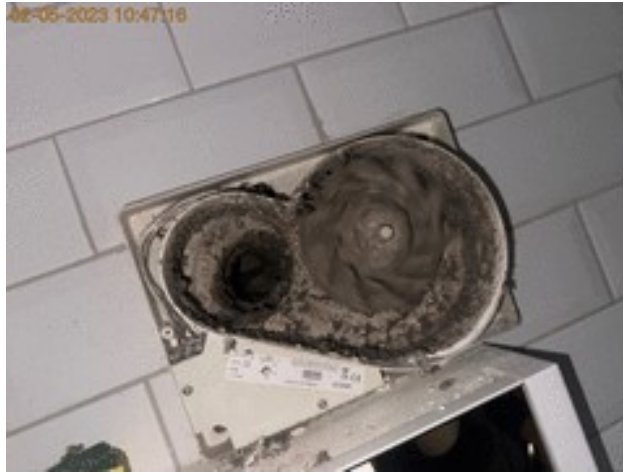
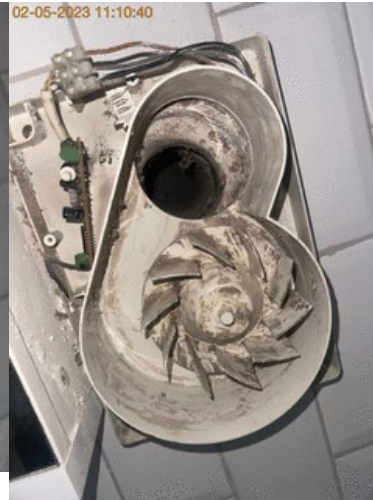
Goulden House - Entrance C Level 4 Flat 225 - bathroom extract. No access to the ducting as the unit is sealed. No access to the vertical ducting riser from this Flat. The unit has been cleaned.

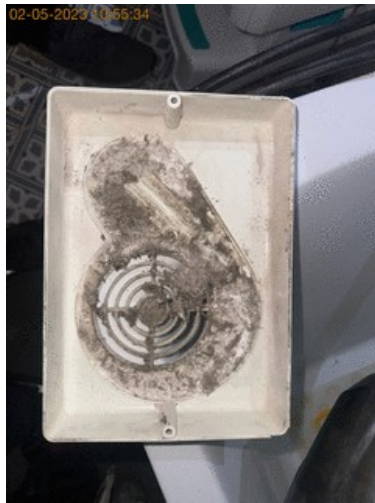
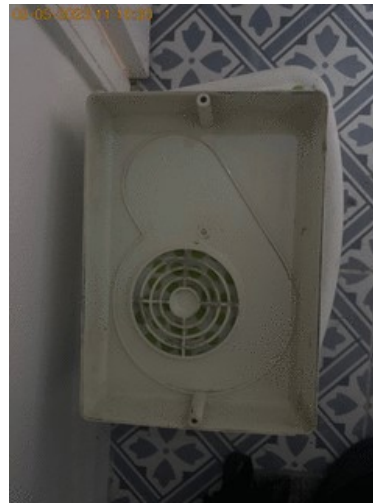
Goulden House - Flat 225 - bathroom extract fan cover. No access to the ducting as the unit is sealed. No access to the vertical ducting riser from this Flat. The unit has been cleaned.

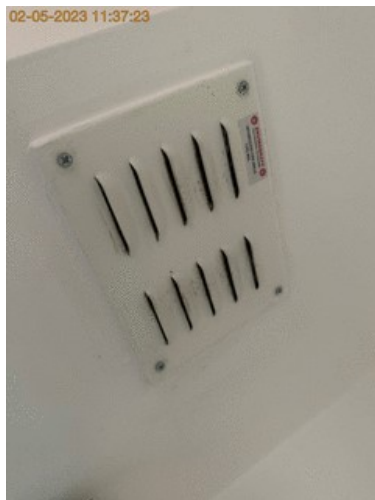
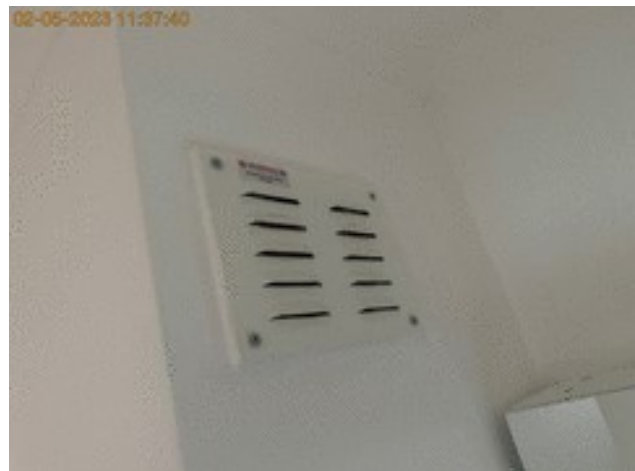
Goulden House - Flat 225 - bathroom extract. No access to the ducting as the unit is sealed. No access to the vertical ducting riser from this Flat. The unit has been cleaned.

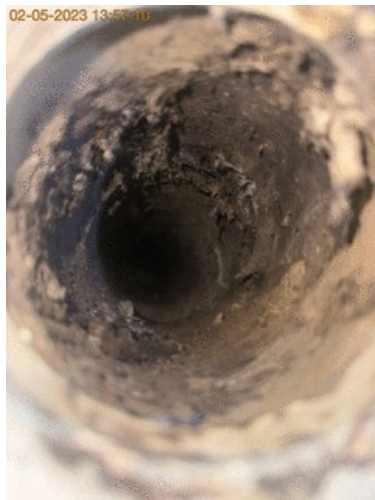
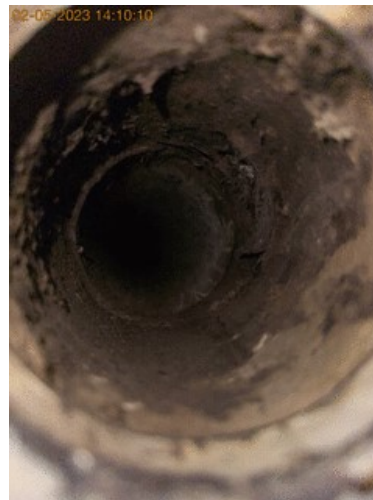
Goulden House - Entrance C Level 4 Flat 221 - bathroom extract. Solid ducting in bad condition (visual and borescope camera inspection). We can not reach vertical riser duct from this grille to see if any fire dampers fitted. No access to vertical ducting riser from this Flat.

3.26 – after clean

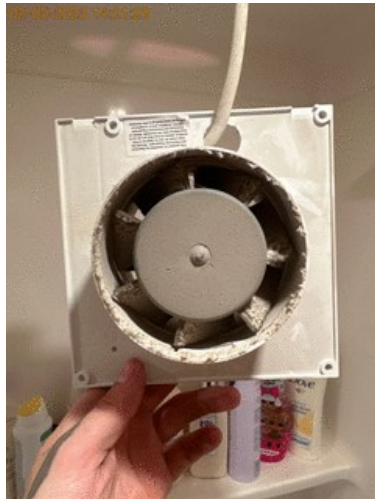
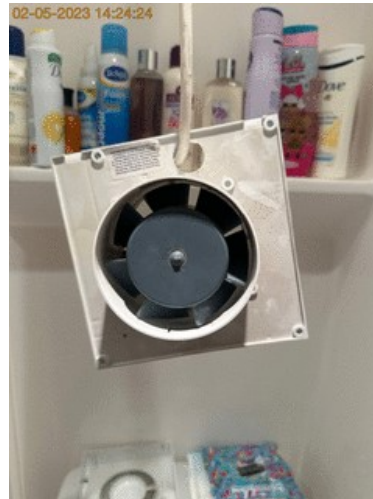
Goulden House - Entrance C Level 4 Flat 229 - bathroom extract. No access to the ducting as the unit is sealed. No access to the vertical ducting riser from this Flat. The unit has been cleaned.

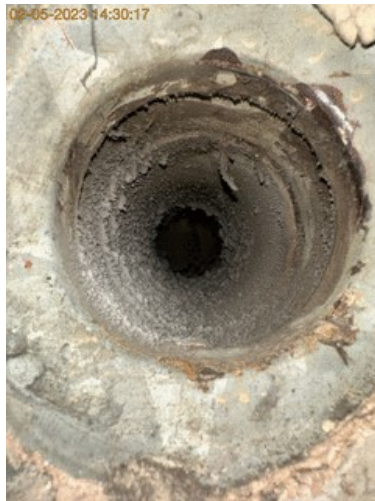
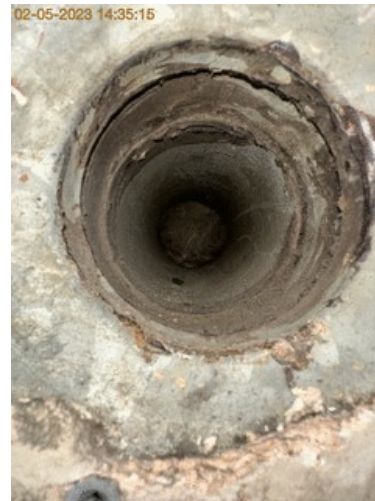
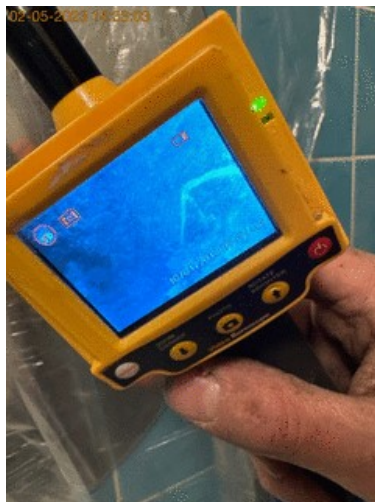
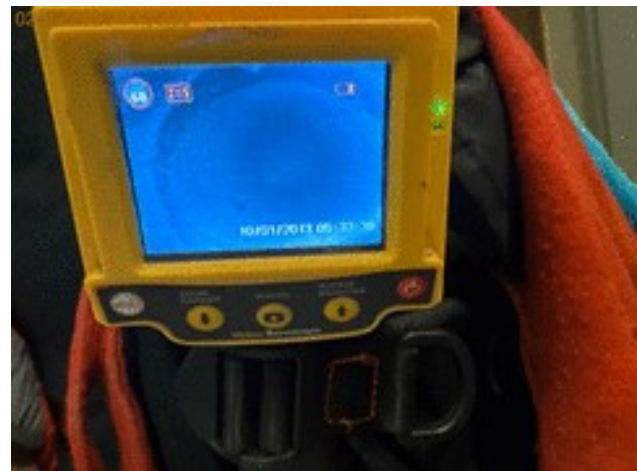
Goulden House - Entrance C Level 4 Flat 230 bathroom extract. Solid ducting in bed condition (visual and borescope camera inspection) – the system is isolated. We can not reach vertical riser duct from this grille to see if any fire dampers fitted. No access to vertical ducting riser from this Flat.

Air flow reading:  
0.00 – before clean  
0.00 – after clean

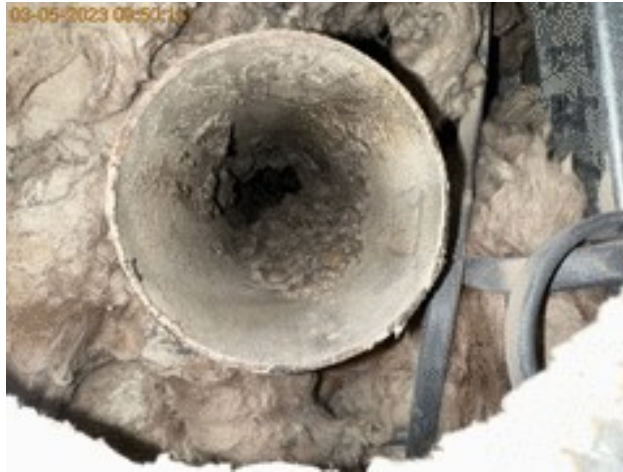
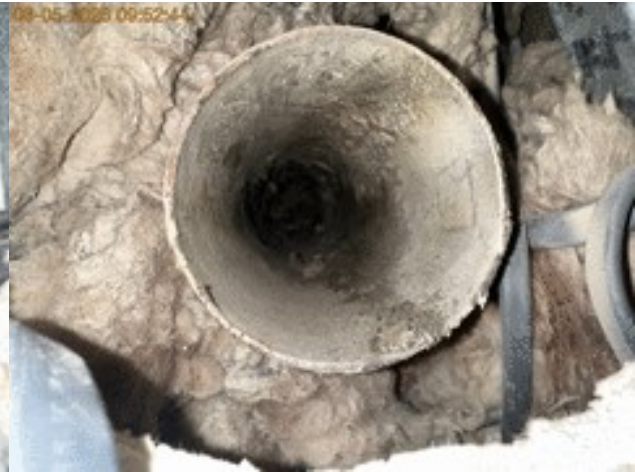
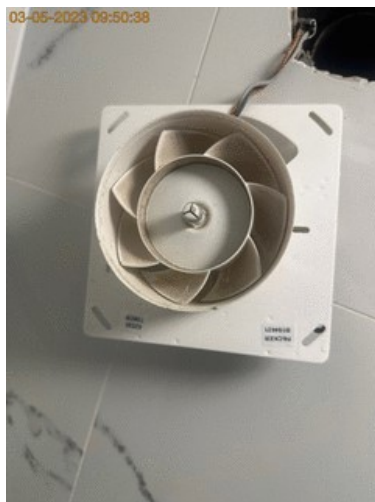
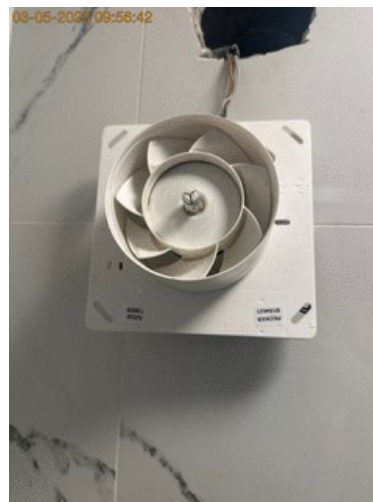
Goulden House - Entrance C Level 4 Flat 231 bathroom extract. Solid ducting in bad condition (visual and borescope camera inspection). We can not reach vertical riser duct from this grille to see if any fire dampers fitted. No access to vertical ducting riser from this Flat.

Air flow reading:  
3.10 – before clean  
3.22 – after clean

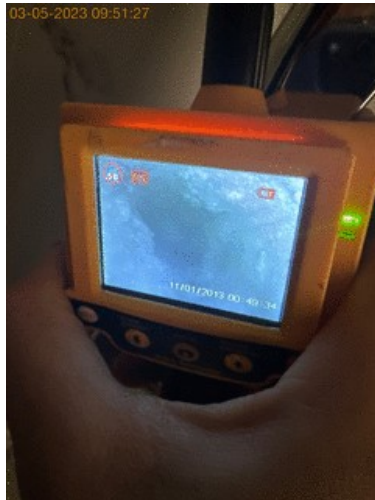
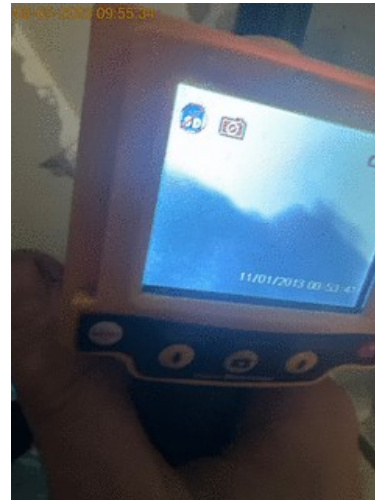
Goulden House - Entrance C Level 4 Flat 232 – bathroom extract. Solid ducting in good condition (visual and borescope camera inspection). We can not reach vertical riser duct from this grille to see if any fire dampers fitted. No access to vertical ducting riser from this Flat.

Air flow reading:  
2.81 – before clean  
3.10 – after clean

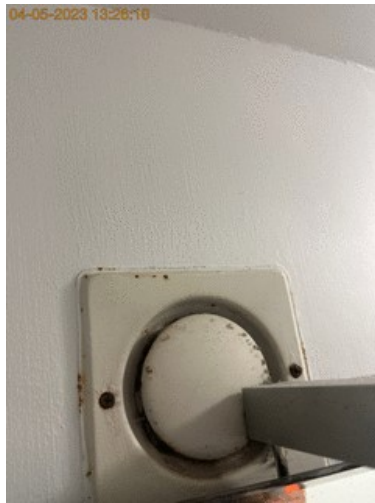
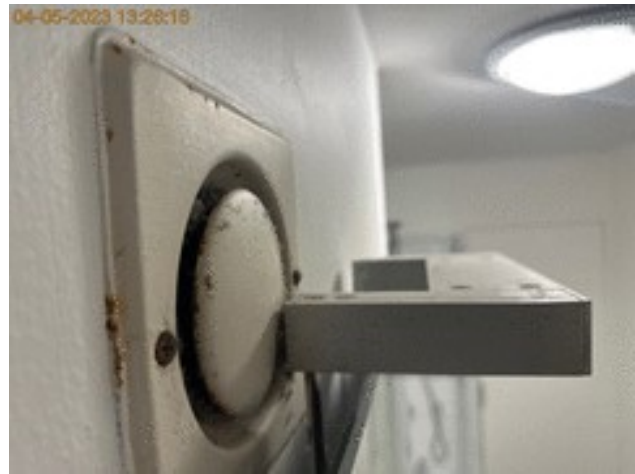
Goulden House - Entrance C Level 4 Flat 236 – bathroom extract. No access to the ducting as the unit is sealed. No access to the vertical ducting riser from this Flat. The unit has been cleaned.

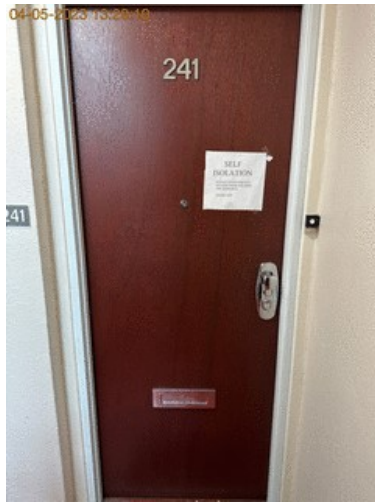
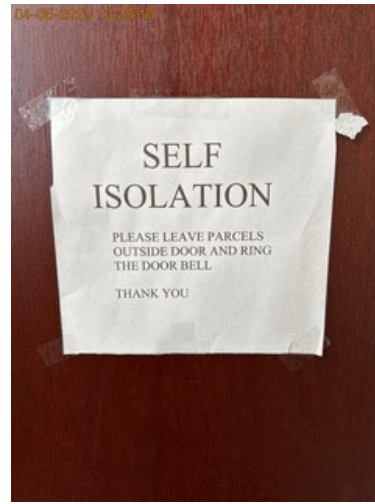
Goulden House - Flat 241 - no access to this Flat.

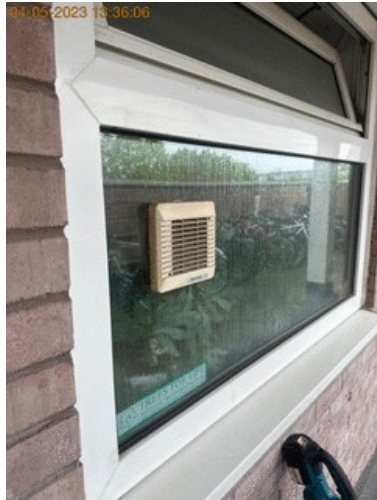
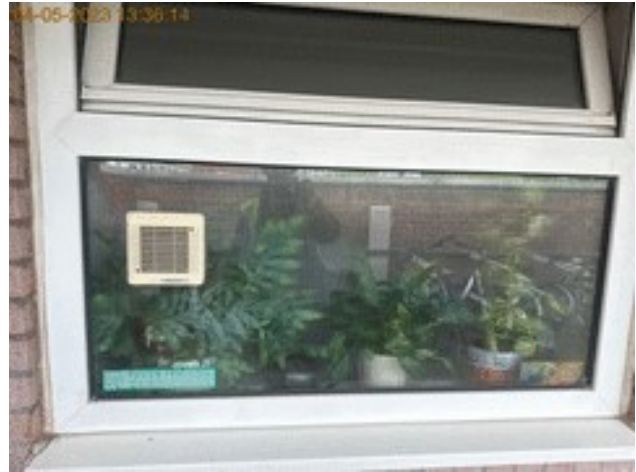
Goulden House - Entrance C Level 4 Flat 250 – window based fan.

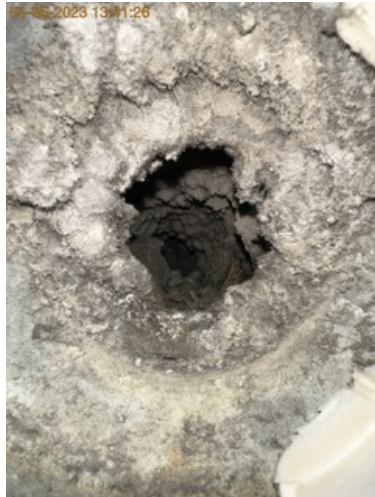
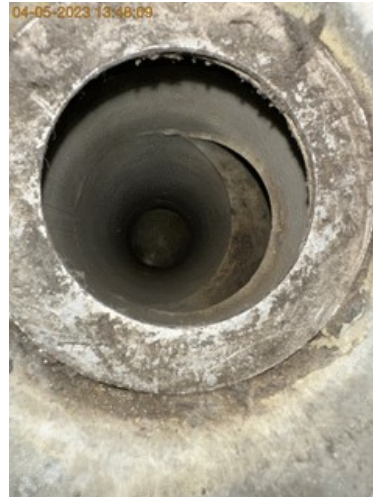
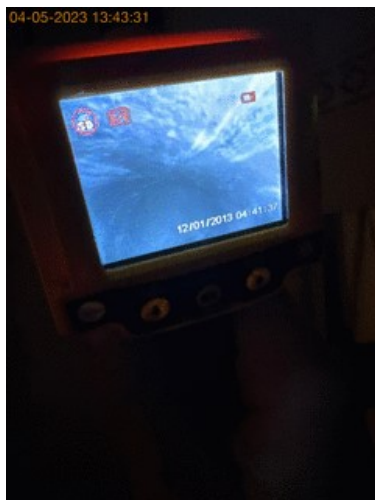
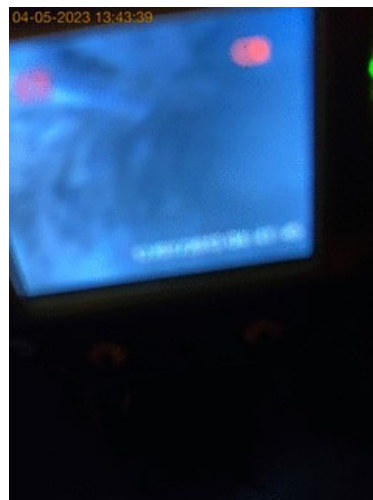
Goulden House - Entrance C Level 4 Flat 253 - bathroom extract. Solid ducting in good condition (visual and borescope camera inspection). We can not reach vertical riser duct from this grille to see if any fire dampers fitted. No access to vertical ducting riser from this Flat.

Air flow reading:  
2.45 – before clean  
3.68 – after clean
