## VENTILATION HYGIENE REPORT

Site Name: Goulden House

Overclean Job Ref: 33331

Completion Date: 05/05/2023

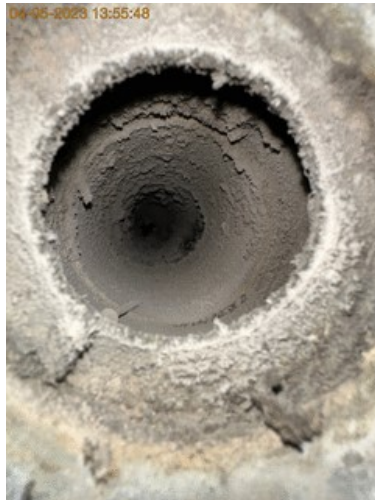
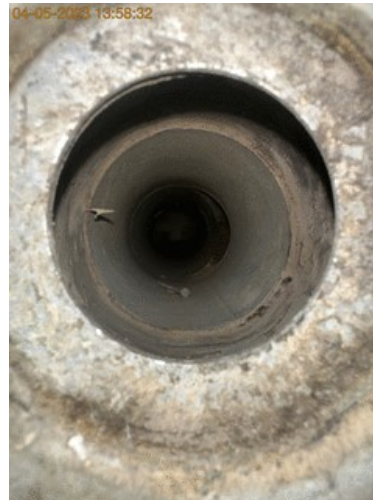
Goulden House - Entrance C Level 4 Flat 259 - bathroom extract. Solid ducting in good condition (visual and borescope camera inspection). We can not reach vertical riser duct from this grille to see if any fire dampers fitted. No access to vertical ducting riser from this Flat.

Air flow reading:  
3.56 – before clean  
4.67 – after clean

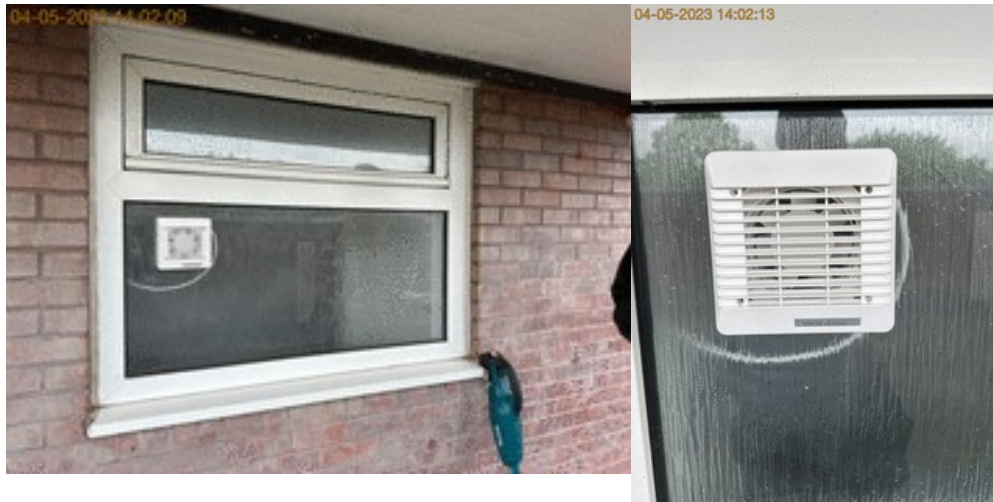
Goulden House - Flat 260 - window based fan

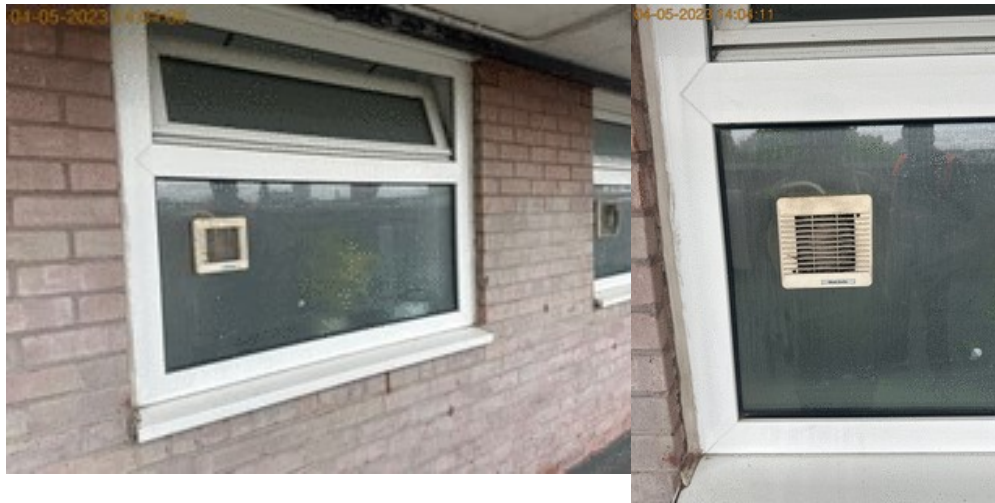
Goulden House - Flat 261 bathroom window based fan.

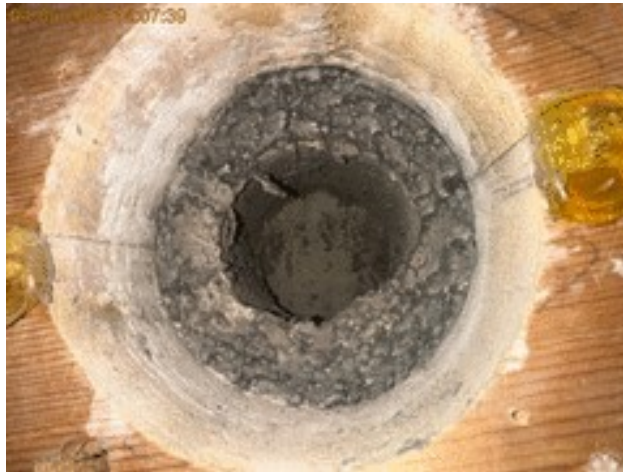
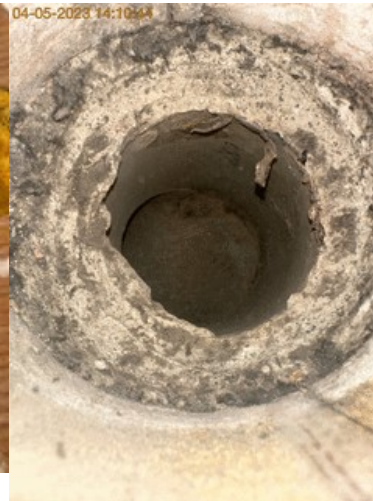
Goulden House - Entrance C Level 4 Flat 263 - bathroom extract. Solid ducting in bad condition (visual and borescope camera inspection). We can not reach vertical riser duct from this grille to see if any fire dampers fitted. No access to vertical ducting riser from this Flat.

Air flow reading:  
3.12 – before clean  
4.02 – after clean

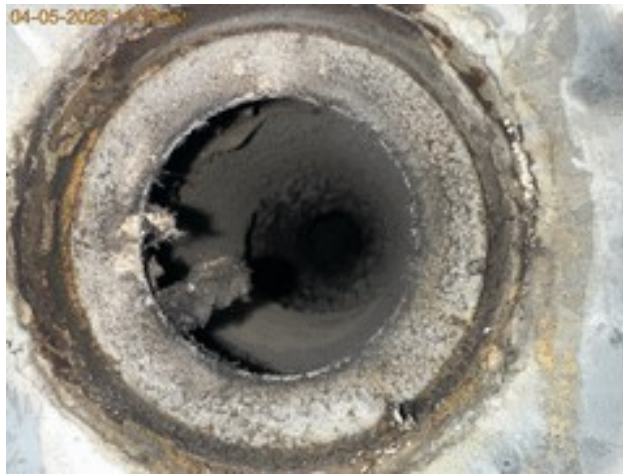
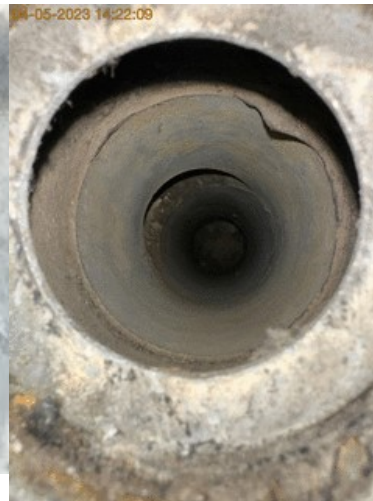
Goulden House - Entrance C Level 4 Flat 264 - bathroom extract. Solid ducting in bad condition (visual and borescope camera inspection). We can not reach vertical riser duct from this grille to see if any fire dampers fitted. No access to vertical ducting riser from this Flat.

3.22 – after clean

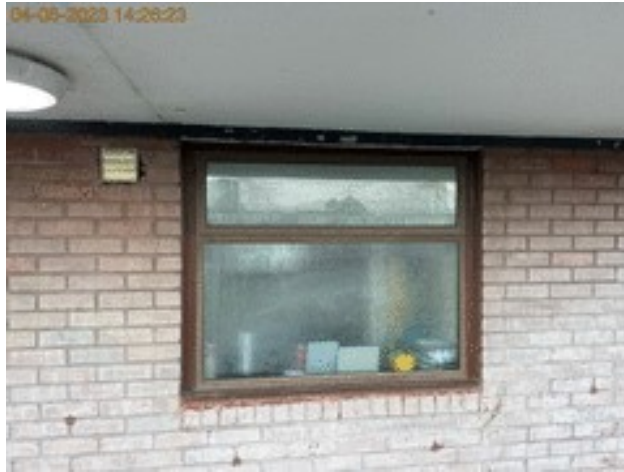
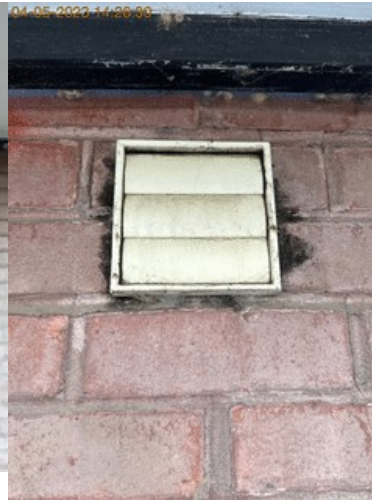
Goulden House - Flat 266 – wall based unit.

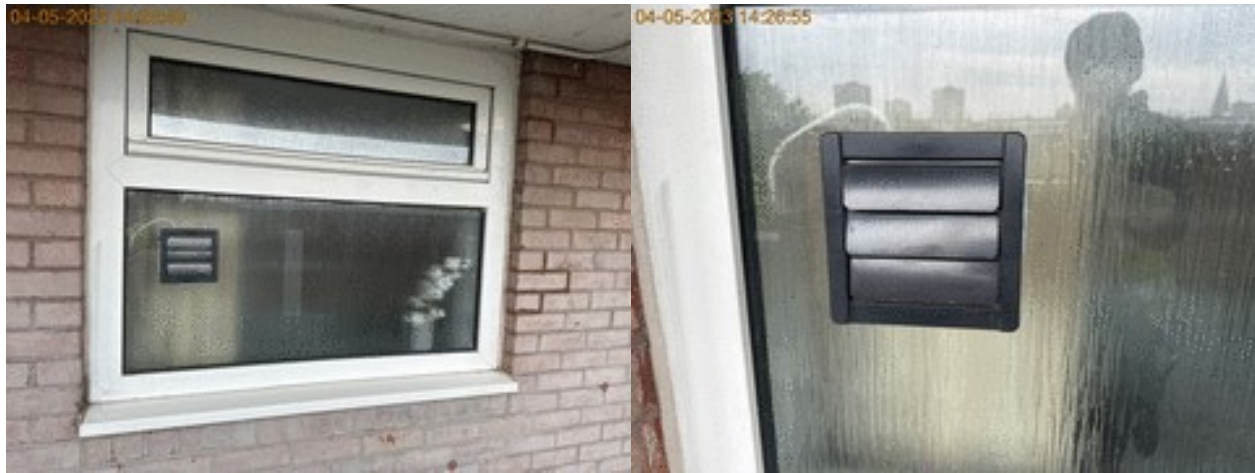
Goulden House - Flat 267 - window based fan.

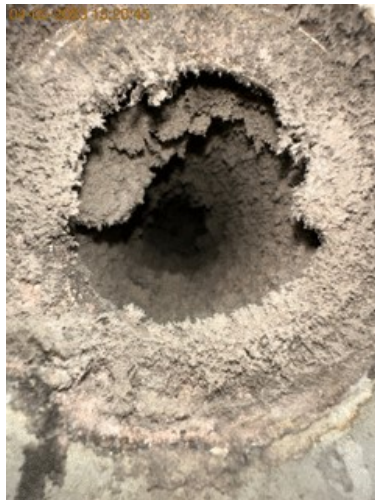
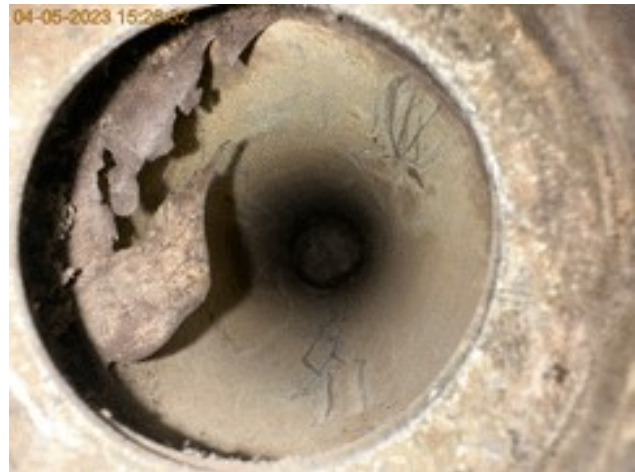
Goulden House - Flat 113 - bathroom extract. Solid ducting in bad condition (visual and borescope camera inspection). We can not reach vertical riser duct from this grille to see if any fire dampers fitted. No access to vertical ducting riser from this Flat.

Air flow reading:  
3.11 – before clean  
3.59 – after clean

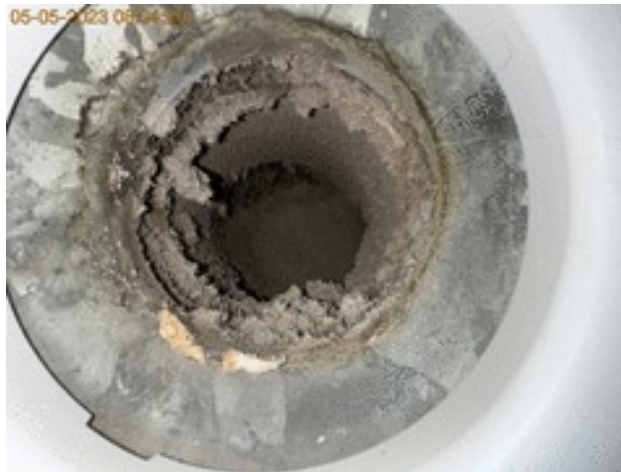
Goulden House - Entrance C Level 5 Flat 87 bathroom extract. Solid ducting in good condition (visual and borescope camera inspection). We can not reach vertical riser duct from this grille to see if any fire dampers fitted. No access to vertical ducting riser from this Flat.

Air flow reading:  
2.44 – before clean  
3.56 – after clean

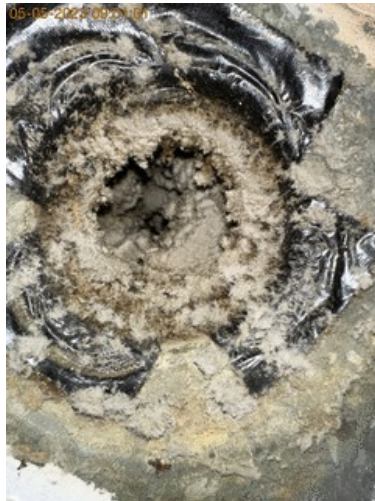
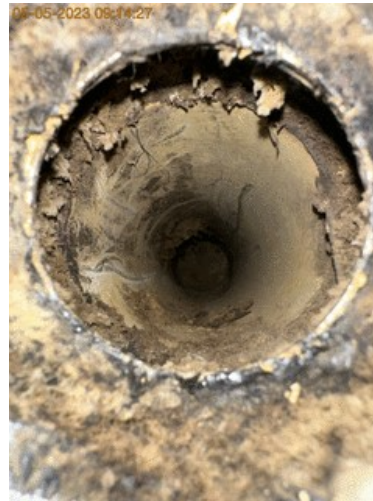
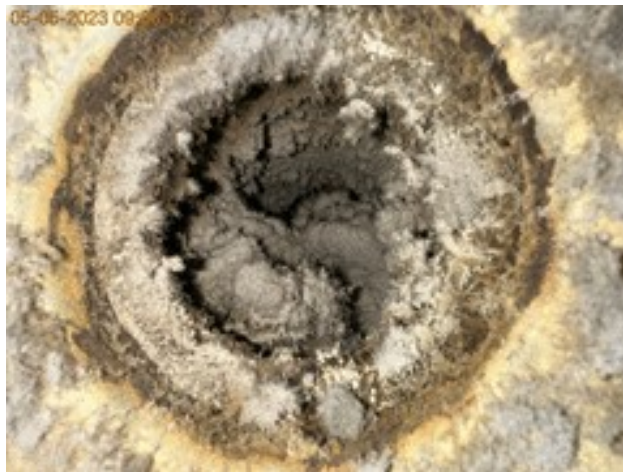
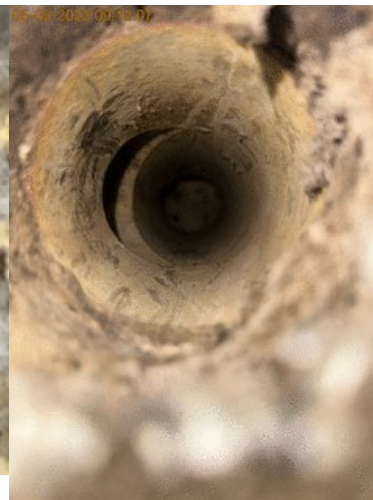
Goulden House - Flat 117 - bathroom extract. Solid ducting in bad condition (visual and borescope camera inspection) We can not reach vertical riser duct from this grille to see if any fire dampers fitted. No access to vertical ducting riser from this Flat.

Air flow reading:  
0.00 – before clean  
2.44 – after clean

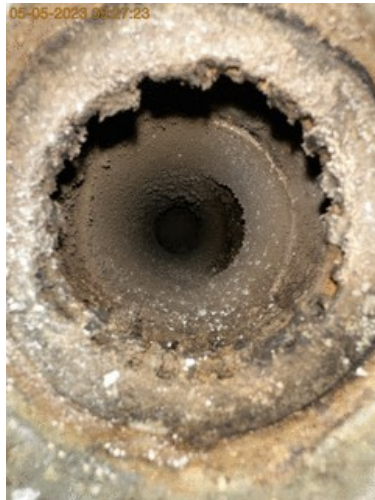
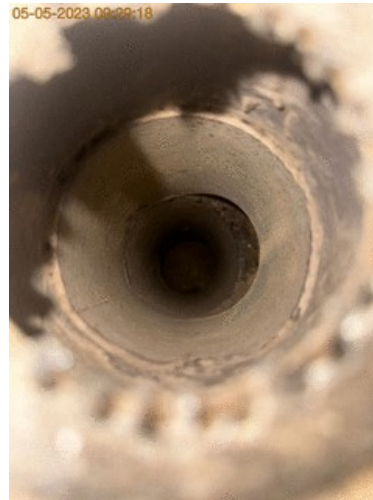
Goulden House - Flat 118 - bathroom extract. Solid ducting in good condition (visual and borescope camera inspection). We can not reach vertical riser duct from this grille to see if any fire dampers fitted. No access to vertical ducting riser from this Flat.

4.66 – after clean

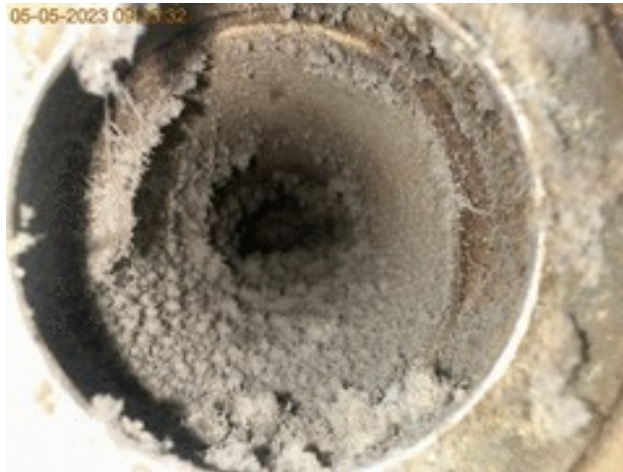
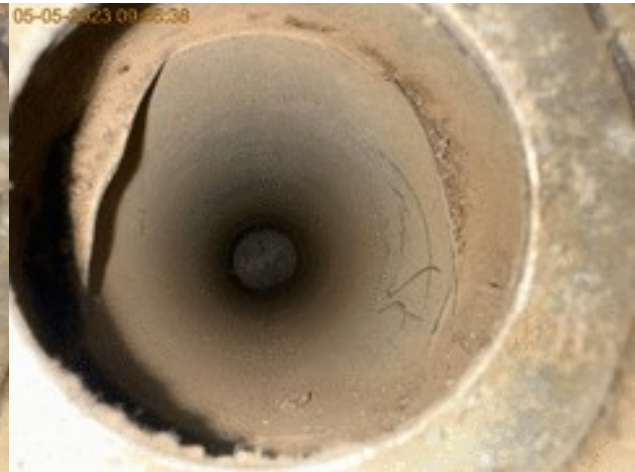
Goulden House - Flat 119 - bathroom extract. Solid ducting in bad condition (visual and borescope camera inspection). We can not reach vertical riser duct from this grille to see if any fire dampers fitted. No access to vertical ducting riser from this Flat.

Air flow reading:  
3.44 – before clean

4.67 – after clean

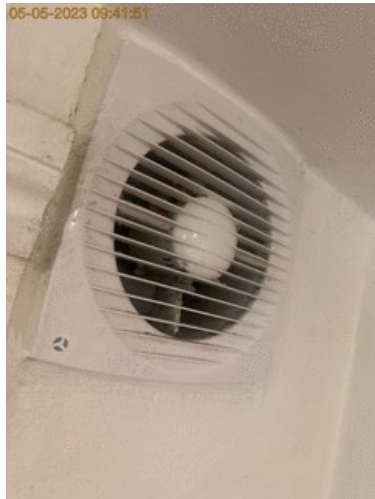
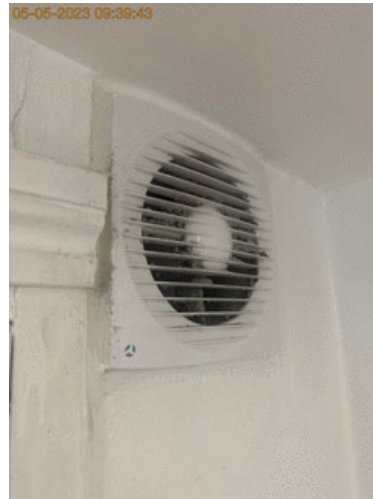
Goulden House - Flat 120 - bathroom extract. No access to the ducting as the unit is sealed. No access to the vertical ducting riser from this Flat. The unit has been cleaned.

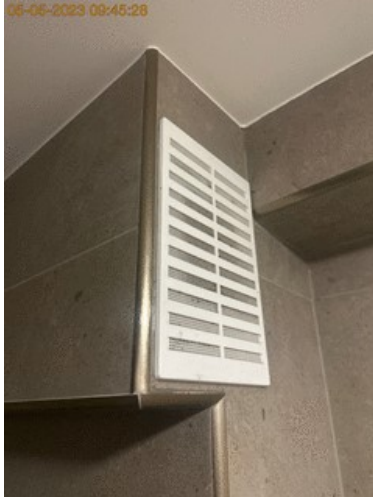
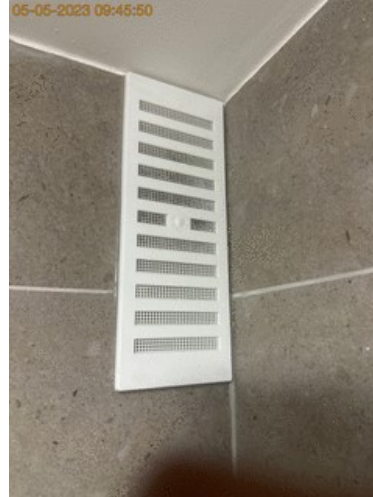
Goulden House - Flat 122. No access to the ducting as the unit is sealed. No access to the vertical ducting riser from this Flat. The unit has been cleaned.

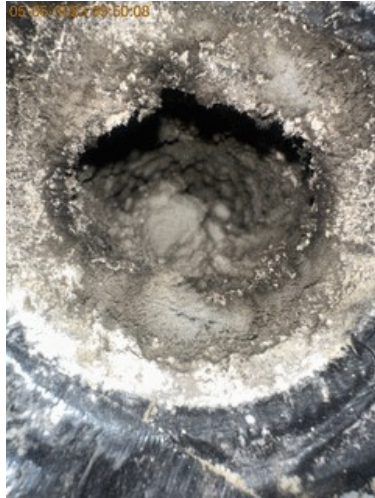
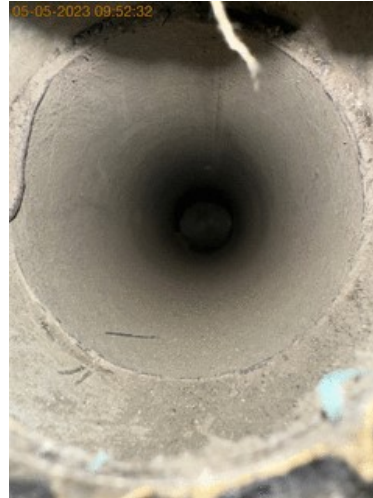
Goulden House - Flat 123 - bathroom extract. Solid ducting in good condition. We can not reach vertical riser duct from this grille to see if any fire dampers fitted. No access to vertical ducting riser from this Flat.

3.28 – after clean

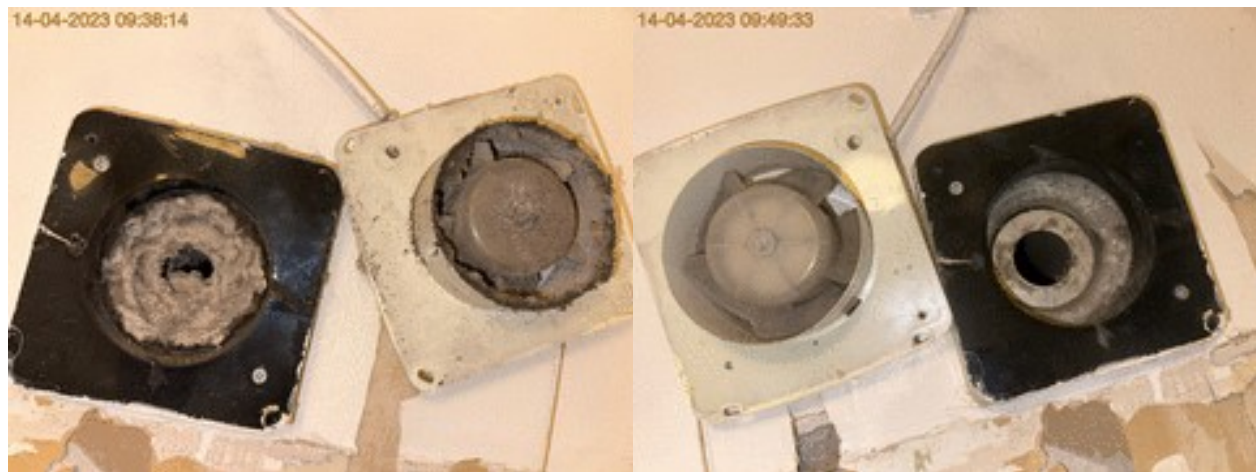
Goulden House - Entrance A Flat 51 bathroom extract. Solid ducting in good condition. We can not reach vertical riser duct from this grille to see if any fire dampers fitted. No access to vertical ducting riser from this Flat

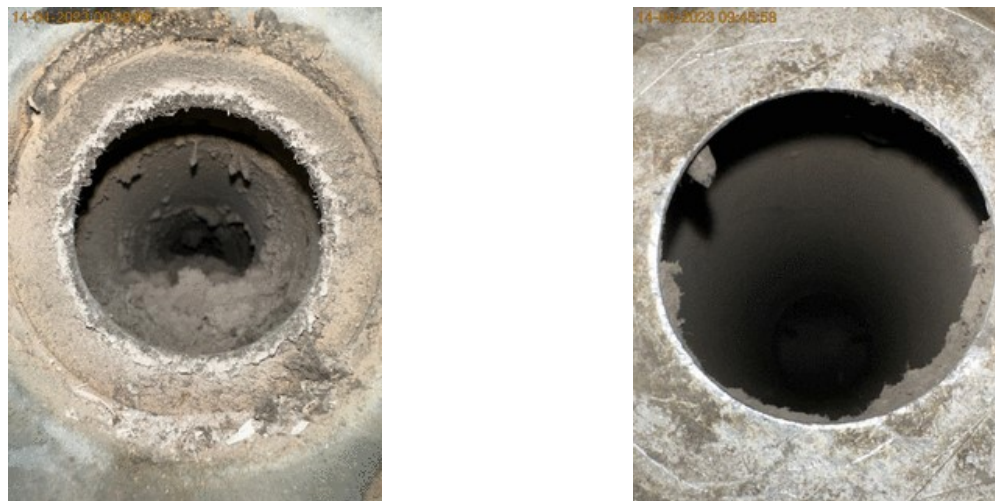
Goulden House - Entrance A Flat 51 - bathroom extract. Solid ducting in bad condition. We can not reach vertical riser duct from this grille to see if any fire dampers fitted. No access to vertical ducting riser from this Flat.

before clean air flow - 2.89

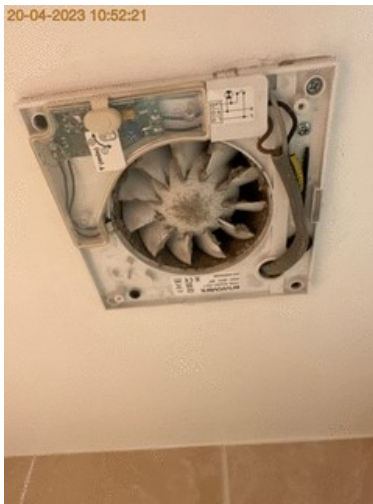
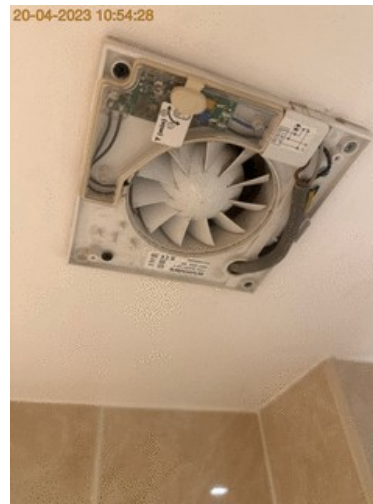
Goulden House - Flat 57 bathroom extract. No access to the ducting as the unit is sealed. No access to the vertical ducting riser from this Flat. The unit has been cleaned.

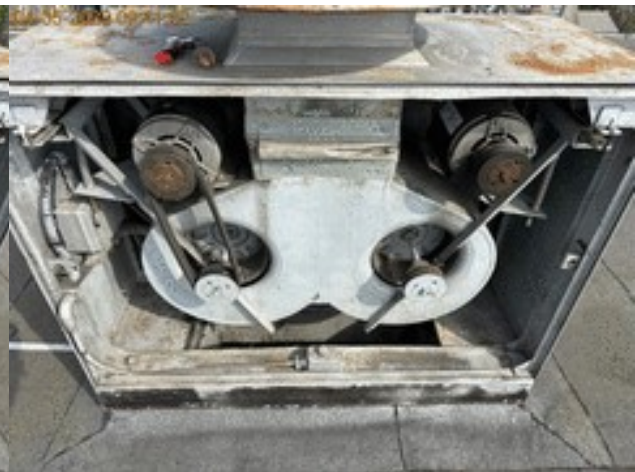
After

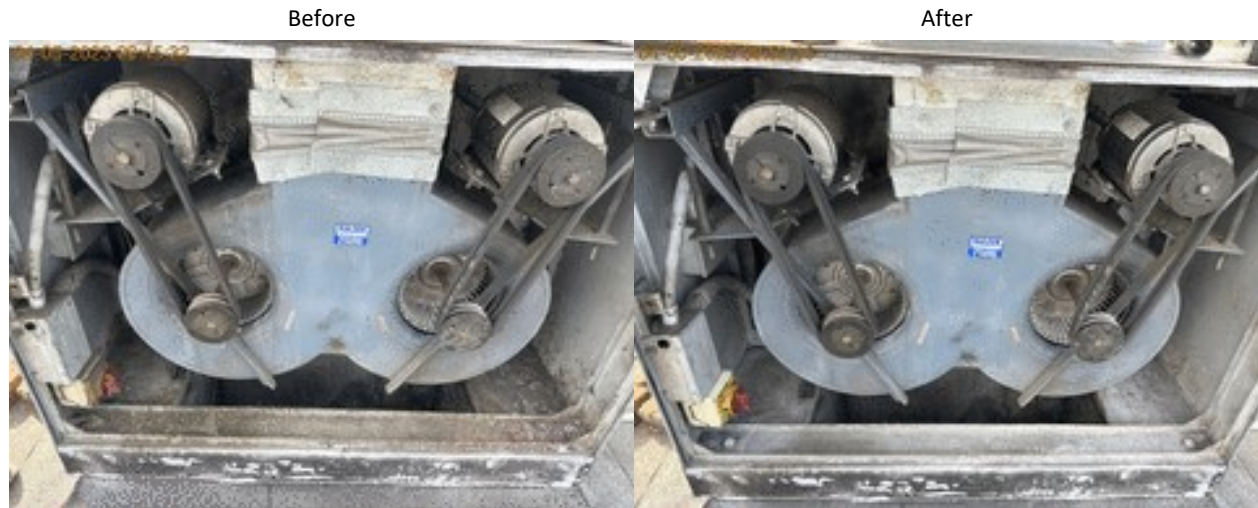
Goulden House - Phase B Fan No.685 far side flats near entrance B - belts changed due to breakage – Extract
